Airworthiness Directive Schedule

Piper PA-30 Series (Twin Comanche)

28 June 2018

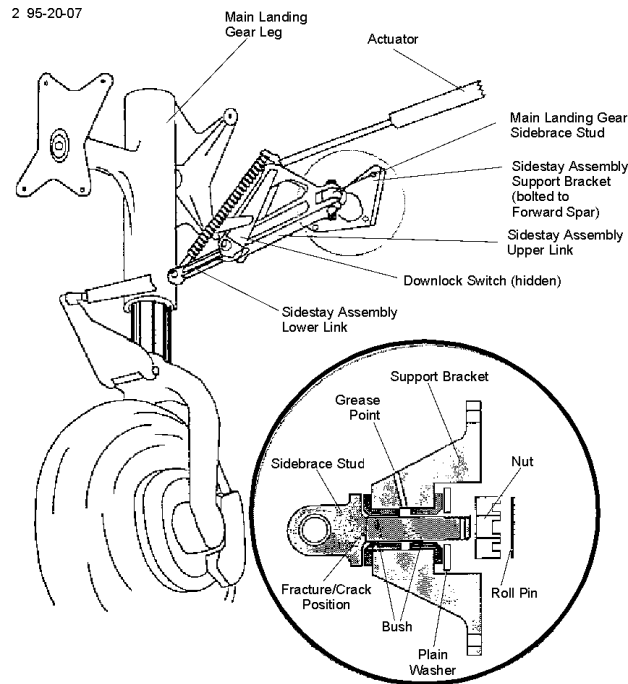
- Remove both the left and right main gear sidebrace studs from the aircraft per the instructions in the landing gear section of the aircraft MM. Inspect both the main gear sidebrace stud for cracks using Type I (fluorescent) liquid penetrant or magnetic particle inspection methods. Figure 1 of this AD depicts the area where the sidebrace stud is to be inspected.

Note: This figure is provided to depict the area of the sidebrace stud to be inspected. This is not intended to represent the configuration of all models affected.

For any main gear sidebrace stud not found cracked, before to further flight reinstall the stud per the instructions in the Landing Gear section of the applicable MM, and reinspect and replace (as necessary) per this AD.

For any main gear sidebrace stud found cracked, before to further flight replace the cracked stud with a serviceable part per the instructions in the Landing Gear section of the applicable MM, and reinspect and replace (as necessary) per this AD.
