# **CIVIL AVIATION AUTHORITY OF NEW ZEALAND**

## **AIRWORTHINESS DIRECTIVES**

**Amendment Nr 24-02**

**Effective date 29 February 2024**

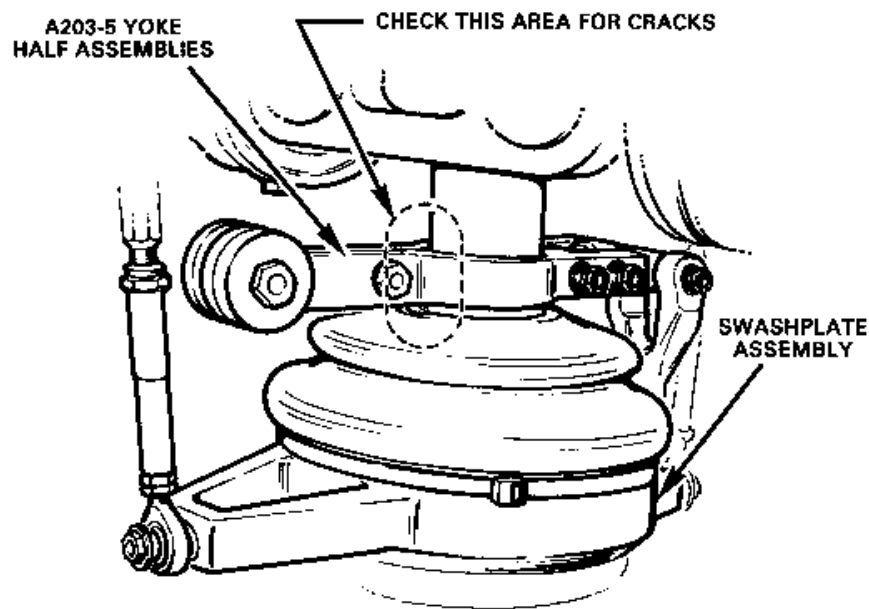
**Requirement:** To prevent failure of a yoke, separation of a yoke from the main rotor drive shaft, and subsequent loss of control of the helicopter, accomplish the following:-

1. Inspect each yoke for cracks. The diagram shows the area to be inspected. If a yoke is found cracked, before further flight, replace the yokes with airworthy yokes, P/N A203-7. Both yokes must be replaced with P/N A203-7.

2. Determine the Lot identifier of each yoke. If the Lot identifier is from 24 through 43, if it is a letter code, or if it is illegible, replace yokes, P/N A203-5, with airworthy yokes, P/N A203-7. Yoke, P/N A203-7, cannot be installed with yoke, P/N A203-5.

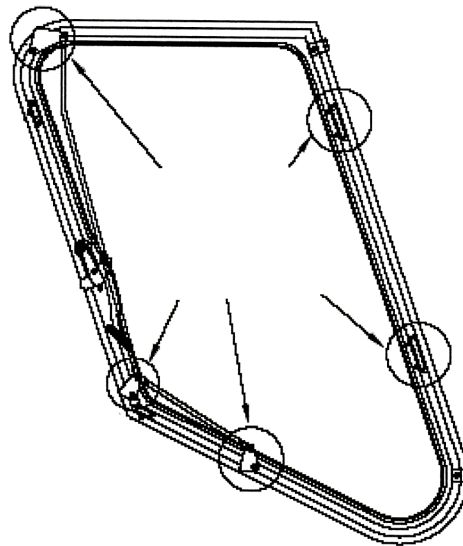
**Requirement:** To prevent separation of the door window or door assembly from the helicopter, which could damage the tail rotor during flight, and result in loss of control of the aircraft, accomplish the following:

1. Visually inspect each pilot and copilot door assembly integral frame for cracks in the locations indicated in the figure below:

**If a crack is found** in any door assembly integral frame, replace LH door assembly P/N R-22-101-51 or P/N R-22- 101-53, and R/H door assembly P/N R-22-101-52 or P/N R-22- 101-54, per Tech-Tool Plastics, Inc. Installation Instructions TTP-1R, Revision A, and per the sections titled "Door Weather Seal Installation" and "Cotter Pin Installation" in Tech-Tool Plastics, Inc. Service Bulletin TTP2005-01, Revision A, prior to further flight.

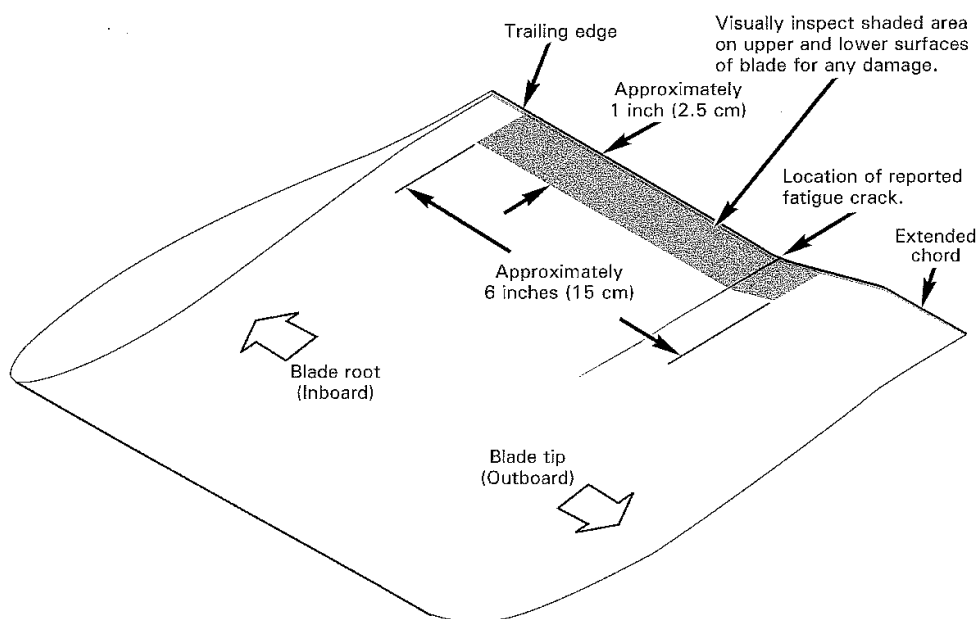
*Figure 1 – Section of MRB P/N C016-7 (View of blade lower surface)*

If any unusual rotor system vibration is detected in flight, land immediately and inspect the main rotor blades in the area shown in Figure 1. If the inspection reveals any damage or unusual marks, then the blades must be inspected by a maintenance engineer before further flight.

If the inspection reveals any damage or unusual marks, then the blades must be inspected by a maintenance engineer before further flight.

2. Modify the main rotor blades per the instructions in Robinson Helicopter Company R44 Service Bulletin SB-89 dated 30 March 2015.
