Airworthiness Directive Schedule

Aeroplanes

Britten-Norman Islander BN2A and BN2B Series

23 February 2023

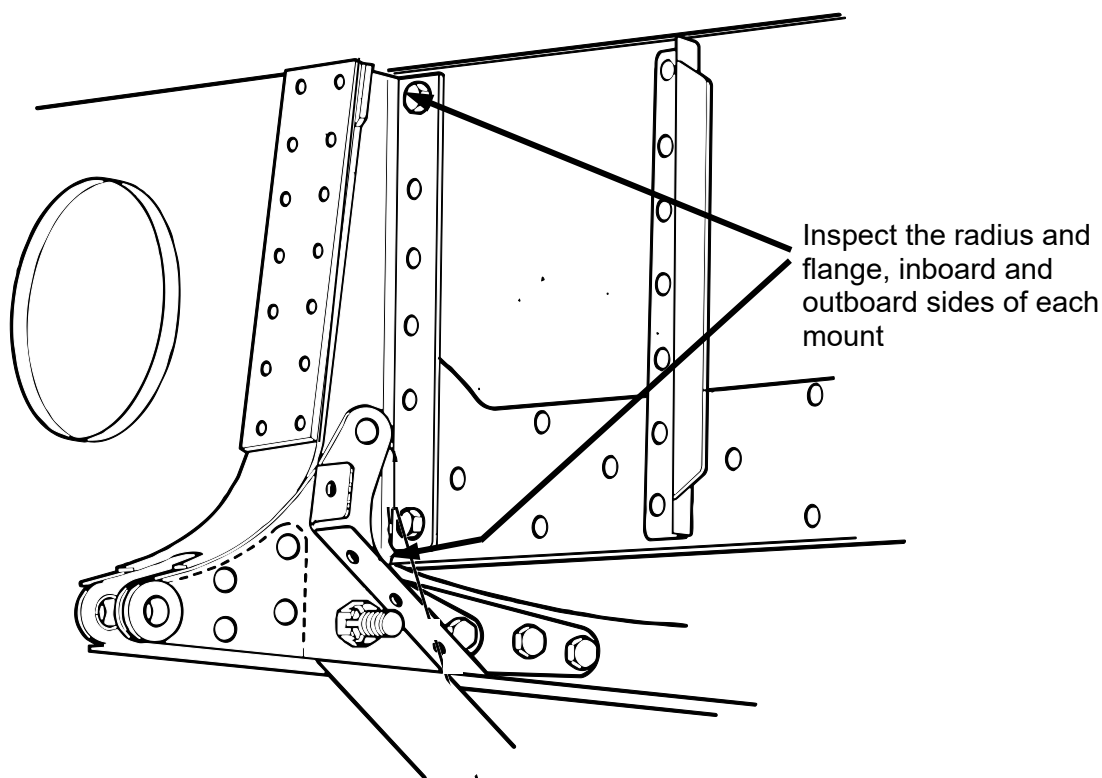
DCA/BN-2/62 Inspection of Engine Mounting Brackets

- Applicability:** All model BN2A, BN2B, BN2T, BN2T-4R and BN2T-4S series aircraft.
- Requirement:** To prevent cracking of the engine mount from progressing to the point where it may require extensive spar repairs or degrade the integrity of the engine mount, inspect the upper engine mounts per BN SB 275. In addition to the inspection area described in the SB, inspect the entire length of the flange that attaches the engine mount to the spar as shown on the diagram below. Inspect both inboard and outboard flanges of each engine mount.
(UK AD 005-11-2001 refers)
- Compliance:** Initial inspection within 100 hours TIS.
Repeat inspection at intervals not to exceed 500 hours TIS or 1000 landings whichever occurs first.
- Effective Date:** 27 June 2002
