Airworthiness Directive Schedule

Aeroplanes

Britten-Norman Islander BN2A and BN2B Series

26 July 2018

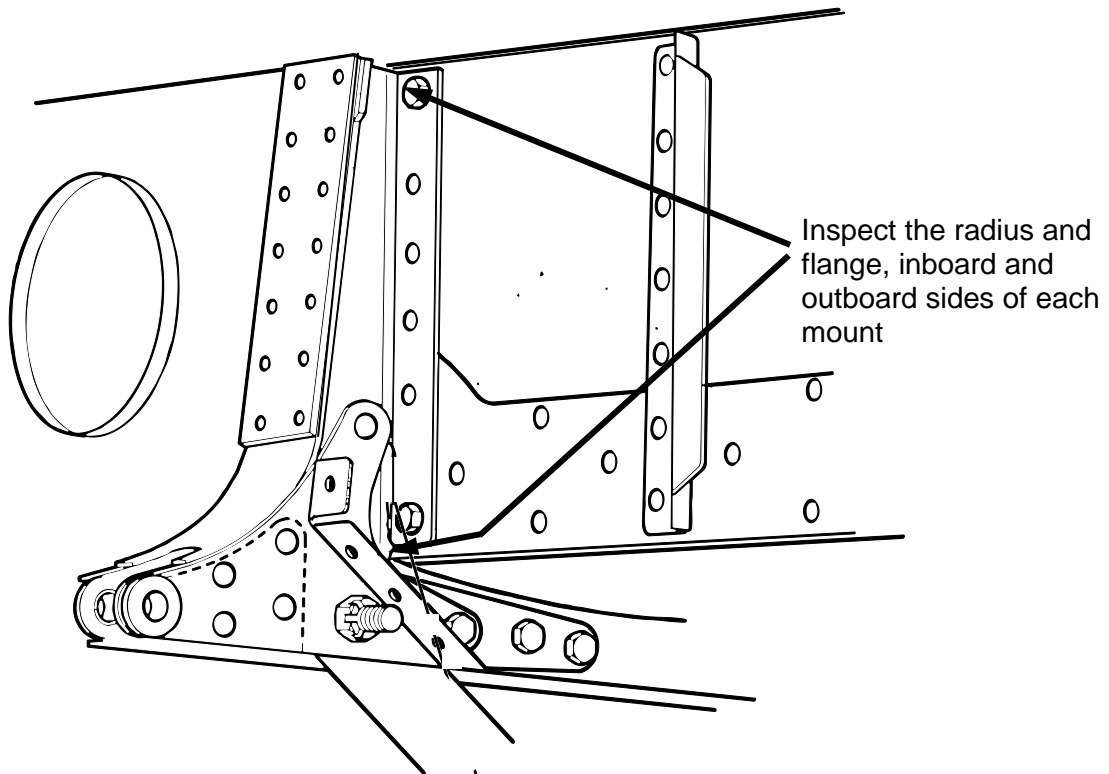
DCA/BN-2/62 Inspection of Engine Mounting Brackets

- Applicability:** All model BN2A, BN2B, BN2T, BN2T-4R and BN2T-4S series aircraft.
- Requirement:** To prevent cracking of the engine mount from progressing to the point where it may require extensive spar repairs or degrade the integrity of the engine mount, inspect the upper engine mounts per BN SB 275. In addition to the inspection area described in the SB, inspect the entire length of the flange that attaches the engine mount to the spar as shown on the diagram below. Inspect both inboard and outboard flanges of each engine mount.
(UK AD 005-11-2001 refers)
- Compliance:** Initial inspection within 100 hours TIS.
Repeat inspection at intervals not to exceed 500 hours TIS or 1000 landings whichever occurs first.
- Effective Date:** 27 June 2002
