Airworthiness Directive Schedule

Aeroplanes

Eagle X-TS and 150 Series

30 August 2007

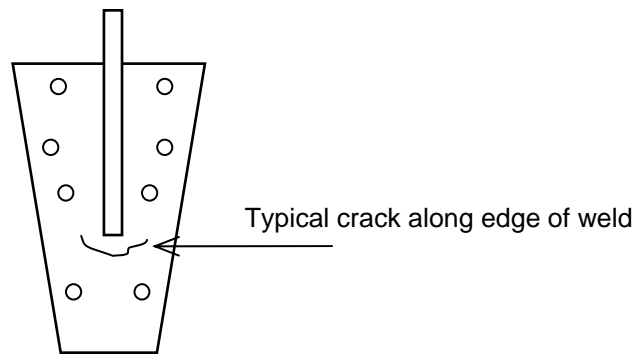
Figure 1

Requirement: To prevent failure of the inner flap attachment which may result in asymmetric flap deployment and/or inability to lower or raise the flaps, accomplish the following;

1. Visually inspect the gusset weld area for cracks, see figure 1 for typical crack location. If there is any cracked, lifted or missing paint in the area of the weld, or a crack is suspected, then perform detailed inspection per Part 2 of this AD before further flight. If bracket integrity is assured, no further action is required.
2.
 - a. Remove paint in area of weld.
 - b. Visually inspect the weld area for cracks using a bright light and 10X magnifying glass.
 - c. If bracket cannot be verified free of cracks, then inspect using Fluorescent Penetrant Inspection. Any cracked brackets must be replaced or repaired in accordance with approved data before further flight.

3. Embodiment of Eagle Aircraft (M) SB 1120 constitutes terminating action for the requirements of this AD.
