# Airworthiness Directive Schedule

## Aeroplanes

### Taylorcraft BC12-D

29 May 2008

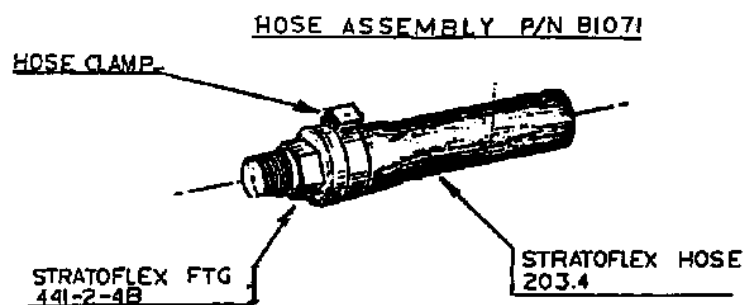
**Figure 1**

**DCA/TAYLOR/1 Canceled – DCA/TAYLOR/8 refers****Effective Date:** 28 March 2008**DCA/TAYLOR/2 Oil Pressure Gauge Hose – Inspection and Replacement****Applicability:** Model BC12-D aircraft, all S/N**Requirement:** To prevent loss of engine oil and the possibility of engine failure, inspect the oil pressure gauge hose assembly at the engine and establish whether hose assembly P/N B7071 is fitted to the aircraft per figure 1 below.

If the oil pressure hose assembly is not the type illustrated in figure 1, no further action is required.

If the oil pressure hose assembly fitted to the aircraft is the type illustrated in figure 1, replace with a new hose assembly P/N B7071 identified by Taylorcraft with a "T" stamped on a wrench flat on the hose assembly brass fitting.
