Airworthiness Directive Schedule

Aeroplanes

Yakovlev/Aerostar 3, 18, 50, 52 and 55 Series

27 October 2016

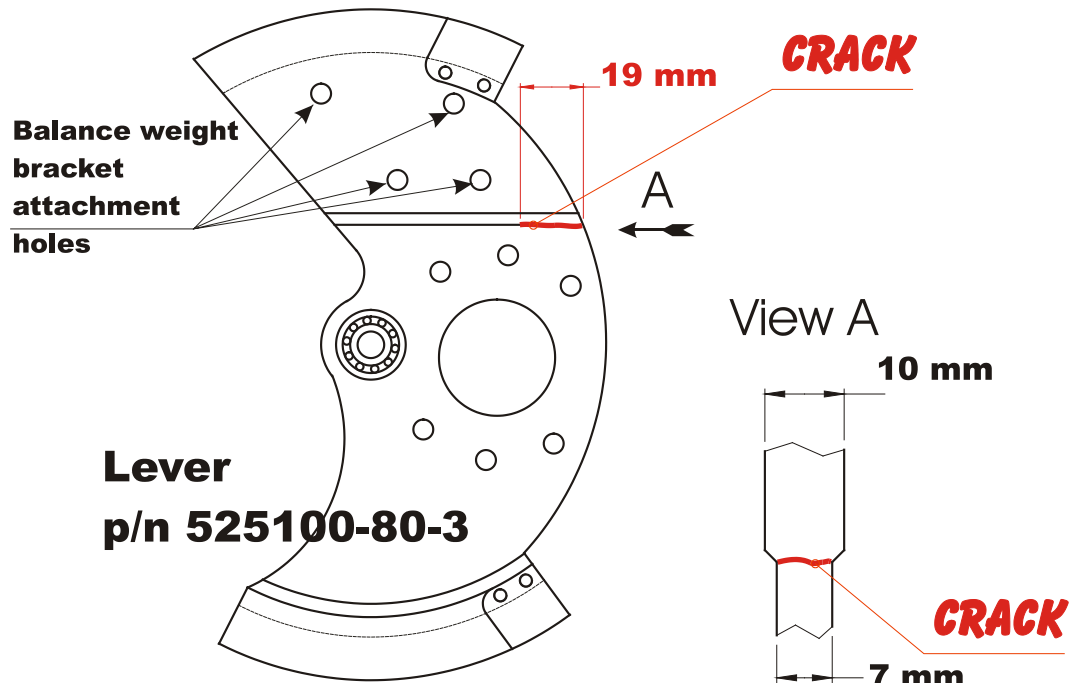
Note: This AD is prompted by a report of finding a 19 mm crack in the elevator control pulley P/N 525100-80-3 (referred to in the Romanian parts catalogue as a “lever”). The failure of this component could result in loss of elevator control.

Inspect lever P/N 525100-80-3 for cracks using a dye penetrant method. Inspect in the area below the attachment of the balance weight bracket at the point where the section reduces from 10 mm to 7 mm.

If the lever is found cracked, replace affected parts before further flight.

Inspect the primary stops of the lever for damage and wear. If any defects are found, or if the rubber pads are excessively worn, replace affected parts before further flight.
