Airworthiness Directive Schedule

Aeroplanes

Beechcraft F33, 35, V35 and A36 Series (Bonanza and Debonair)

19 December 2019

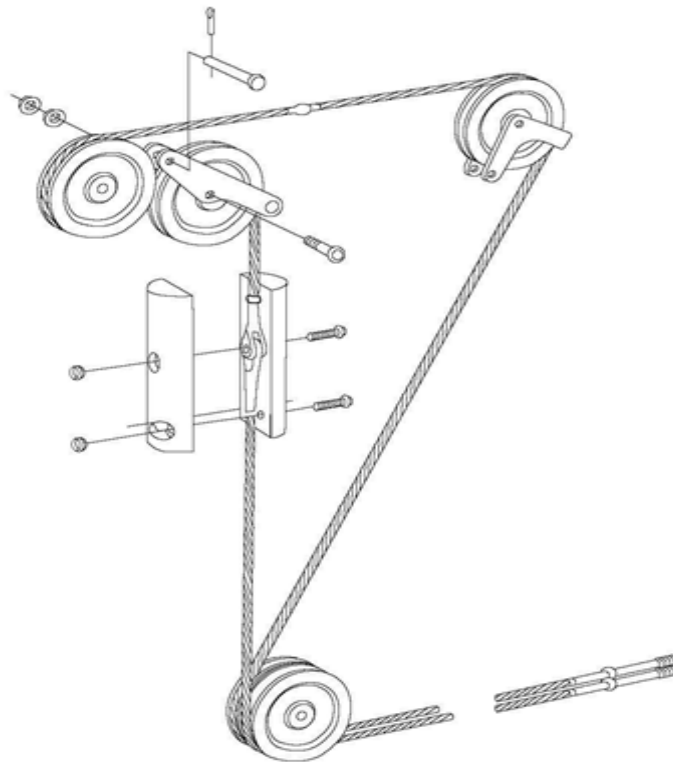
Figure 1 - Forward Elevator Control Cable - Adapted from the Beechcraft IPC.

Note 1: No further AD action required for those aircraft already in compliance with DCA/B35/32A. This AD revised to clarify the applicability and revise the requirement. Figure 1 introduced to provide additional information to determine AD applicability. The repetitive inspections and the requirement to replace forward elevator control cable assemblies which have been in service for more than 15 years has been removed from this AD with the publication of manufacturer Instructions for Continuing Airworthiness (ICA).

Inspect the forward elevator control cable assembly for wear, broken wires and corrosion. If any defects are found, replace the forward elevator control cable assembly before further flight.

1. Replace the forward elevator cable assembly, or

2. Cable assemblies or parts removed from service per the requirements of this AD may not be installed on any aircraft.
