# Airworthiness Directive Schedule

## Aeroplanes

### Cessna 210 Series

23 February 2023

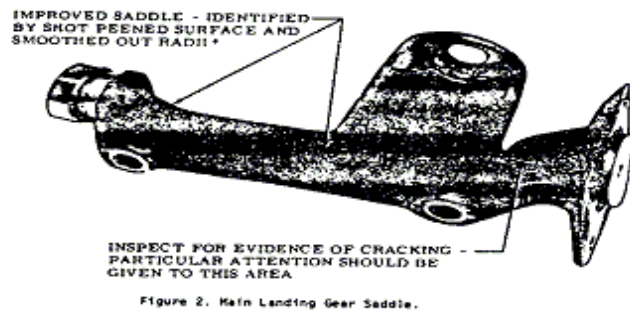
Inspect P/N 1241004-1 and 1241004-2 landing gear saddles for cracks using dye penetrant method in accordance with either procedure 1 or 2 as specified in note 4 and 5 of this AD. Pay particular attention to the critical areas shown in Figure 1 of this AD.

Inspect P/N 1241423-1 and 1241423-2 main landing gear saddles for cracks using dye penetrant method in accordance with either procedure 1 or 2 as specified in note 4 and 5 of this AD. Pay particular attention to the critical areas shown in Figure 2 of this AD.

If any cracks are found, replace saddles before further flight.
