Airworthiness Directive Schedule

De Havilland DH83 Series (Fox Moth)

26 April 2018

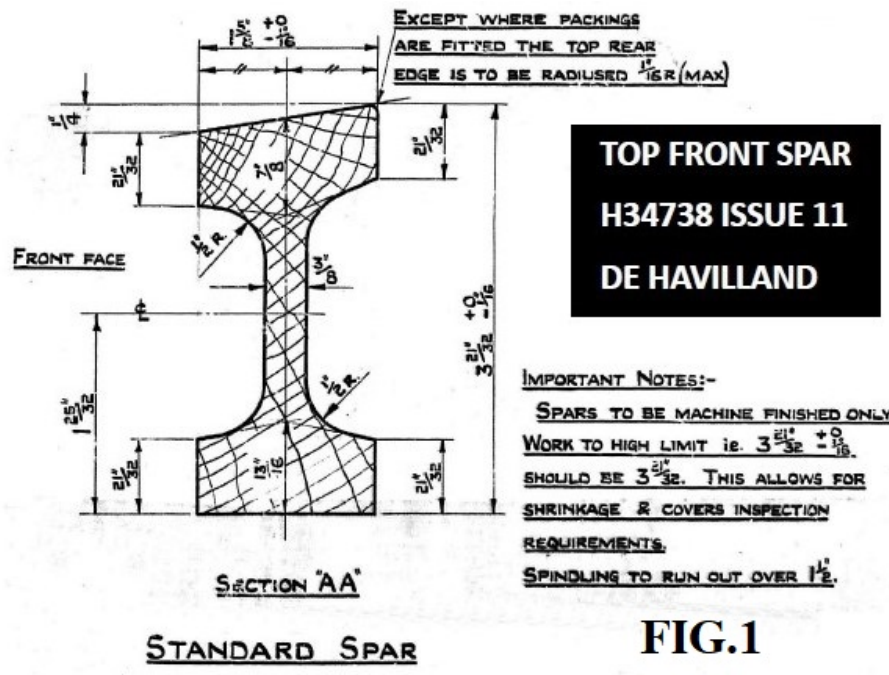
Figure 1 - De Havilland Design:

Note 1: DCA/DH83/105B revised to introduce a one-time inspection of the wing spars. If the spar section properties conform to the original de Havilland design shown in Figure 1, or if the wing spar section properties (minimum radius and dimensions) are no less than that shown in Figure 2, then no further action is required, and the previous flight limitations can be removed.

1. If an affected wing or aileron spar is found installed, then aerobatics or other flights involving high load factors, including flight in turbulent conditions are prohibited until requirement 2 of this AD has been accomplished.
2. If an affected wing or aileron spar is found installed, accomplish the following:
 - 2.1. If an affected aileron spar part number is found fitted, then conform the spar to the approved type design per the original de Havilland design, or replace the affected aileron spar, before further flight.
 - 2.2. If an affected mainplane/wing spar is found fitted, then inspect the forward and the aft faces of the affected spars in four places, and determine if the spar section properties (i.e. area, shape) conform to the approved type design per the original de Havilland design shown in Figure 1.

If the wing spar section properties conforms to the original de Havilland design shown in Figure1, then no further action is required, and the previous flight limitations can be removed.

If the wing spar section properties do not conform to the original de Havilland design shown in Figure1, then accomplish requirement 3 of this AD, before further flight.
3. Inspect the affected wing spar and compare the spar section properties with the Croydon spar profile shown in Figure 2.

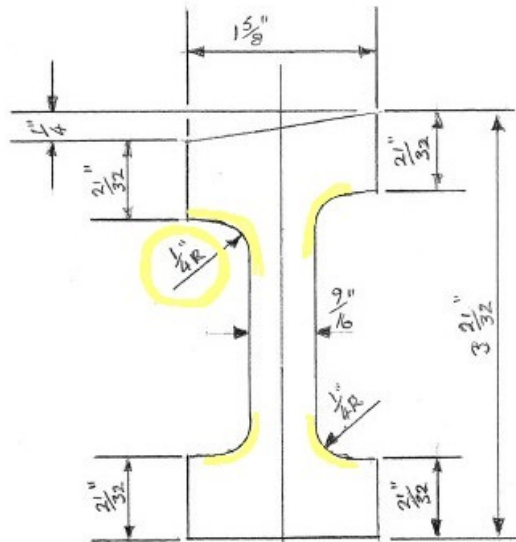
Figure 2 – Croydon Spar Profile:

If the wing spar section properties (minimum spar web radius and dimensions) are found not less than that shown in Figure 2, (i.e. the inside radii of the spar cut-outs

are found not less than 0.25 inches as shown in Figure 2), then no further action is required, and the previous flight limitations can be removed.

If the wing spar section properties (minimum spar web radius and dimensions) are found less than that shown in Figure 2, (i.e. the inside radii of the spar cut-outs are found less than 0.25 inches as shown in Figure 2), then remove the affected spar from service, and replace with a serviceable part, before further flight.

Report any machined spars with section properties less than that shown in Fig.2 to the CAA by completing a CA005 Defect Report form. Please provide the spar part and serial numbers, and a copy of the release documentation. The form can be obtained from CA005@caa.govt.nz. The completed form can be emailed to the CAA at http://www.caa.govt.nz/Forms/CA005D_Form.pdf
