Airworthiness Directive Schedule

Aeroplanes

Piper PA-39 Series (Twin Comanche)

17 December 2015

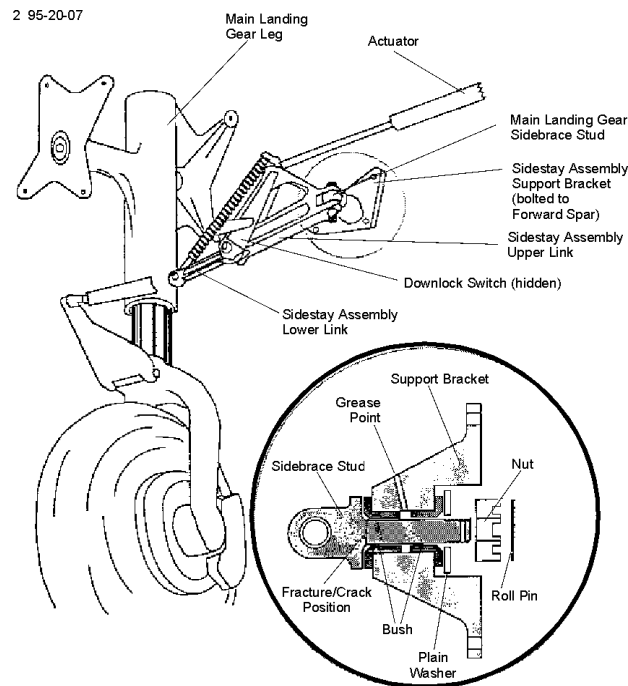
Remove both the left and right main gear sidebrace studs from the aircraft per the instructions in the landing gear section of the aircraft MM. Inspect both the main gear sidebrace stud for cracks using Type I (fluorescent) liquid penetrant or magnetic particle inspection methods. Figure 1 of this AD depicts the area where the sidebrace stud is to be inspected.

Note: This figure is provided to depict the area of the sidebrace stud to be inspected. This is not intended to represent the configuration of all models affected.

For any main gear sidebrace stud not found cracked, before to further flight reinstall the stud per the instructions in the Landing Gear section of the applicable MM, and reinspect and replace (as necessary) per this AD.

For any main gear sidebrace stud found cracked, before to further flight replace the cracked stud with a serviceable part per the instructions in the Landing Gear section of the applicable MM, and reinspect and replace (as necessary) per this AD.
