# Airworthiness Directive Schedule

## Aeroplanes

### Piper PA-34 Series (Seneca I, II, III, IV and V)

17 December 2020

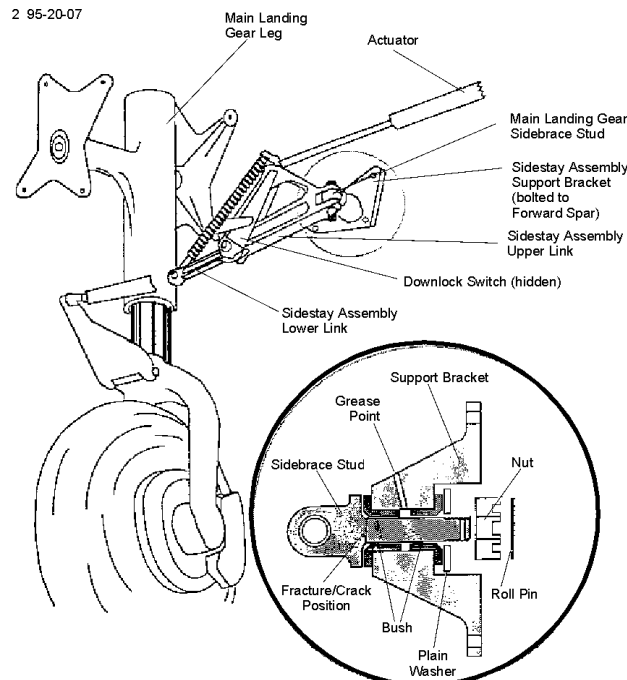
**Figure 1**

**Requirement:** To prevent main landing gear (MLG) collapse due to possible main gear sidebrace stud cracks which if not detected and corrected could result in loss of aircraft control during landing, accomplish the following:

Remove both the left and right main gear sidebrace studs from the aircraft per the instructions in the landing gear section of the aircraft MM. Inspect both the main gear sidebrace stud for cracks using Type I (fluorescent) liquid penetrant or magnetic particle inspection methods. Figure 1 of this AD depicts the area where the sidebrace stud is to be inspected.

**Note:** This figure is provided to depict the area of the sidebrace stud to be inspected. This is not intended to represent the configuration of all models affected.

For any main gear sidebrace stud not found cracked, before to further flight reinstall the stud per the instructions in the Landing Gear section of the applicable MM, and reinspect and replace (as necessary) per this AD.

For any main gear sidebrace stud found cracked, before to further flight replace the cracked stud with a serviceable part per the instructions in the Landing Gear section of the applicable MM and accomplish one of the following, as applicable:

- Reinspect and replace (as necessary) per the repetitive requirements in this AD, or
- For affected PA34-200 and PA34-200T aircraft the 9/16 inch main gear sidebrace studs (P/N 95299-00, 95299-02 or 67543 as applicable) are no longer manufactured: Install a new main gear sidebrace stud bracket assembly P/N 95643-06, 95643-07, 95643-08 or 95643-09 as applicable. No repetitive inspections will be required by this AD for when this bracket assembly is installed on both the LH and RH sides, or

- Ream the existing two-piece bushings P/N 67026-6 to an inside diameter of .624 inch to .625 inch, chamfer the head side of the bushing to accommodate the radius in the shank of the main gear sidebrace stud and install the 5/8 inch stud P/N 78717-02. No repetitive inspections will be required by this AD when this action is accomplished on both the LH and RH bracket assemblies. If the bushings cannot be reamed while installed in the bracket (i.e., the bushings are loose), then install a main gear sidebrace bracket assembly P/N 95643-06, 95643-07, 95643-08 or 95643-09, as applicable.

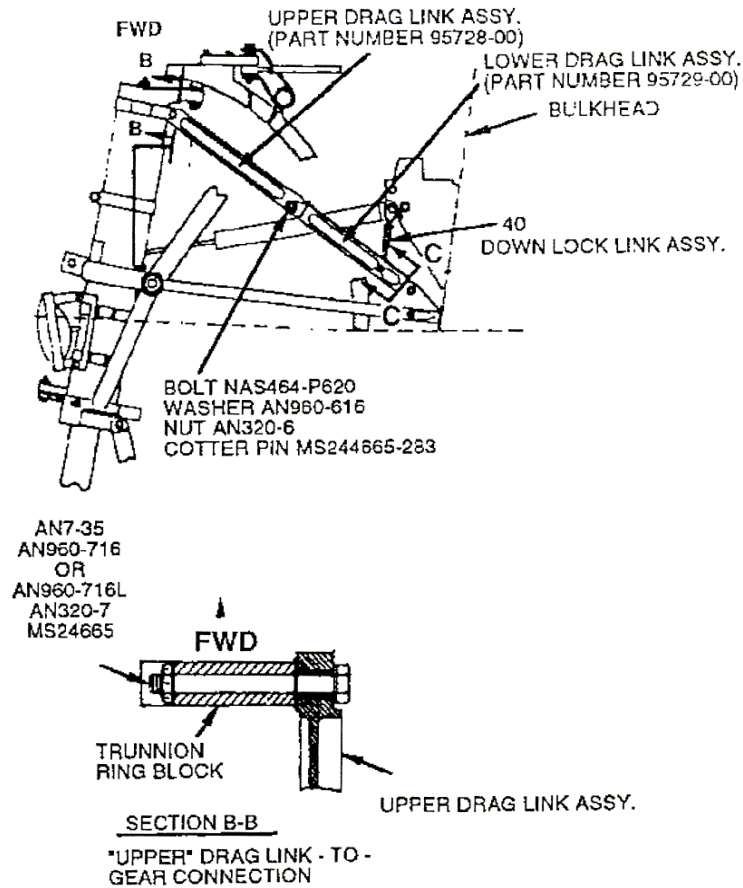
**Requirement:** To prevent prevent failure of components of the NLG which could result in the NLG collapsing, accomplish the following:

1. Replace the bolt and stack up that connects the upper drag link to the nose gear trunnion with new Piper parts (or approved equivalent parts) per the figure in this AD:
