Airworthiness Directive Schedule

Aeroplanes

Piper PA-34 Series (Seneca I, II, III, IV and V)

28 April 2022

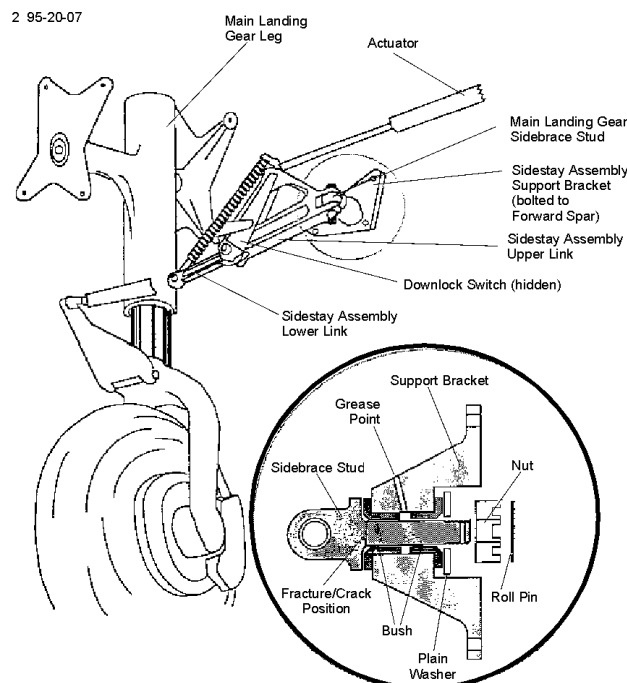
Remove both the left and right main gear sidebrace studs from the aircraft per the instructions in the landing gear section of the aircraft MM. Inspect both the main gear sidebrace stud for cracks using Type I (fluorescent) liquid penetrant or magnetic particle inspection methods. Figure 1 of this AD depicts the area where the sidebrace stud is to be inspected.

Note: This figure is provided to depict the area of the sidebrace stud to be inspected. This is not intended to represent the configuration of all models affected.

For any main gear sidebrace stud not found cracked, before to further flight reinstall the stud per the instructions in the Landing Gear section of the applicable MM, and reinspect and replace (as necessary) per this AD.

For any main gear sidebrace stud found cracked, before to further flight replace the cracked stud with a serviceable part per the instructions in the Landing Gear section of the applicable MM and accomplish one of the following, as applicable:

- Reinspect and replace (as necessary) per the repetitive requirements in this AD, or
- For affected PA34-200 and PA34-200T aircraft the 9/16 inch main gear sidebrace studs (P/N 95299-00, 95299-02 or 67543 as applicable) are no longer manufactured: Install a new main gear sidebrace stud bracket assembly P/N 95643-06, 95643-07, 95643-08 or 95643-09 as applicable. No repetitive inspections will be required by this AD for when this bracket assembly is installed on both the LH and RH sides, or

- Ream the existing two-piece bushings P/N 67026-6 to an inside diameter of .624 inch to .625 inch, chamfer the head side of the bushing to accommodate the radius in the shank of the main gear sidebrace stud and install the 5/8 inch stud P/N 78717-02. No repetitive inspections will be required by this AD when this action is accomplished on both the LH and RH bracket assemblies. If the bushings cannot be reamed while installed in the bracket (i.e., the bushings are loose), then install a main gear sidebrace bracket assembly P/N 95643-06, 95643-07, 95643-08 or 95643-09, as applicable.
