# Airworthiness Directive Schedule

## Components & Equipment

### Aircraft Seats and Harnesses

30 June 2022

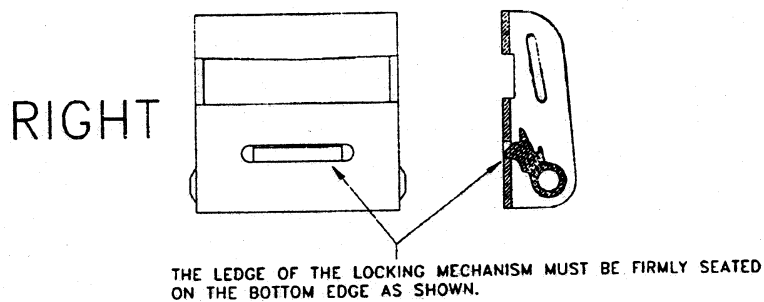
**Requirement:** To prevent failure of the seat restraint system due to the buckle assembly locking mechanism not engaging properly, which could result in the restraint system failing to properly secure the occupant during turbulence or landing, accomplish the following:

After the lever is completely closed, examine the slot in the bottom of the buckle. The locking mechanism should be firmly seated against the edge of the slot as shown in Figure 1.

If the locking mechanism does not seat properly, replace the buckle with an airworthy buckle.
