# Airworthiness Directive Schedule

## Components & Equipment

### Carburettors and Injection Systems

30 July 2020

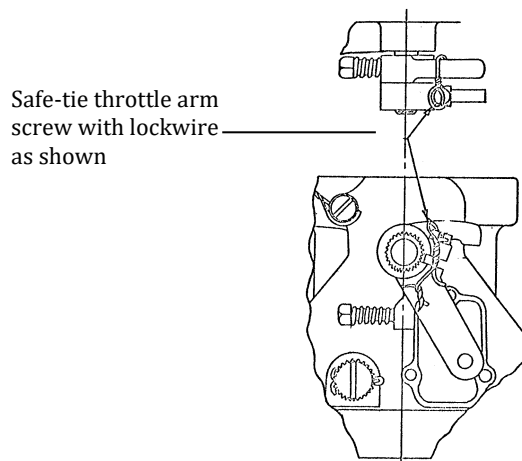
**Requirement:** To prevent throttle arm becoming loose and separating from the throttle shaft accomplish the following:-

View of Carburetor Throttle Arm Showing Method of Tying Lockwire

1. Check for correct torque the clamp screw, or alternative bolt and self-locking nut securing the throttle arm to the throttle shaft. The correct torque values are 15 to 20 inch pounds for the number 10-24 screw on MA-3 series carburettors, 20 to 25 inch pounds for the number 10-24 screw on MA-4 series carburettors and 35 to 40 inch pounds for the number 10-32 bolt and nut.
2. Check that there is clearance between the clamp faces when the torque value is correct.
3. Lock screws with 0.032 inch lockwire as shown in the drawing below.
