# Continuing Airworthiness Notice – 27-021 Rev 1

## MD Helicopters 369 series, 500N and 600N fitted with a Cyclic Pitch Torque Tube P/N 369H7133-3 or -7

27 January 2023

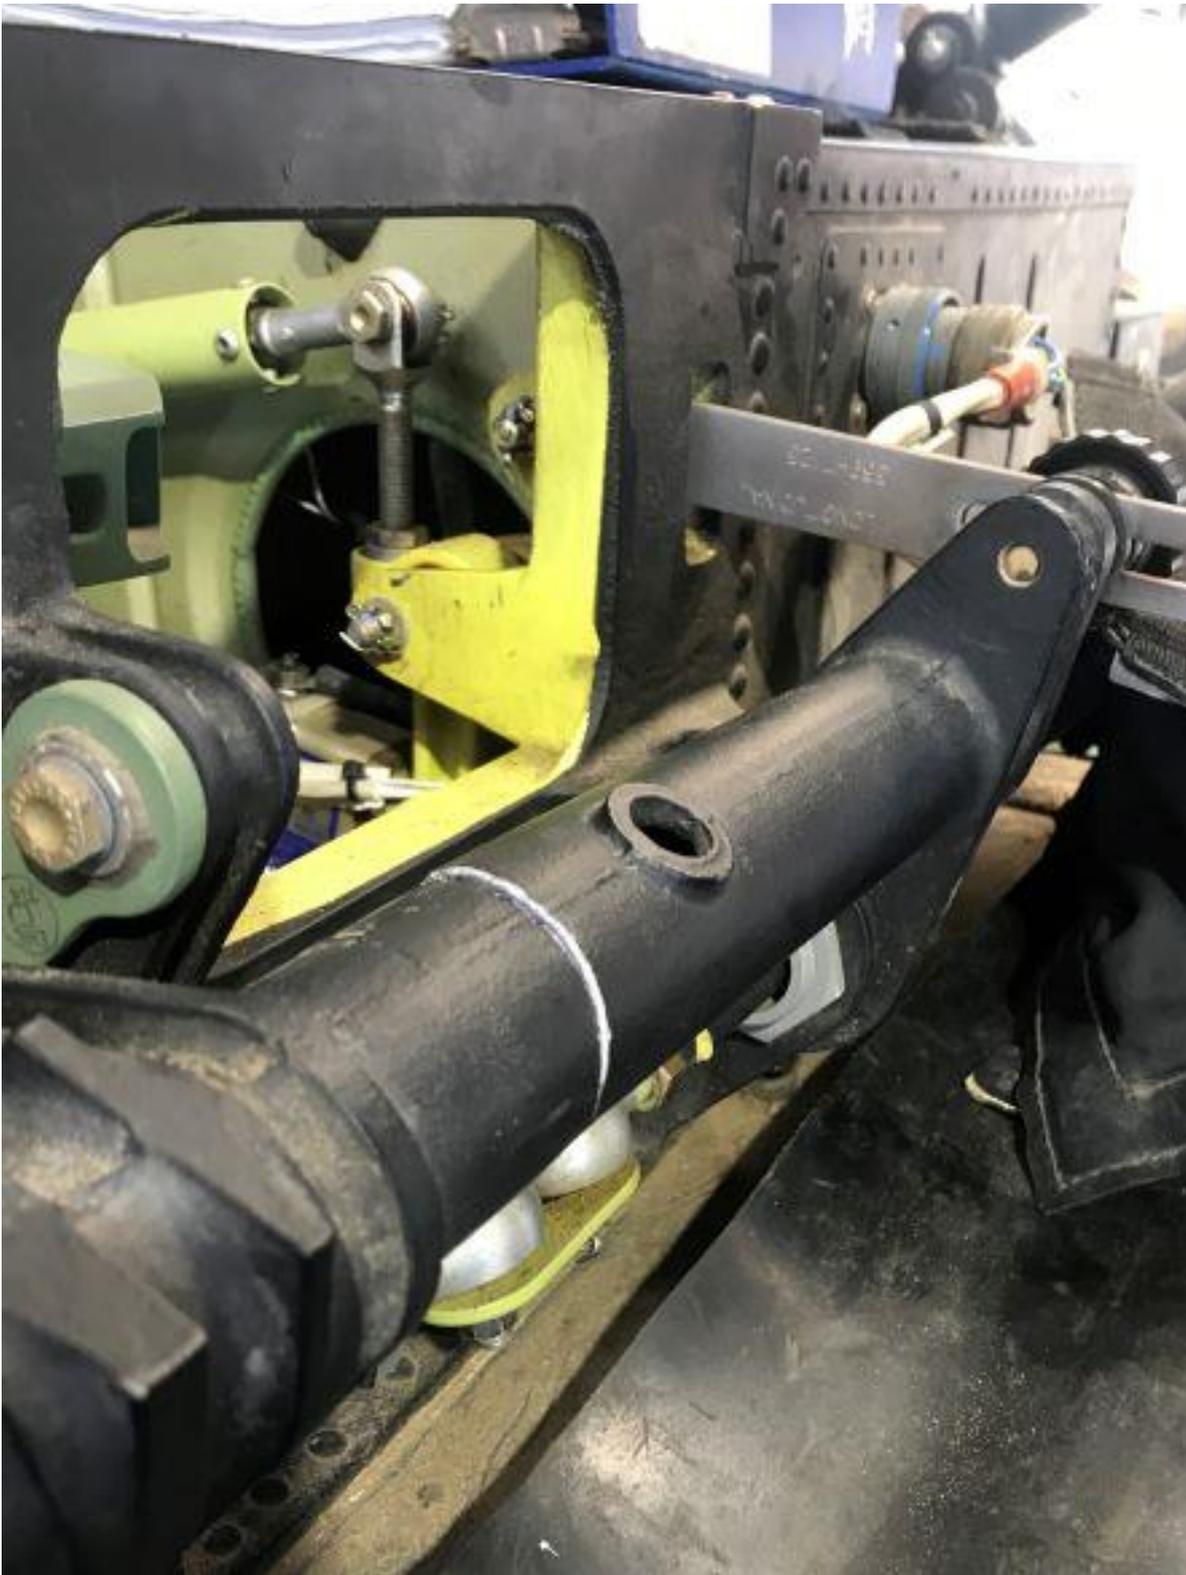
Investigation to date has revealed a spiral crack around the circumference of the cast tube that initiated from the casting hole with a small crack also found at the opposite side of the casting hole.

This CAN is prompted by a significant crack found in cyclic torque tube with P/N 369H7133-7 on a Hughes 369E (MD500E) helicopter which resulted in limited cyclic control.

Location of the crack found in Cyclic Torque Tube P/N 369H7133-7.

- Review Service Letter SL369H-158, SL369D-142, SL369E-097, SL369F-088, SL500N-044, SL600N-038 (issued as a single document) and updated the relevant aircraft ICA and introduced an inspection for freedom of movement of the torque tube and bearings.
- Take precautions when cleaning the interior of the helicopter to ensure that cleaning products, including water cannot contaminate the torque tube bearings.
