Continuing Airworthiness Notice – 05-005

Cargo Hook System – Inspection Requirements

13 September 2016

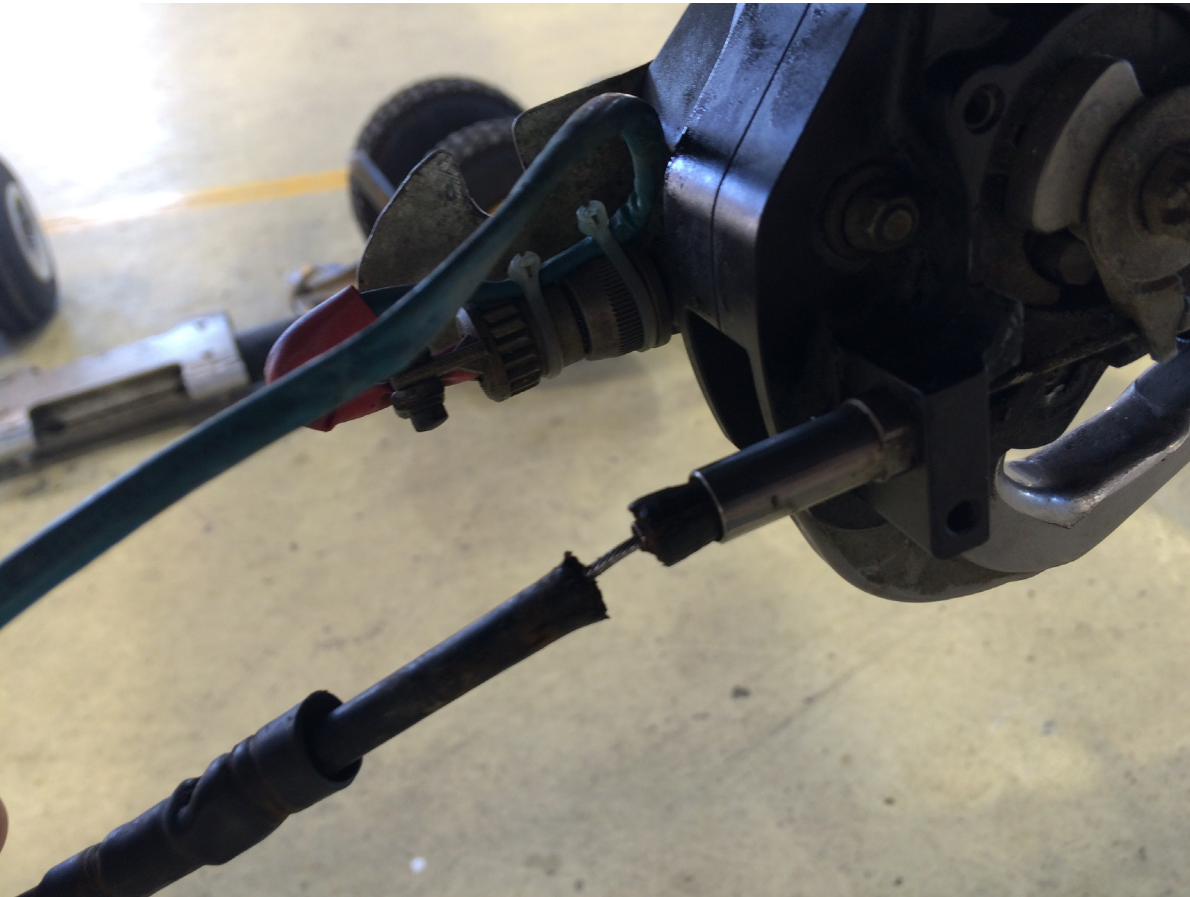
This Continuing Airworthiness Notice (CAN) is prompted by a recent inadvertent load release during an external load operation. Investigation revealed that the outer conduit of the manual release cable had broken approximately 50mm forward of the cargo hook with the cable free-play taken up by the cable conduit break. With subsequent in-flight motion of the cargo hook suspension system, the release cable moved sufficiently to activate the hook release mechanism, which resulted in inadvertent load release. Further investigation revealed that the outer cable conduit may have broken due to cargo hook movement, age hardening/fatigue. For further detail refer to the enclosed photographs.

Cable conduit fractured approximately 50mm forward of the cargo hook.

Prior to every external load operation the cargo hook manual release cable must be inspected for broken or kinked conduit, inner cable kinks, frays and sticky operation. If any defects are found, accomplish correctives actions before commencing an external load operation. The inspections required prior to every external load operation are specified in Onboard Systems Mechanical Release Cable Warning Sheet 197-162-00.

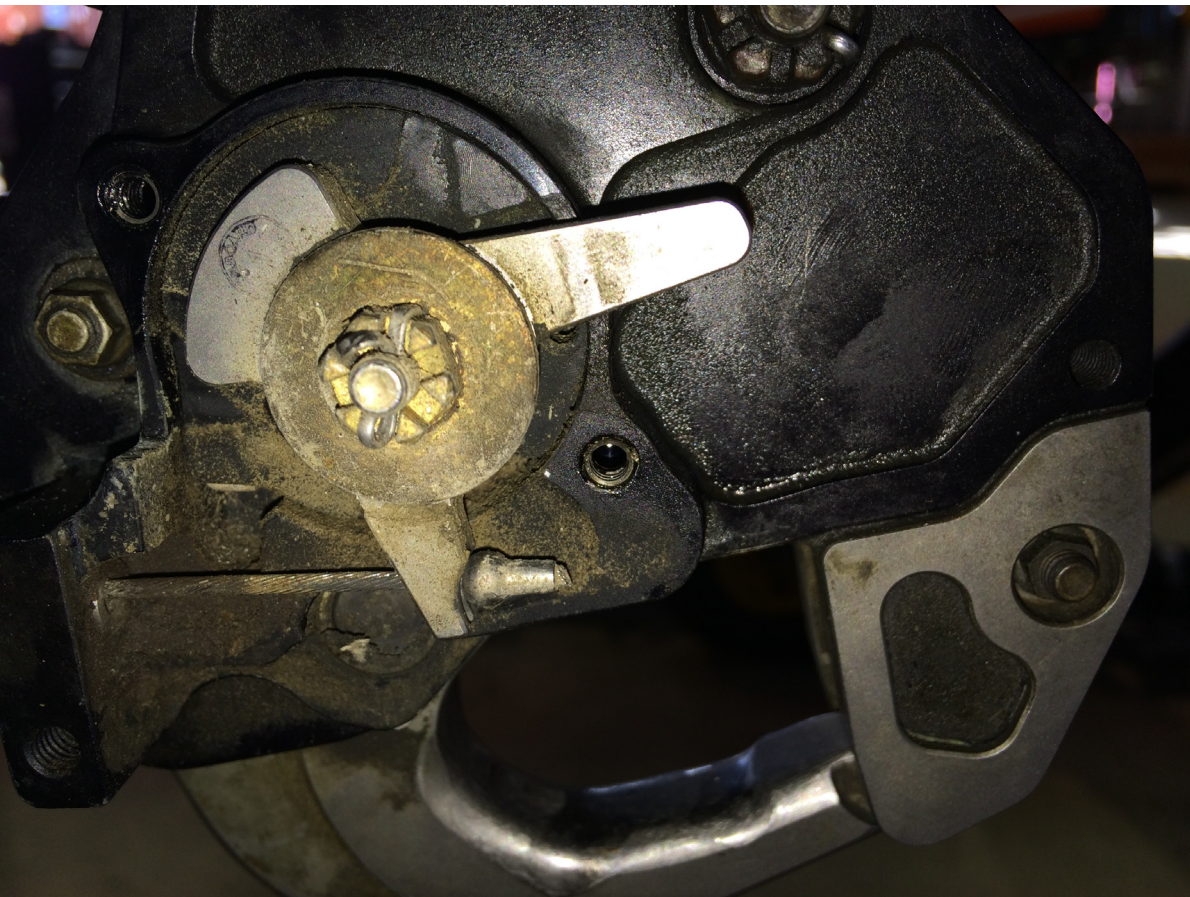
Due to fractured cable conduit, no cable free-play present.
