Guimbal Cabri G2 Main Rotor Pitch Link Assembly Cracking

6 May 2021

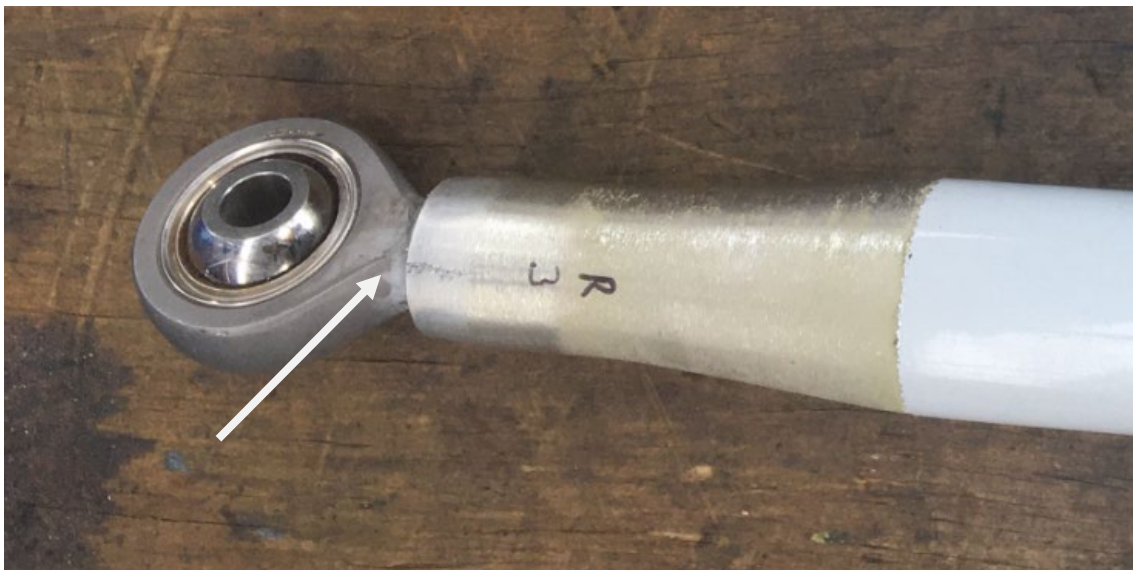
The CAA recently received a report from a New Zealand operator of a Guimbal Cabri G2 of finding cracks in all three main rotor pitch link assemblies (IPC Ref 4.1-02 #24 P/N G41-01-100). The cracks were found in the swaged end of each pitch link, running lengthwise to the rod. Refer to the photo below for further details. The CAA is in discussion with the manufacturer to further understand the likely cause of the cracks and to identify any necessary corrective actions.

1. When carrying out pre-flight inspections pay extra attention to the lower (swaged) end of the pitch link assemblies for any indication of corrosion, paint cracking, or surface anomalies. If any indications of cracks are identified, then a maintenance engineer should inspect the pitch link assemblies. If engineers identify any crack-like indications after referral, or during scheduled maintenance, they should further inspect the rods to determine if a crack is present.
2. Operators are advised to review the instructions in Guimbal SB 21-006B, which provides inspections and preventative maintenance actions related to main rotor pitch link assemblies.
