Continuing Airworthiness Notice – 63-002

Robinson R44 Series Helicopters - Sprag Clutch Assembly

6 October 2021

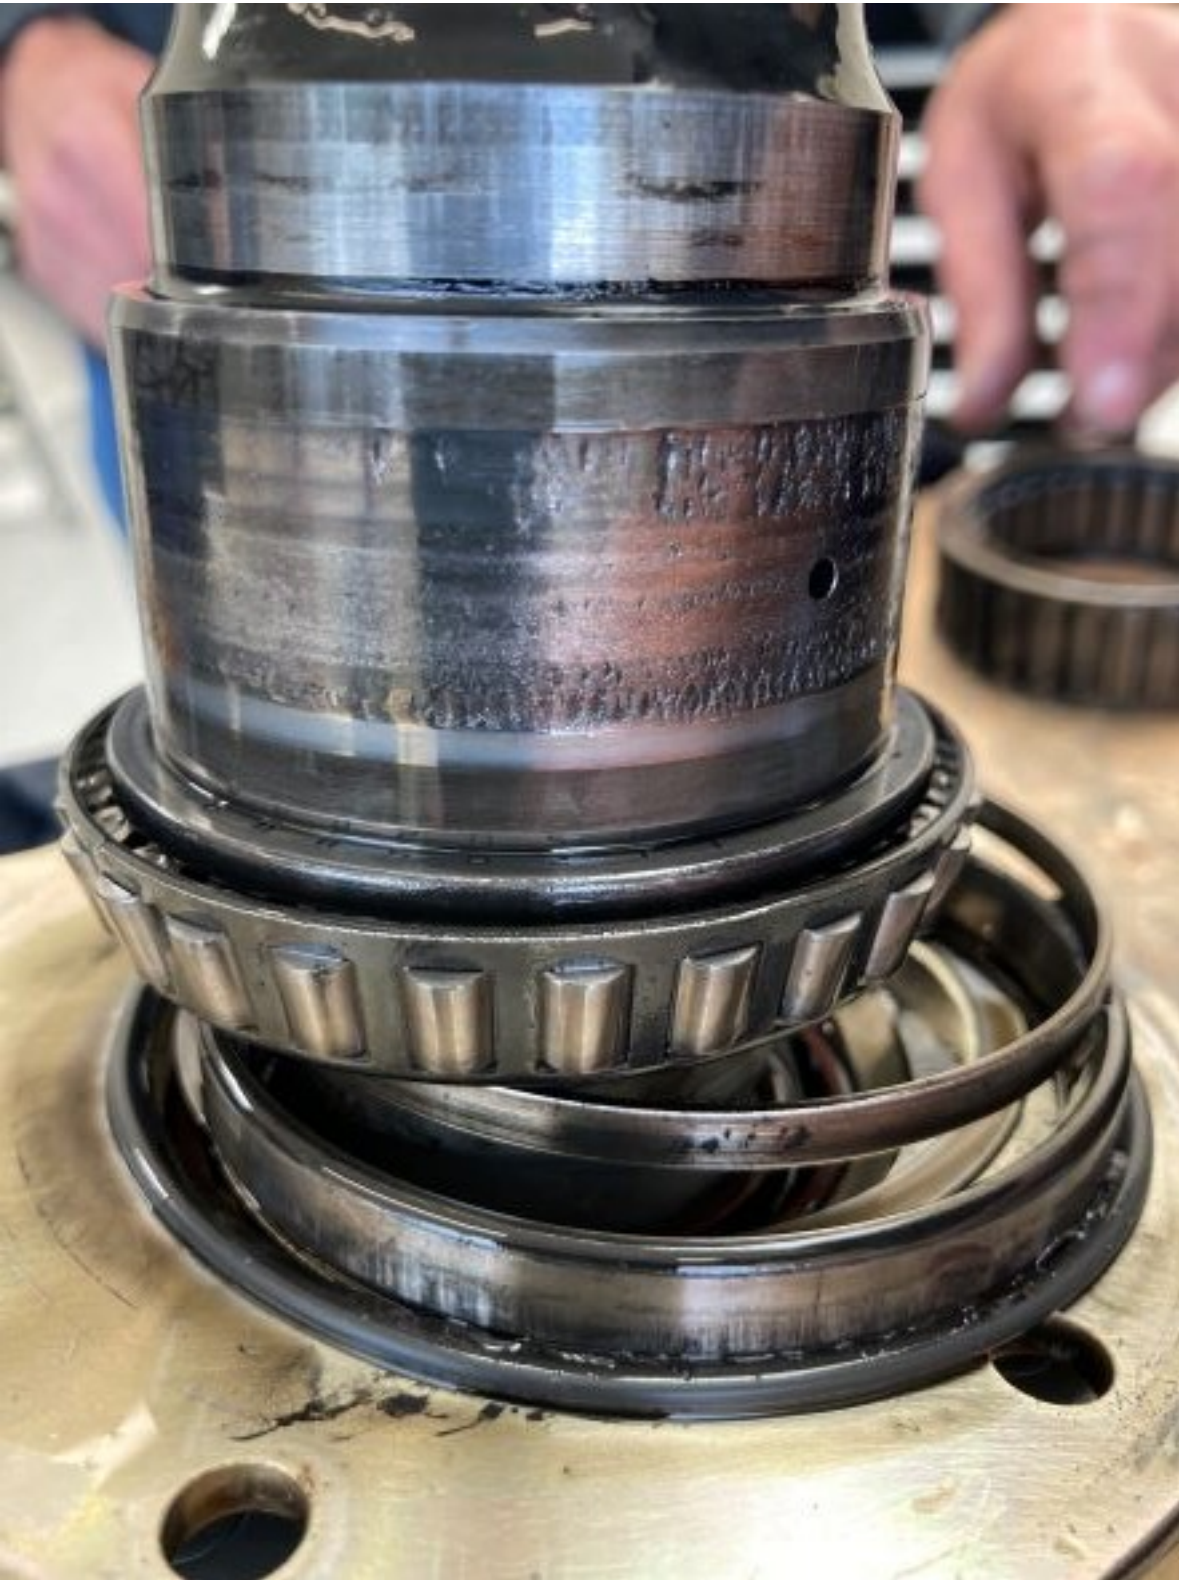
The clutch assembly was then removed, stripped and inspected. The inner race on shaft P/N C166-5 was found with significant spalling damage (see photo on page 2 of this CAN). The clutch oil was dark in colour burnt and the sprag clutch was found in good condition, with very little wear.

It was determined that the spalling caused the abnormal noise. An aircraft maintenance record review determined that the clutch assembly had been in service for approximately 350 hours since the last inspection in accordance with DCA/R44/23B.

Shaft P/N C166-5 - Spalling damage.

The CAA recommends that operators and engineers be vigilant in identifying abnormal noises from the clutch assembly area on engine shut down, which may be an indicator of a pending failure of shaft P/N C166-5. A stethoscope etc. is recommended to identify the source of abnormal noises.
