Airworthiness Directive Schedule

Engines

Continental IO-470 Series and O-470 Series

23 February 2023

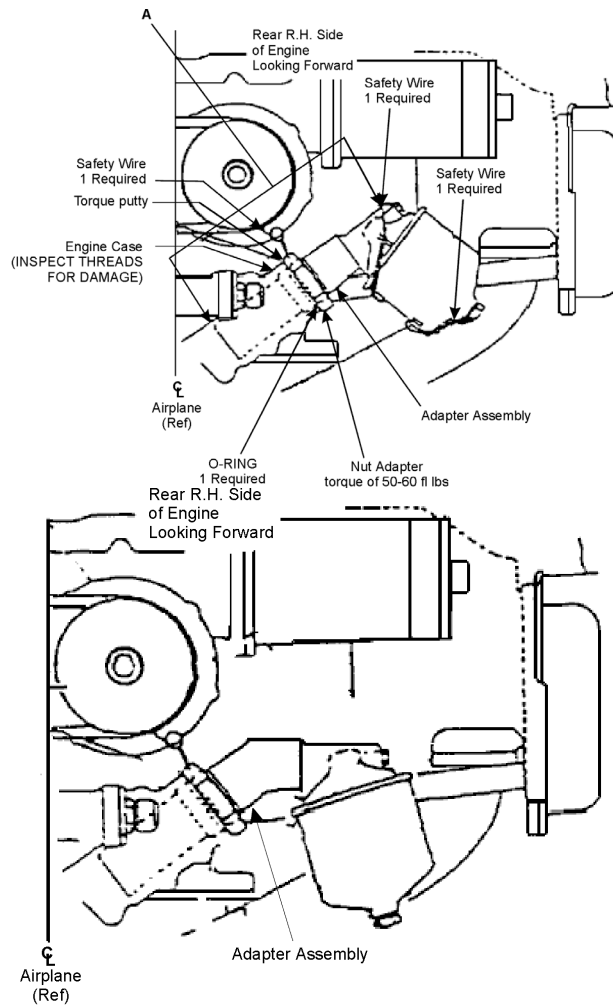
Manufactured by Teledyne
Continental Motors
Not Applicable to This AD

(d) Apply torque putty between the engine filter adapter assembly, nut, and oil pump housing as specified in the diagram.

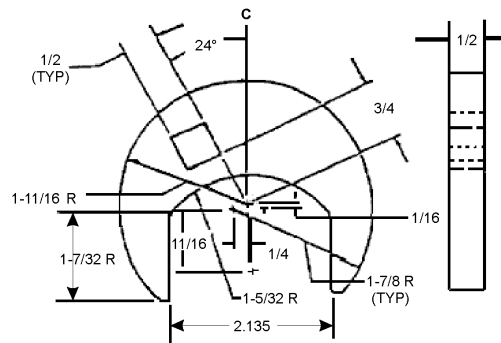
MATERIAL: 4130 (Rc. 35-38)

TOOL NUMBER SE709 IS AVAILABLE FROM THE CESSNA SERVICE PARTS CENTER

Snap-On crows foot P/N AN8508-34A have ground down the ends for clearance
