Airworthiness Directive Schedule

Engines

Continental IO-550 Series and TSIO-550-K Series

23 February 2023

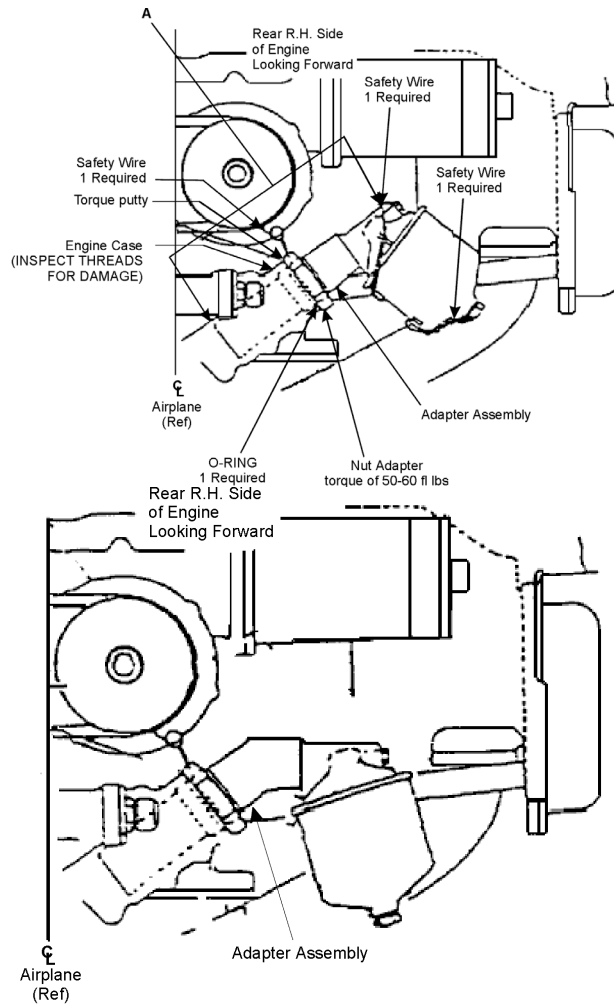
2. For oil filter adapter assemblies that do have torque putty between the engine filter adapter assembly, nut, and oil pump housing, inspect the torque putty for misalignment, evidence of oil leakage, or cracks.

Manufactured by Teledyne
Continental Motors
Not Applicable to This AD

- (a) Inspect the adapter locking nut installation for evidence of oil leakage.
- (b) Check the torque of the adapter nut installation and ensure that the torque value is within the limits of 50 through 60 foot pounds.
- (c) If evidence of oil leakage is found or the torque is not within the 50 through 60 foot pound limit, prior to further flight, remove the adapter and filter assembly, and:
 - (i) Inspect the threads of the adapter assembly and engine for signs of damaged or cracked threads; and
 - (ii) Replace any adapter assembly and engine oil pump housing (if necessary) that have evidence of thread damage or cracks.
- (d) Apply torque putty between the engine filter adapter assembly, nut, and oil pump housing as specified in the diagram.
- (e) Reassemble the engine oil filter assembly.

If any misalignment, evidence of oil leakage, or torque putty cracks are found, prior to further flight, accomplish the requirements specified in paragraph (1) of this AD, including all subparagraphs.
