Airworthiness Directive Schedule

Engines

Continental IO-550 Series and TSIO-550-K Series

27 August 2020

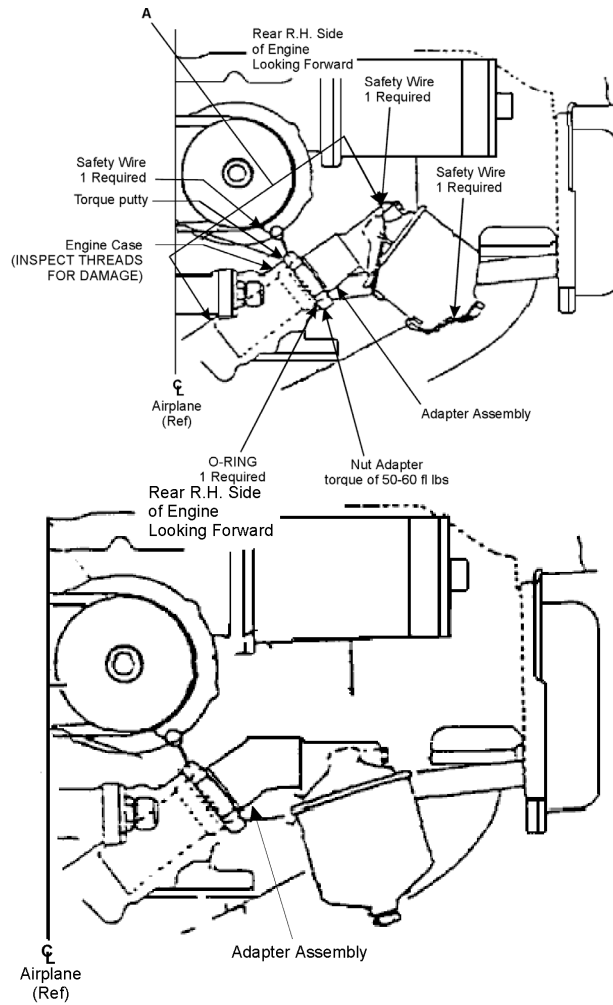
Manufactured by Teledyne
Continental Motors
Not Applicable to This AD

- (d) Apply torque putty between the engine filter adapter assembly, nut, and oil pump housing as specified in the diagram.
 - (e) Reassemble the engine oil filter assembly.
