Airworthiness Directive Schedule

Engines

Rolls-Royce Merlin and Packard Merlin

DCA/MER/1 Rocker Arm – Inspection and Replacement

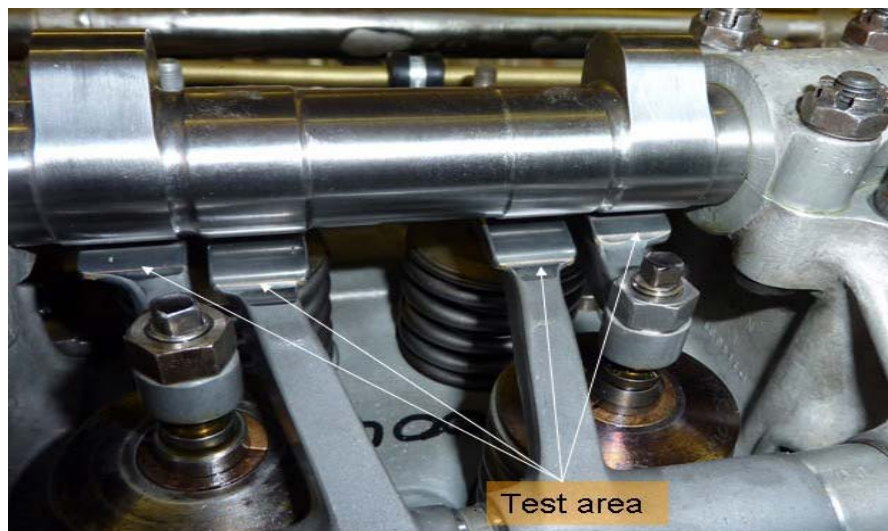
Figure 1:

Note 1: Modification 9/223/M2623 introduces the installation of rocker arm carbide pads. This AD requires repetitive inspections for carbide pad detachment and indications of debonding of the pad from rocker arm. These inspections are an interim requirement as the bond failures are still under investigation.

Requirement: To prevent failure of the rocker arm carbide pads due to possible separation of the pad from the rocker arm which could result in the pad dropping onto the block and migrating, which could result in engine damage and failure, accomplish the following:

For all modified rocker arms with the aid of a X10 magnifying glass inspect the region of the brazed joint between the carbide pad and the rocker arm as shown in figure 1. A stylus of a maximum radius 0.005" may be used if preferred. Inspect for any evidence of movement of the pad on the rocker arm which can be detected by a line or a step on the arm.

If any movement is detected accomplish a comparison with a feeler gauge to measure the size of the step. Any arm which has a step estimated at 0.005" or less, or has a step in excess of 0.005" but less than 0.015" may remain in service subject to accomplishment of the repetitive inspections specified in the compliance of this AD.

Inspect all modified rocker arms for detachment of the carbide pad. Remove rocker arms which have a released pad along with the associated pad and replace with a serviceable rocker arm before further flight.

Any arm which has a step of 0.015" or more must be replaced before further flight.

Re-inspect these rocker arms per the requirements in this AD at intervals not to exceed 15 hours TIS or at every annual inspection whichever occurs sooner. Replace rocker arms which have a step of 0.015" or more before further flight, and

Re-inspect these rocker arms per the requirements in this AD at intervals not to exceed 25 hours TIS or at every annual inspection whichever occurs sooner. Replace rocker arms which have a step of 0.015" or more before further flight.
