Airworthiness Directive Schedule

Engines

Rolls-Royce 250 Series Turbine Engines

26 May 2022

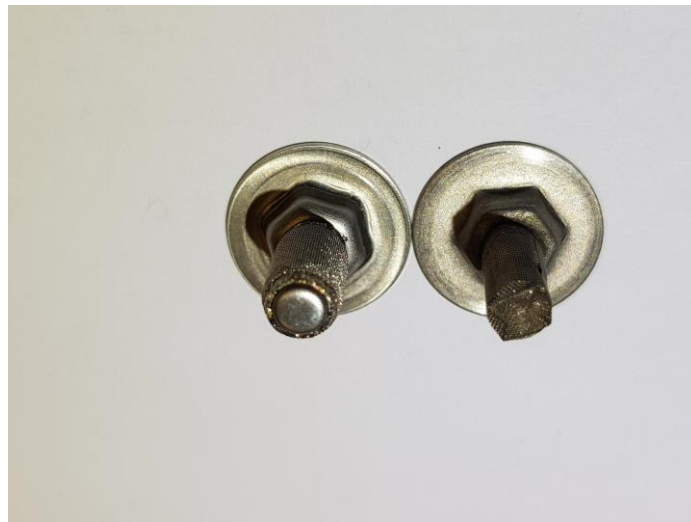
The screen filter on the left of the photo is the new design screen filter, which has a solid metal disc at the aft end of the screen filter.

The screen filter on the right of the photo is the old design screen filter, which is completely constructed of gauze mesh, including the aft end of the screen – Replace before further flight.

If the aft end of the screen filter is constructed of gauze mesh, then replace the fuel nozzle before further flight.

If the inspection through the fuel inlet of the nozzle assembly cannot determine that the aft end of the screen filter has a solid metal disc, then replace the fuel nozzle before further flight.
