# Airworthiness Directive Schedule

## Helicopters

### Airbus Helicopters AS 350 Series

22 December 2022

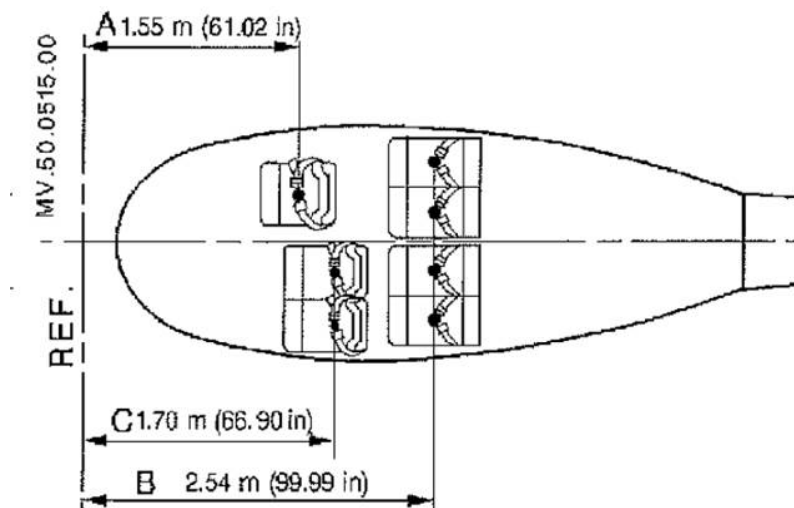
**Figure: Airbus Helicopters recommended CG position of forward two-place seat**

**Requirement:** To prevent a reduction of flight safety from that provided by the manufacturer, accomplish the following:

1. Determine the longitudinal moment arm of the forward two-place seat using the center of the seat pan cushion as a measurement reference point.  
Complete and issue a new form CAA 2173 Weight and Balance Data.  
The weight of the seat components must be included in the CG calculations. If a seat adaptor plate is fitted the moment (position and weight) of the plate must also be considered for the CG calculation.  
The lateral CG arm of the helicopter must not be assumed to be zero. The lateral CG must be recorded and be within the limits specified in the AFM.  
Annotate the CAA2173 to include the value of the longitudinal moment arm of the forward two-place seat used.
2. Remove CAA Limitations Section, (1 page), dated 14 December 2015 and insert 1 page dated 30 June 2016.
