Airworthiness Directive Schedule

Helicopters

Airbus Helicopters AS 350 Series

30 September 2021

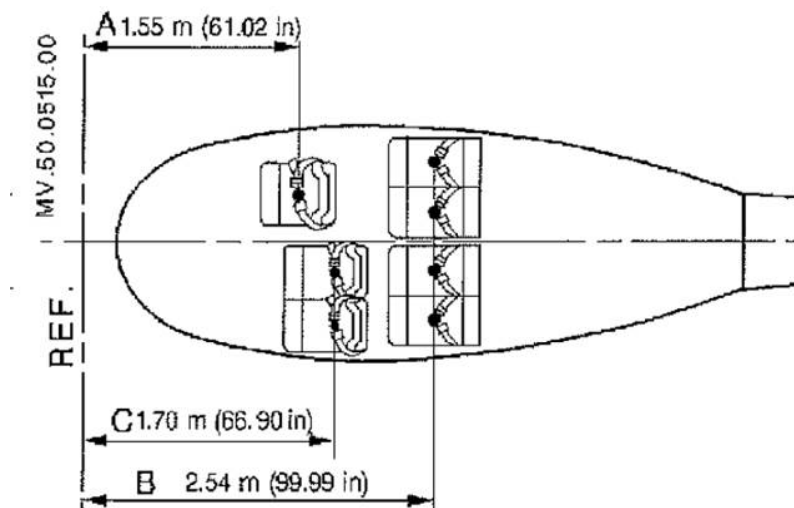
Requirement: To prevent a reduction of flight safety from that provided by the manufacturer, accomplish the following:

Figure: Airbus Helicopters recommended CG position of forward two-place seat

1. Determine the longitudinal moment arm of the forward two-place seat using the center of the seat pan cushion as a measurement reference point.
Complete and issue a new form CAA 2173 Weight and Balance Data.
The weight of the seat components must be included in the CG calculations. If a seat adaptor plate is fitted the moment (position and weight) of the plate must also be considered for the CG calculation.
The lateral CG arm of the helicopter must not be assumed to be zero. The lateral CG must be recorded and be within the limits specified in the AFM.
Annotate the CAA2173 to include the value of the longitudinal moment arm of the forward two-place seat used.
2. Remove CAA Limitations Section, (1 page), dated 14 December 2015 and insert 1 page dated 30 June 2016.
