Airworthiness Directive Schedule

Helicopters

Airbus Helicopters AS 355 Series

22 December 2022

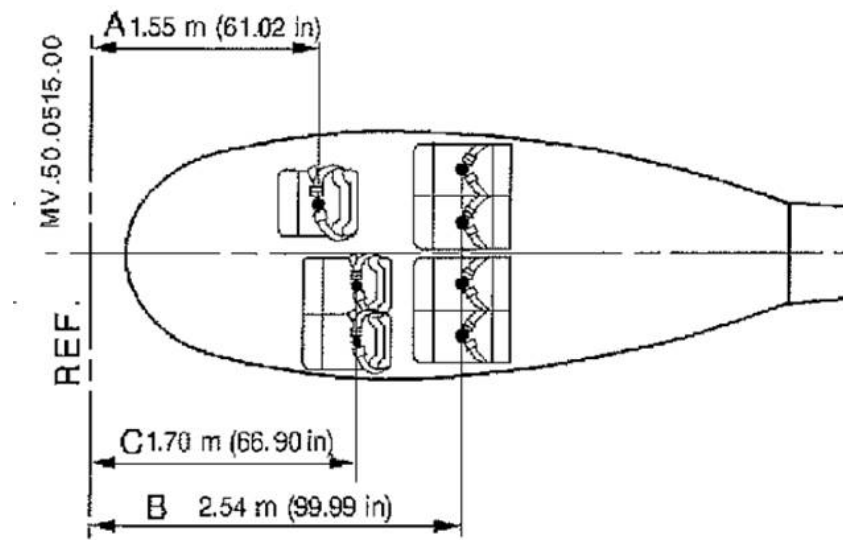
Requirement: To prevent a reduction of flight safety from that provided by the manufacturer, accomplish the following:

Figure: Airbus Helicopters recommended CG position of forward two-place seat.

1. Determine the longitudinal moment arm of the forward two-place seat using the center of the seat pan cushion as a measurement reference point.
Complete and issue a new form CAA 2173 Weight and Balance Data.
The weight of the seat components must be included in the CG calculations. If a seat adaptor plate is fitted the moment (position and weight) of the plate must also be considered for the CG calculation.
The lateral CG arm of the helicopter must not be assumed to be zero. The lateral CG must be recorded and be within the limits specified in the AFM.
Annotate the CAA2173 to include the value of the longitudinal moment arm of the forward two-place seat used.
2. Remove CAA Limitations Section, (1 page), dated 14 December 2015 and insert 1 page dated 30 June 2016.
