# Airworthiness Directive Schedule

## Helicopters

### Airbus Helicopters AS 355 Series

30 September 2021

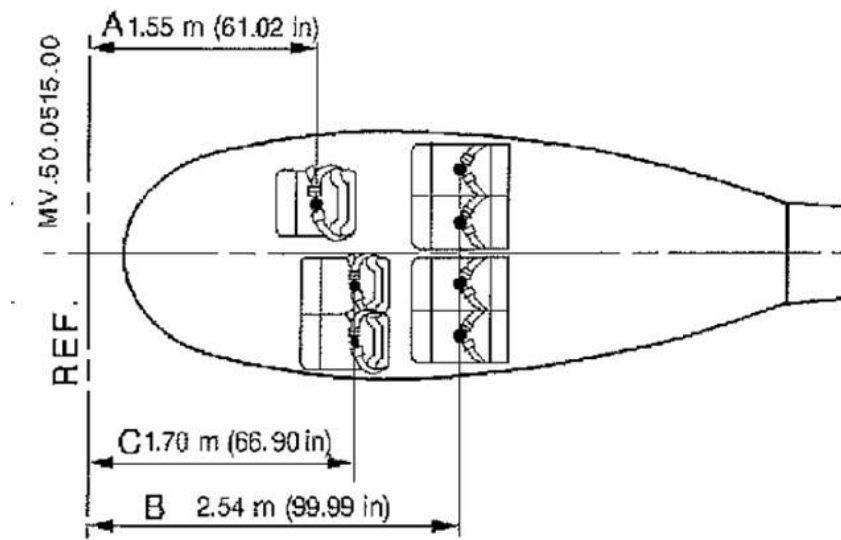
**Requirement:** To prevent a reduction of flight safety from that provided by the manufacturer, accomplish the following:

**Figure: Airbus Helicopters recommended CG position of forward two-place seat.**

1. Determine the longitudinal moment arm of the forward two-place seat using the center of the seat pan cushion as a measurement reference point.  
Complete and issue a new form CAA 2173 Weight and Balance Data.  
The weight of the seat components must be included in the CG calculations. If a seat adaptor plate is fitted the moment (position and weight) of the plate must also be considered for the CG calculation.  
The lateral CG arm of the helicopter must not be assumed to be zero. The lateral CG must be recorded and be within the limits specified in the AFM.  
Annotate the CAA2173 to include the value of the longitudinal moment arm of the forward two-place seat used.
2. Remove CAA Limitations Section, (1 page), dated 14 December 2015 and insert 1 page dated 30 June 2016.
