Airworthiness Directive Schedule

Helicopters

Bell 412 Series

24 November 2022

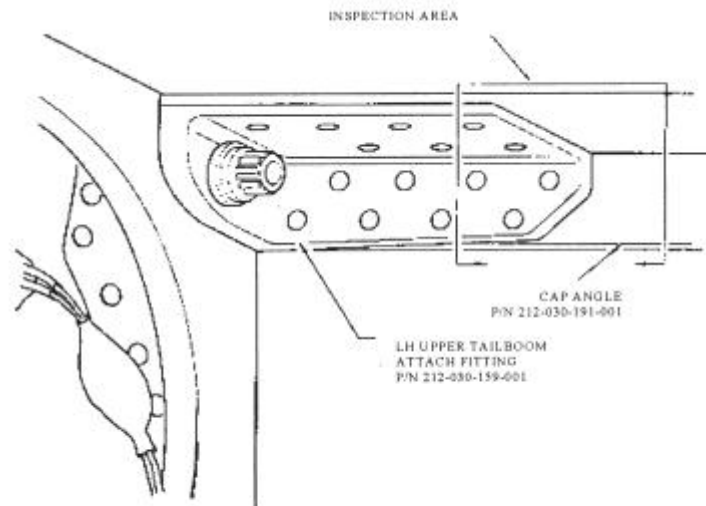
Requirement: To prevent failure of a cap angle, loss of the tail boom, and subsequent loss of control of the helicopter, inspect the cap angle and adjacent structure for a crack in the area shown in figure 1. Use a 10-power or higher magnifying glass. If a crack is found in the cap angle, replace it with an airworthy cap angle before further flight. Repair any crack found in the adjacent structure before further flight.

Figure 1 Fuselage tailboom attachment inspection

Compliance: Within 25 hours TIS and thereafter at intervals not to exceed 100 hours TIS.
