Airworthiness Directive Schedule

Helicopters

Bell 412 Series

24 June 2021

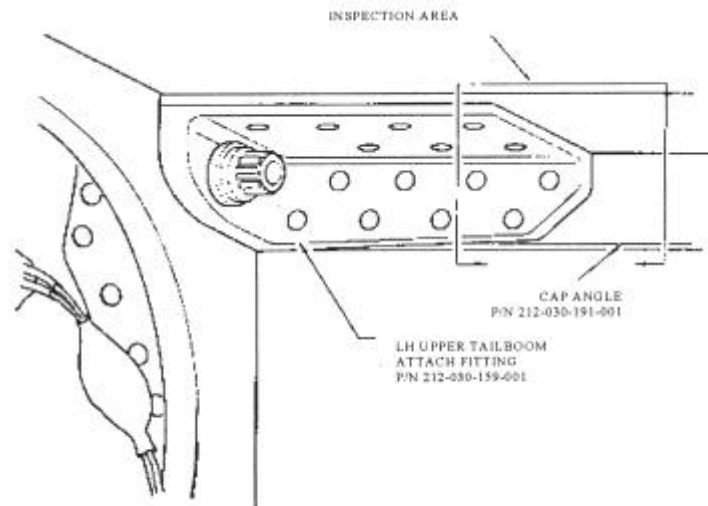
Figure 1 Fuselage tailboom attachment inspection

Requirement: To prevent failure of a cap angle, loss of the tailboom, and subsequent loss of control of the helicopter, inspect the cap angle and adjacent structure for a crack in the area shown in figure 1. Use a 10-power or higher magnifying glass. If a crack is found in the cap angle, replace it with an airworthy cap angle before further flight. Repair any crack found in the adjacent structure before further flight.
