Airworthiness Directive Schedule

Helicopters

Robinson R22 Series

30 June 2022

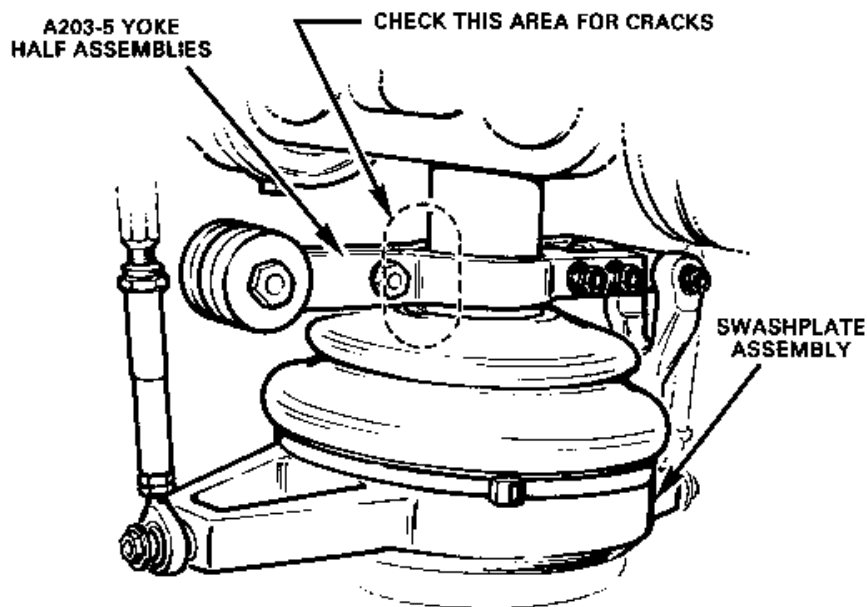
Requirement: To prevent failure of a yoke, separation of a yoke from the main rotor drive shaft, and subsequent loss of control of the helicopter, accomplish the following:-

1. Inspect each yoke for cracks. The diagram shows the area to be inspected. If a yoke is found cracked, before further flight, replace the yokes with airworthy yokes, P/N A203-7. Both yokes must be replaced with P/N A203-7.

2. Determine the Lot identifier of each yoke. If the Lot identifier is from 24 through 43, if it is a letter code, or if it is illegible, replace yokes, P/N A203-5, with airworthy yokes, P/N A203-7. Yoke, P/N A203-7, cannot be installed with yoke, P/N A203-5.
