# Airworthiness Directive Schedule

## Helicopters

### Robinson R44 Series

29 September 2022

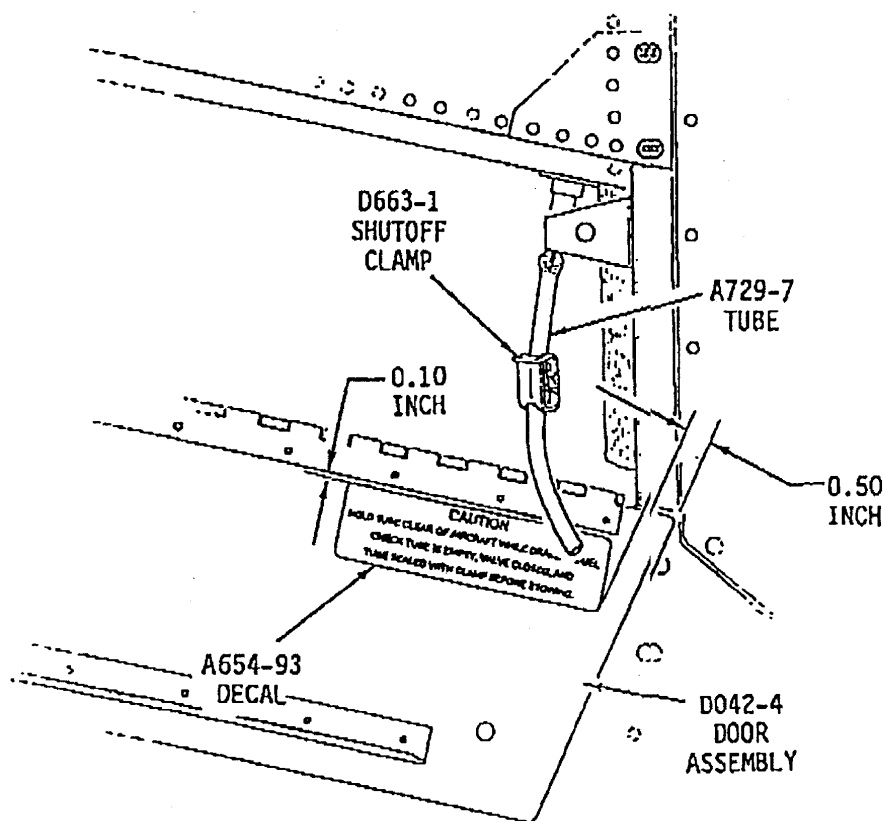
FIGURE 1  
AD 99-13-11

**Requirement:** To prevent fuel leaks from the auxiliary fuel tank sump drain, which could cause a fire and subsequent loss of the helicopter, accomplish the following:-

Install placard decal, P/N A654-93, as shown.

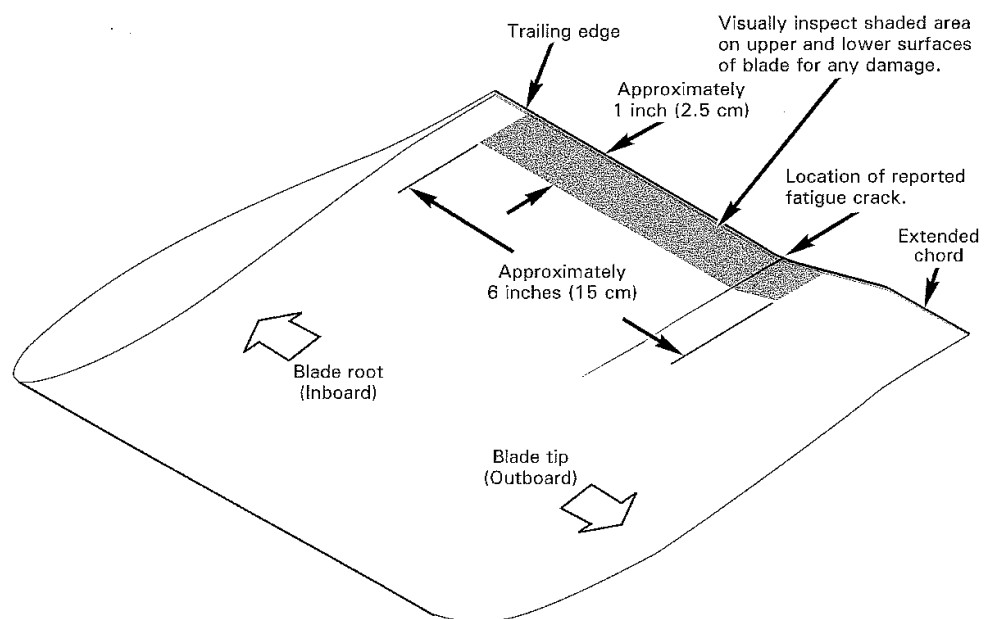
*Figure 1 – Section of MRB P/N C016-7 (View of blade lower surface)*

1. Inspect the upper and lower surfaces of each main rotor blade in the area shown in Figure 1. Inspect for any damage which may initiate a fatigue crack. A stepladder may be required to inspect the blades.

If the inspection reveals any damage or unusual marks, then the blades must be inspected by a maintenance engineer before further flight.

If any unusual rotor system vibration is detected in flight, land immediately and inspect the main rotor blades in the area shown in Figure 1. If the inspection reveals any damage or unusual marks, then the blades must be inspected by a maintenance engineer before further flight.

2. Modify the main rotor blades per the instructions in Robinson Helicopter Company R44 Service Bulletin SB-89 dated 30 March 2015.
