Airworthiness Directive Schedule

Helicopters

Bell 212 Series

31 October 2024

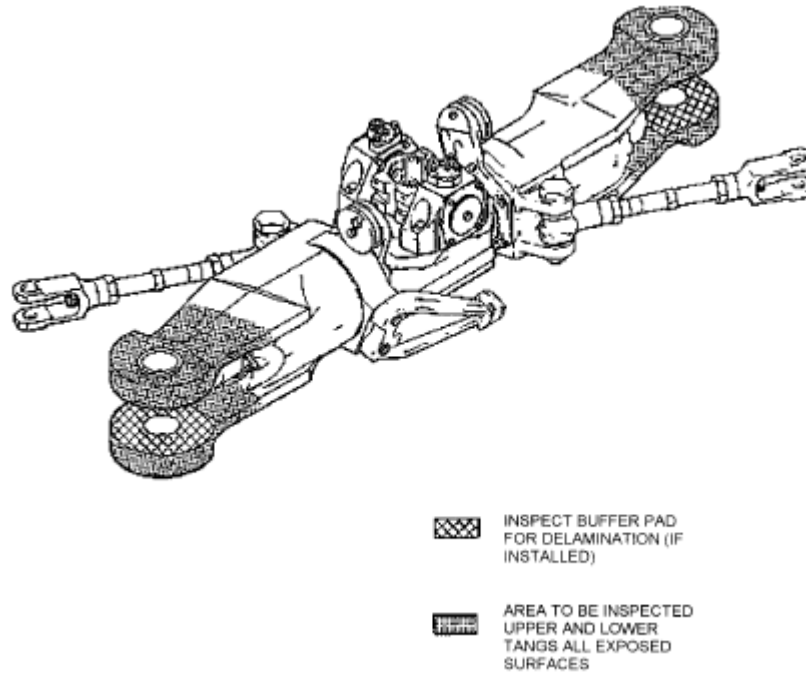
Figure 1. Inspection of Main Rotor Hub Grip Tangs

2. Without removing the main rotor blades, clean the exposed surfaces of the upper and lower tangs of each grip with denatured alcohol. Wipe dry. Using a 10-power or higher magnifying glass, visually inspect the exposed surfaces of the upper and lower tangs of each grip for cracks. Pay particular attention to the lower surface of each lower grip tang from the main rotor blade bolt-bushing flange to the leading and trailing edge of each grip tang. See Figure 1 as follows:

4. Remove each main rotor blade, and inspect each grip buffer pad on the inner surfaces of each grip tang for delamination (see Figure 1 of this AD). If there is any delamination, remove the buffer pad and inspect the grip surface for corrosion or other damage. This inspection interval coincides with the main rotor tension-torsion strap replacement times.

Note: Before further flight replace any cracked grip with an airworthy grip. Replace or repair any grip with any corrosion or other damage which is within the maximum repair damage limits. The maximum repair damage limitations are found in the applicable Component and Repair Overhaul Manual. Bell Helicopter Textron Operations Safety Notice 205-85-9, dated November 14, 1985, also pertains to the subject of this AD.

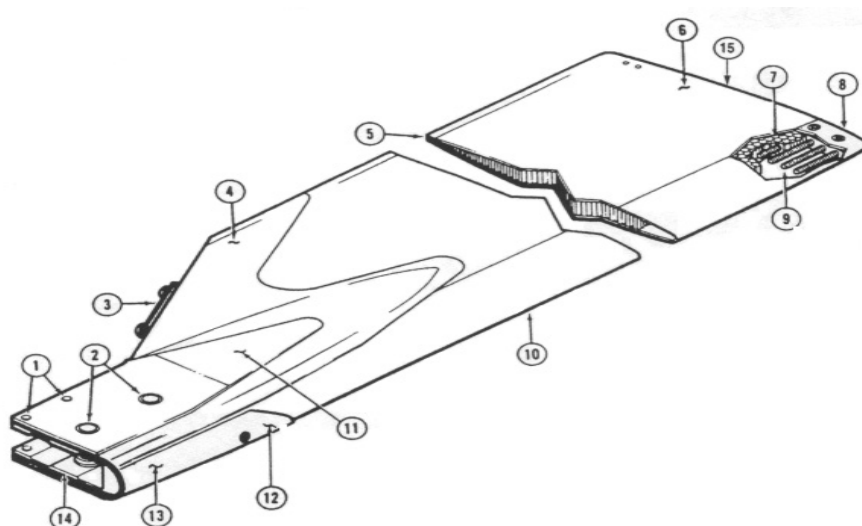
Figure 1 - T/R Blade Assembly

Requirement: To prevent tail rotor blade failure due to damage or corrosion possibly resulting in cracks and subsequent loss of aircraft control, accomplish the following:

Visually inspect each T/R blade using a bright light and a 3X or higher magnifying glass. With reference to figure 1 in this AD, inspect the blade skins, leading edge spar, doublers, grip plates and trailing edge for cracks, corrosion and any other damage including nicks, scratches, and dents. Corrosion may be indicated by blistering, peeling, flaking, bubbling or cracked paint. Pay particular attention to both sides of each T/R blade in the area located 16 to 26 inches from the T/R blade tip (i.e. blade station 25 to 35 - the T/R blade tip is located at blade station 51) and inspect the inboard blade butt area near the attachment of the external balance weights and screws. Also pay particular attention where snags from the cloth are visible, as this may indicate a crack or paint chip that could lead to corrosion. If any blistering, peeling, flaking, bubbling, or cracked paint is found, remove the paint from the affected area and visually inspect the area for corrosion or a crack, using a 10X or higher magnifying glass. If any corrosion is found, measure the depth of the corrosion. A digital optical micrometre can be used for this measurement. If a nick, scratch, or dent is found, visually inspect for a crack using a 10X or higher magnifying glass and measure the depth of the damage. A digital optical micrometre can be used for this measurement. If a crack is found, replace the T/R blade before further flight. If any corrosion, nicks, scratches, dents, or other damage is within the maximum repair limits specified in the applicable maintenance manual, repair or replace the T/R blade before further flight. If any corrosion, nicks, scratches, dents, or any other damage exceeds the maximum specified repair limits specified in the applicable maintenance manual, replace the T/R blade before further flight.

Note 2: Blade repair procedures are specified in the applicable maintenance manual, component repair and overhaul manuals.
(FAA AD 2008-10-03 refers)
