# Airworthiness Directive Schedule

### Bell 212 Series

29 July 2021

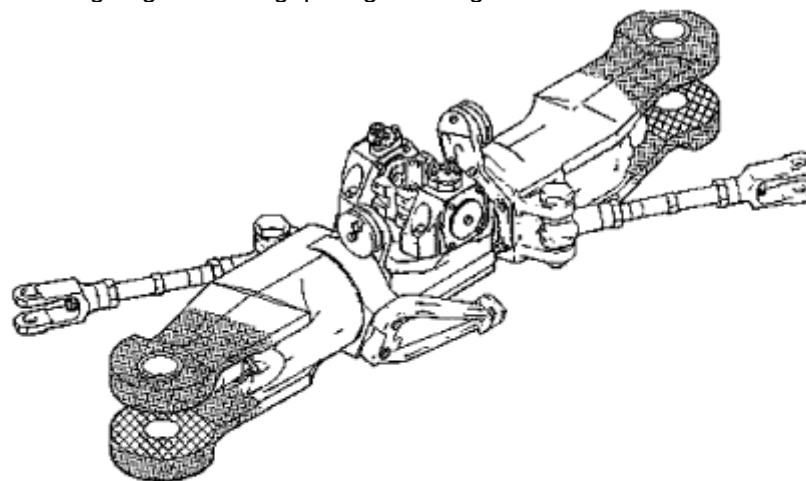
**Figure 1. Inspection of Main Rotor Hub Grip Tangs**

2. Without removing the main rotor blades, clean the exposed surfaces of the upper and lower tangs of each grip with denatured alcohol. Wipe dry. Using a 10-power or higher magnifying glass, visually inspect the exposed surfaces of the upper and lower tangs of each grip for cracks. Pay particular attention to the lower surface of each lower grip tang from the main rotor blade bolt-bushing flange to the leading and trailing edge of each grip tang. See Figure 1 as follows:

INSPECT BUFFER PAD FOR DELAMINATION (IF INSTALLED)  
  AREA TO BE INSPECTED UPPER AND LOWER TANGS ALL EXPOSED SURFACES

4. Remove each main rotor blade, and inspect each grip buffer pad on the inner surfaces of each grip tang for delamination (see Figure 1 of this AD). If there is any delamination, remove the buffer pad and inspect the grip surface for corrosion or other damage. This inspection interval coincides with the main rotor tension-torsion strap replacement times.

5. Remove each main rotor blade. Remove each grip buffer pad (if installed) from the inner surfaces of each grip tang. Inspect the grip surfaces for corrosion or other damage. Fluorescent-penetrant inspect (FPI) the grip for a crack, paying particular attention to the upper and lower grip tangs. When inspecting grips, P/N 204-011-121-005, -09, and -113, pay particular attention to the leading and trailing edges of the grip barrel. FPI procedures are contained in Bell Helicopter Textron's Standard Practices Manual, BHT-ALL-SPM.

**Note:** Before further flight replace any cracked grip with an airworthy grip. Replace or repair any grip with any corrosion or other damage which is within the maximum repair damage limits. The maximum repair damage limitations are found in the applicable Component and Repair Overhaul Manual. Bell Helicopter Textron Operations Safety Notice 205-85-9, dated November 14, 1985, also pertains to the subject of this AD.

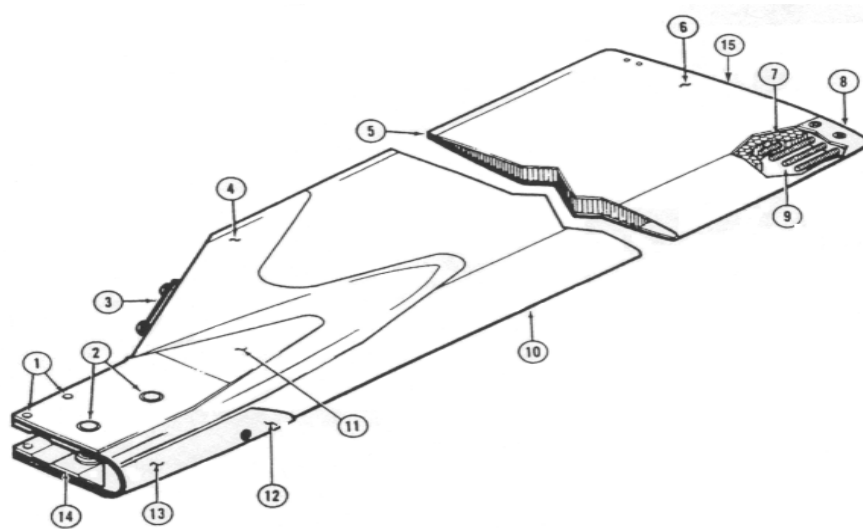
**Figure 1 - T/R Blade Assembly**

**Requirement:** To prevent tail rotor blade failure due to damage or corrosion possibly resulting in cracks and subsequent loss of aircraft control, accomplish the following:

Visually inspect each T/R blade using a bright light and a 3X or higher magnifying glass. With reference to figure 1 in this AD, inspect the blade skins, leading edge spar, doublers, grip plates and trailing edge for cracks, corrosion and any other damage including nicks, scratches and dents. Corrosion may be indicated by blistering, peeling, flaking, bubbling or cracked paint. Pay particular attention to both sides of each T/R blade in the area located 16 to 26 inches from the T/R blade tip (i.e. blade station 25 to 35 - the T/R blade tip is located at blade station 51), and inspect the inboard blade butt area near the attachment of the external balance weights and screws. Also pay particular attention where snags from the cloth are visible, as this may indicate a crack or paint chip that could lead to corrosion. If any blistering, peeling, flaking, bubbling or cracked paint is found, remove the paint from the affected area and visually inspect the area for corrosion or a crack, using a 10X or higher magnifying glass. If any corrosion is found, measure the depth of the corrosion. A digital optical micrometer can be used for this measurement. If a nick, scratch or dent is found, visually inspect for a crack using a 10X or higher magnifying glass and measure the depth of the damage. A digital optical micrometer can be used for this measurement. If a crack is found, replace the T/R blade before further flight. If any corrosion, nicks, scratches, dents or other damage is within the maximum repair limits specified in the applicable maintenance manual, repair or replace the T/R blade before further flight. If any corrosion, nicks, scratches, dents or any other damage exceeds the maximum specified repair limits specified in the applicable maintenance manual, replace the T/R blade before further flight.

**Note 2:** Blade repair procedures are specified in the applicable maintenance manual, component repair and overhaul manuals.  
(FAA AD 2008-10-03 refers)
