Feedback

Canadian Aviation Service Difficulty Reports

The following content was published between 1 October 2021 and 31 December 2021. The full accessible version of each article is available on the Feedback [website](#).

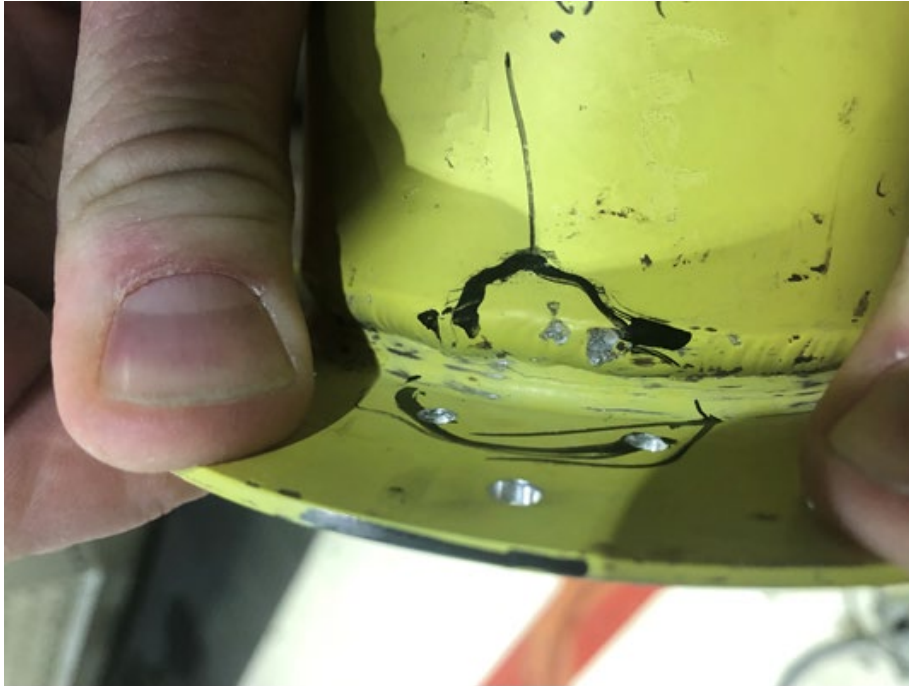
Fuel leakage was noted on the underside of the left wing. Through visual examination, it was determined that the source was the leading edge slat canister assembly for the retraction and stowage of the driven slat track located on the left wing at station 163.00. Fuel seepage did not present itself until approximately 4000 pounds of total fuel was added to the tank due to the location of the crack. The canister assembly damage was found on the aft side, interior radius of the plate flange, where the flange plate joins to the canister tube and is adjacent to the weld (approximately 0.125 inches forward of the weld running parallel to the weld).

The slat canisters provide a space for the slat tracks to retract into the fuel tank area and must also provide a seal against fuel leaks. These are welded and formed parts that are subjected to wing bending moments and flex stress during both flight and ground operations. The stresses on these formed parts will sometimes lead to cracking and fuel leakage as in this case.

Figure 1: Cracked area of flange radius shown in circled area

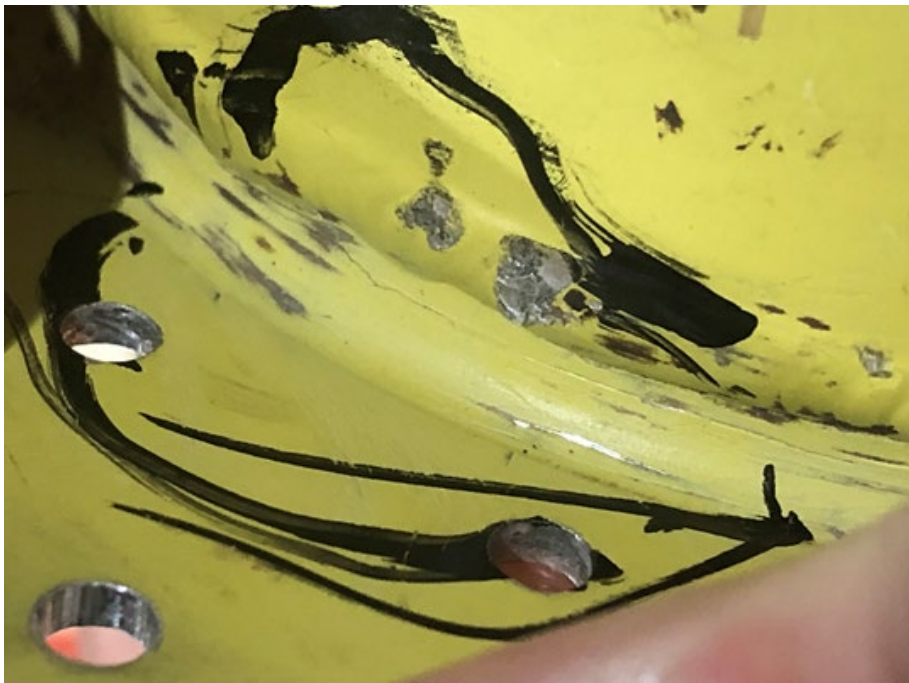
Figure 2: Close-up of cracked area

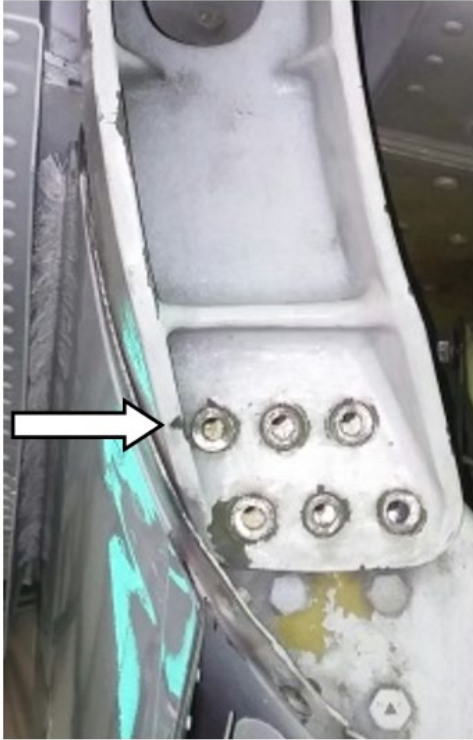
During routine inspection, the bracket between the horizontal stabilizer, fuselage, and vertical stabilizer was found cracked. This may have been caused by a screw from the tail cone coming into contact with the bracket, causing a stress riser.

In addition to the safety message related to the same topic in Feedback publication Issue 1/2015 shown below, care must be taken when installing the tail cone of these aircraft. In at least three (3) cases, damage to the horizontal stabilizer bracket resulting in a crack had been caused by the use of improper hardware when installing the tail cone. Similar findings have also been reported on model 99 series aircraft.

Picture 1 – Left-hand horizontal stabilizer bracket crack

“As aeroplanes age, it is important to take your time to properly inspect all areas in order to find damage that could progress to a failure of the part. Proper lighting is important so that you can see what you are inspecting.”

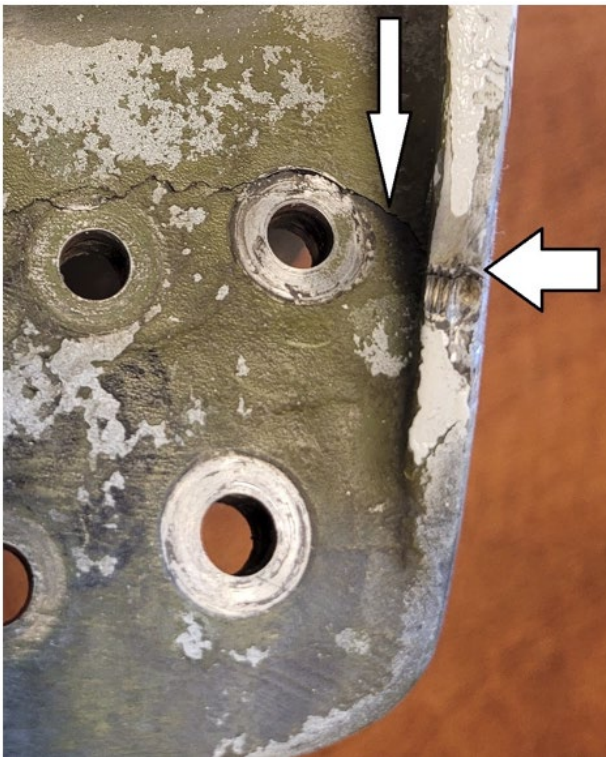
The pictures below, taken of two separate aircraft, depict both left-hand and right-hand brackets cracked in the same location.

Picture 2 – Right-hand horizontal stabilizer bracket crack

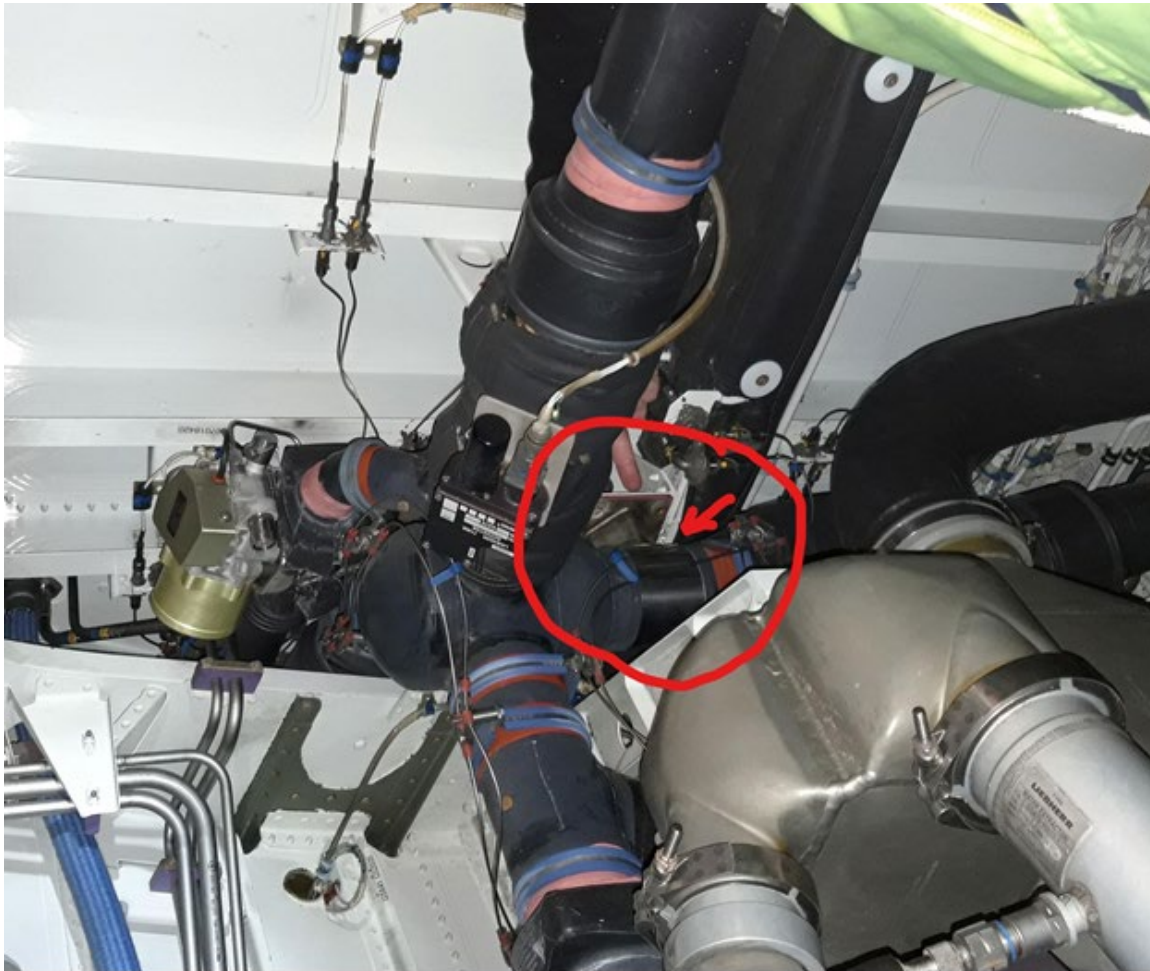
The left-hand (LH) side bleed air supply duct that passes through the aft pressure bulkhead was found cracked at the welded flange on the aft side of the bulkhead.

Figure 1: LH bleed air supply duct leak location

The submitted Service Difficulty Report (SDR) did not discuss how this defect was found, but it should be noted that the area is fairly difficult to access and inspect. Being aware that defects have been found in this location may help maintainers when troubleshooting snags or looking for defects during scheduled inspections.

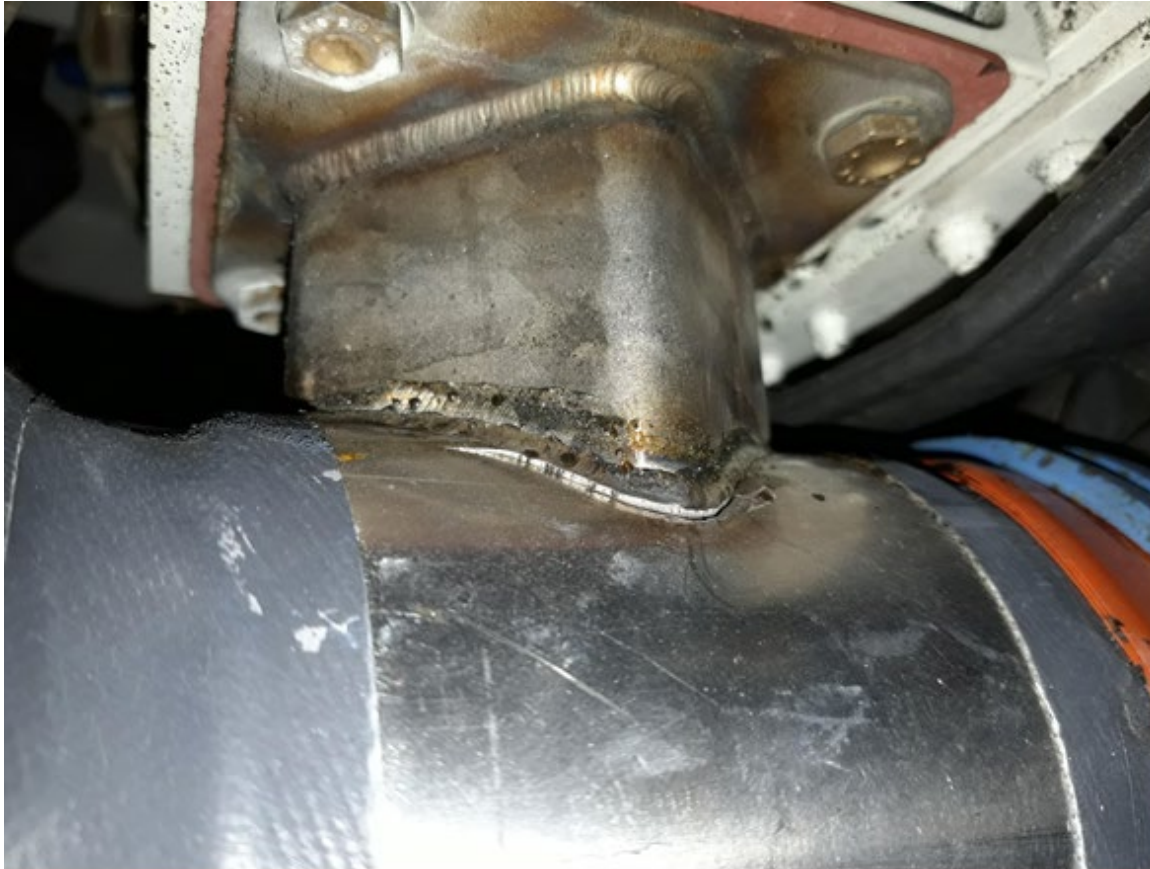
Figure 2: Duct cracked flange shown

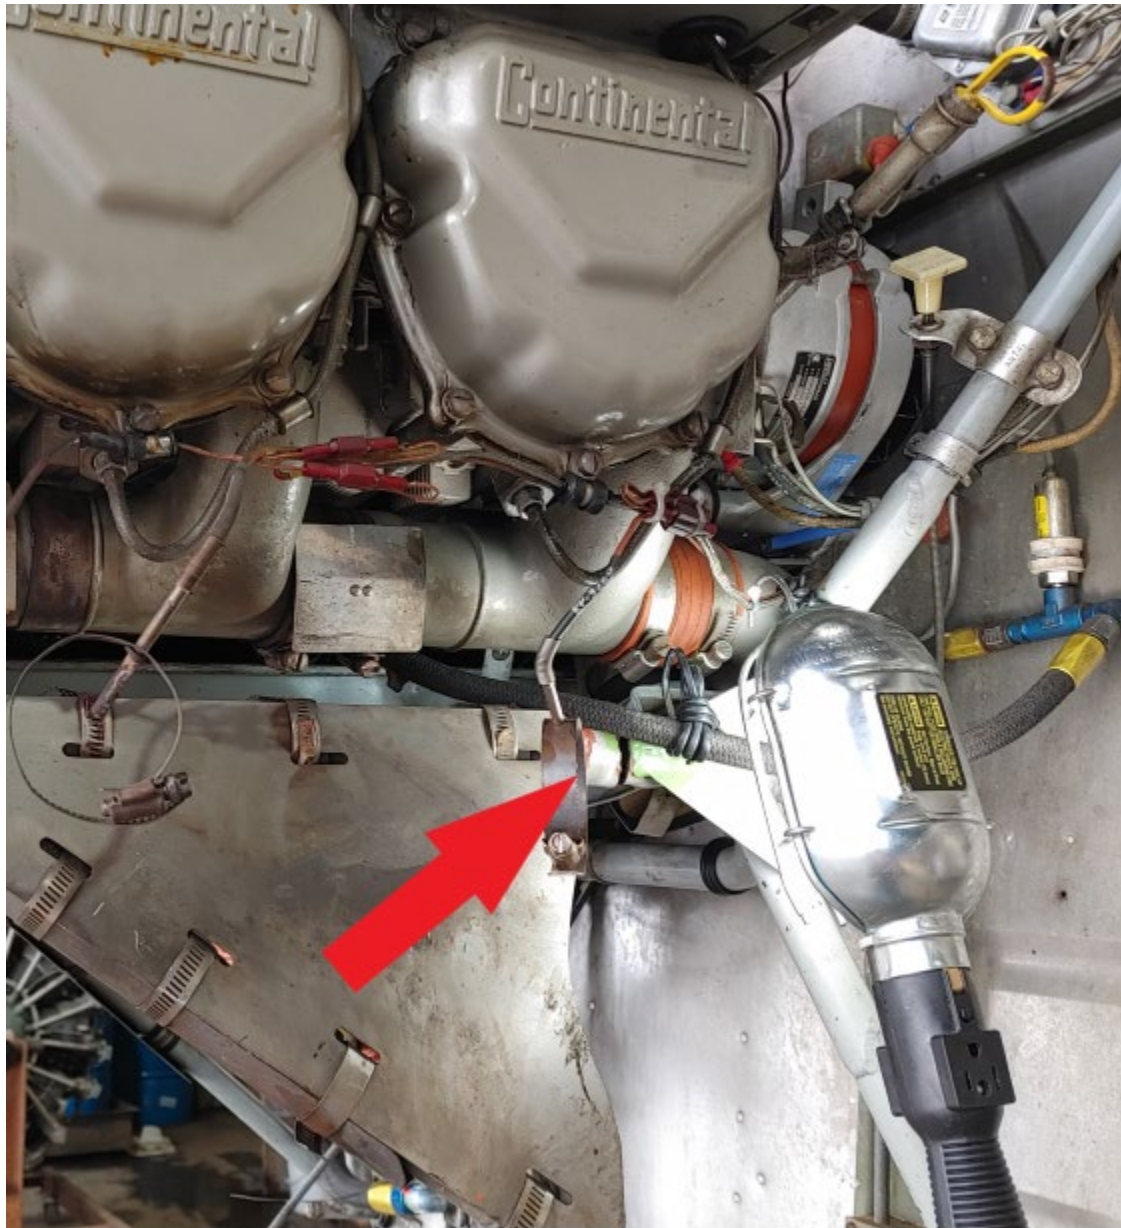
During a scheduled inspection, we found a broken engine mount tube. This aircraft is equipped with a three-blade Hartzell propeller and always had a slight vibration compared to our other two Cessna 180's equipped with a two-blade McCauley propeller, although the vibration was not excessive. The vibration lessened a bit when we balanced the propeller in April 2021. From asking pilots who have flown this aircraft recently, they had not noticed an increase in vibration since the spring.

Preferably, defects such as these should be found prior to complete failure. Contributing factors could include worn isolation mounts, propeller imbalance, and corrosion. This type of failure is avoidable but could go unnoticed as the submitter of this service

Picture 1 – Engine mount tube location

difficulty report (SDR) experienced. Special attention should always be given to the inspection of mounting structures when dealing with vibrations.

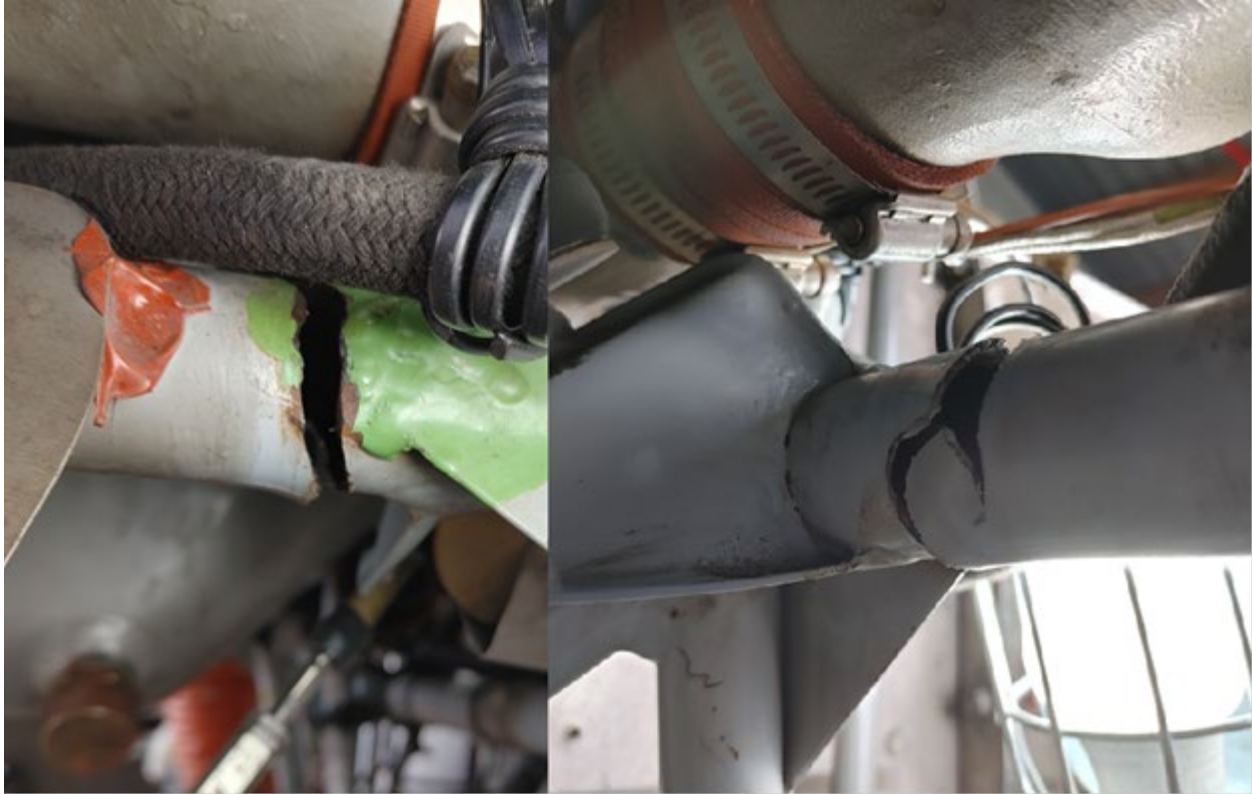
Picture 2 – Outboard and inboard view

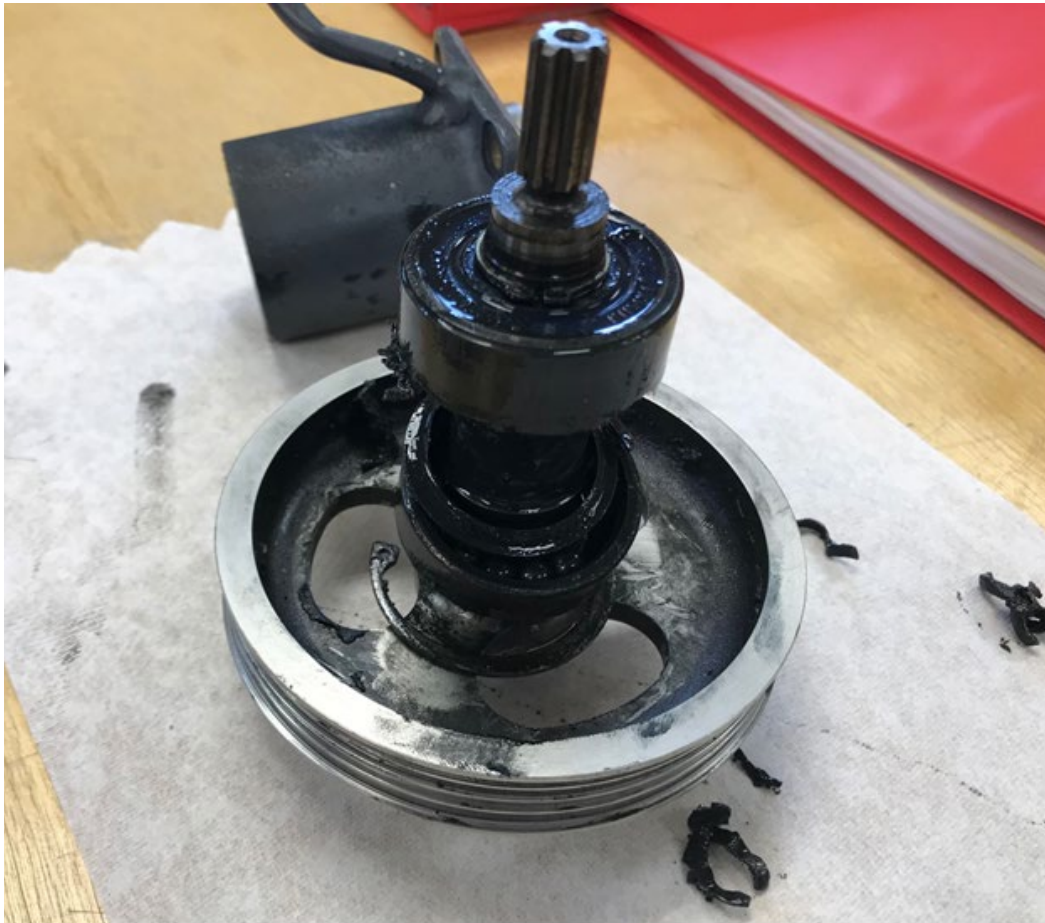
During a flight to xxx, the pilot noticed that the standby power inoperative (INOP) light had illuminated. He then diverted back to xxx, contacted maintenance about the issue and noted that all oil pressure, torque and power output of the engine (Ng) indications were normal. Shortly after the conversation with maintenance, the pilot observed that the oil pressure gauge started to fluctuate. The fluctuations continued to worsen as the flight continued and the pilot elected to divert to a closer airport. The pilot landed the aircraft with no major issues. Maintenance went to inspect the aircraft and noticed a streak of oil along the right side of the fuselage. While inspecting the engine, maintenance noticed that the alternator pulley had a slight wobble. They removed the alternator pulley drive assembly and the oil scavenge pump drive shaft came out along with the alternator pulley drive assembly. The oil scavenge pump drive shaft had sheared off where it couples with the alternator drive shaft. After disassembling the alternator pulley drive assembly, the bearing on the side of the pulley had come apart and the ball bearings came out of the housing.

Picture 1 – Alternator pulley drive shaft, bearing failure

Textron Aviation suggests removing the alternator drive belt during Manual Task 24-36-00-220 (Inspection Document 07 – 400hr / 12 month inspection). Refer to Single-Engine Turboprop Communique # SE-TP-004.

“Removing the alternator belt during this inspection allows for a more thorough check of the pulley assembly, as it does for checking side-to-side play.”

Transport Canada Civil Aviation (TCCA) suggests owners, operators, and maintainers pay particular attention to this area and continue to report any defects noted.

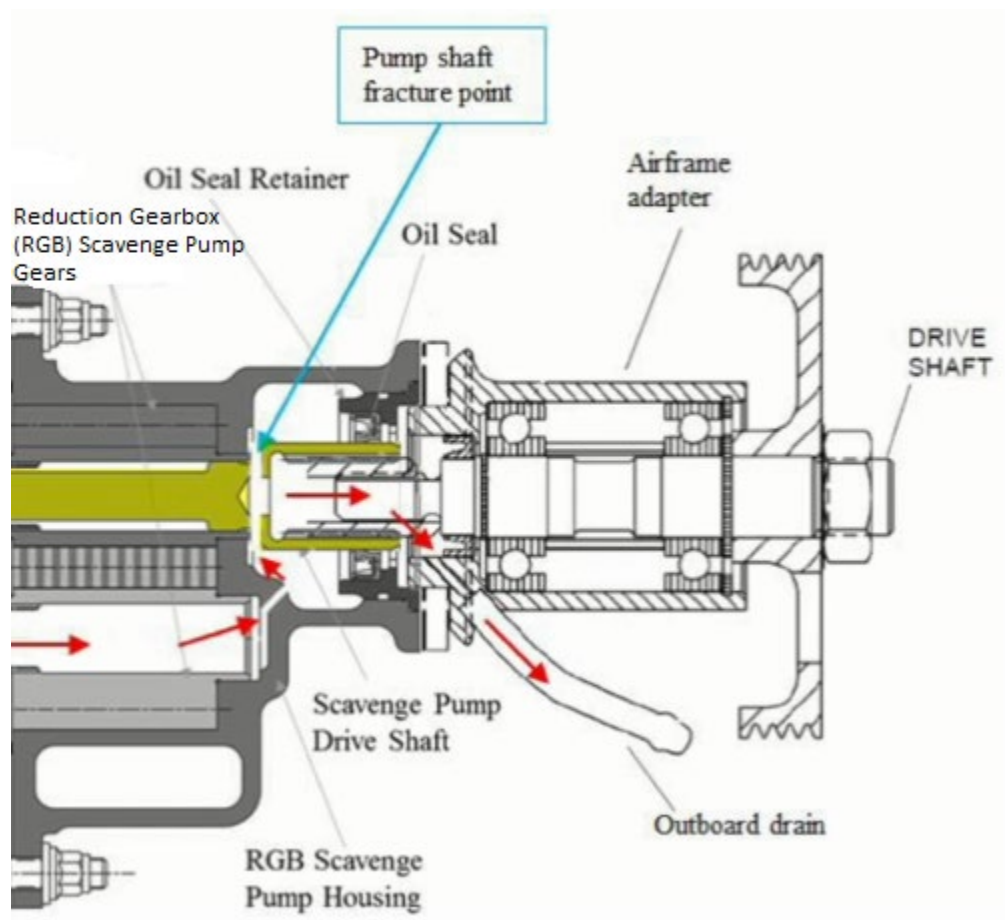
Picture 2 – Oil scavenge pump drive shaft, failure location

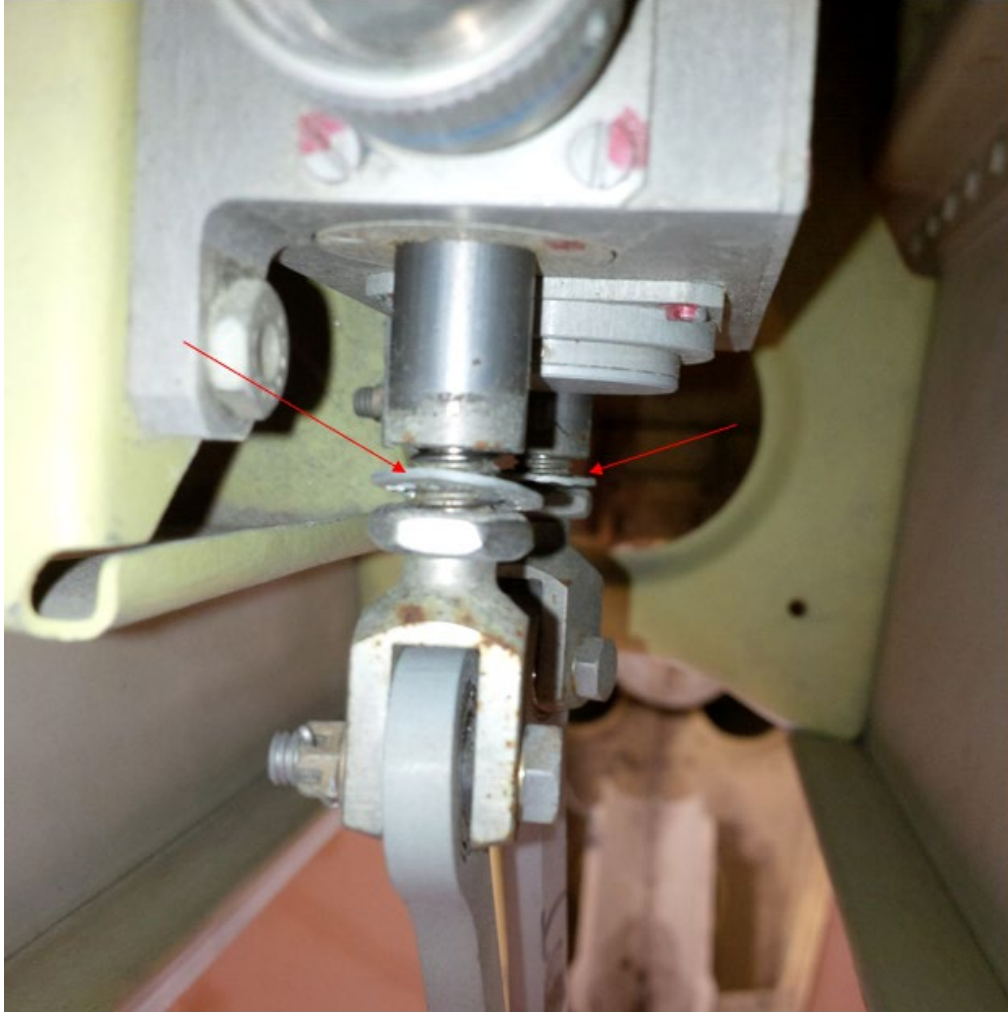
During inspection, it was noticed that the rod end jam nuts were not secure on the rudder trim actuator.

Rudder trim actuator loose jam nuts

After consultation with the service difficulty report (SDR) submitter, Transport Canada Civil Aviation (TCCA) understood that the area was inspected in accordance with Service Bulletin (SB) 80-0444. No other occurrences have been reported to TCCA. Operators and maintainers of these aircraft are reminded, that whenever performing maintenance in this area, to remain vigilant and observant for this reported condition. If the condition of loose jam nuts is found, please submit an SDR accordingly.

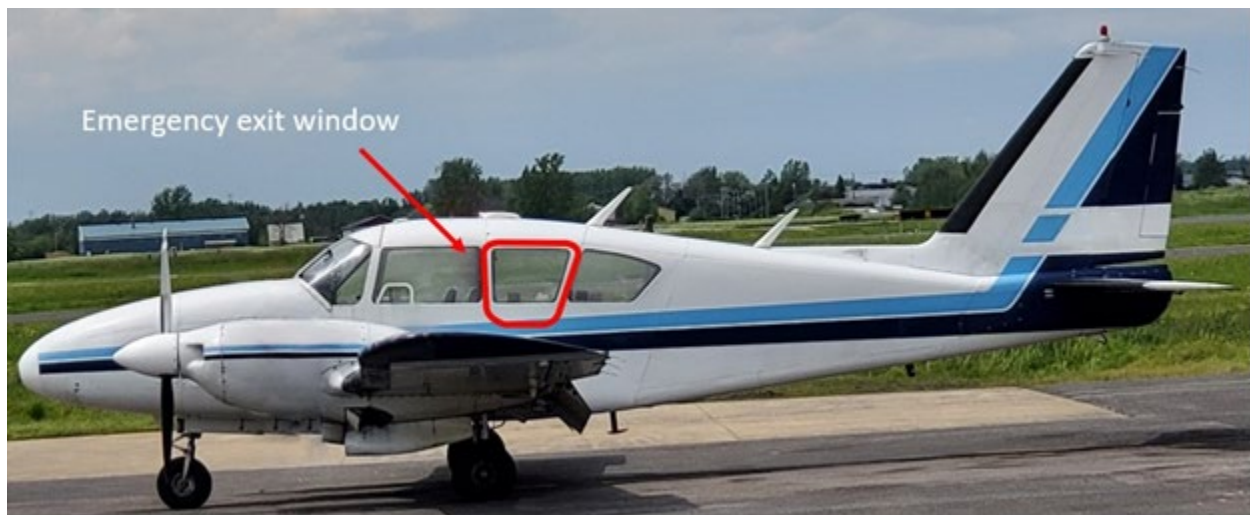
The emergency exit window assembly departed inflight.

The occurrence aircraft had undergone maintenance just prior to the incident flight. It was determined that the emergency exit window assembly was not installed correctly, possibly due to a lack of clarity of the instructions in the maintenance manual (MM).

Picture 1 – Side view of the Piper PA-23-250 aircraft showing the emergency exit window (Source: TSB A19Q0091)

Piper Aircraft completed a thorough review of the MM instructions relevant to the emergency exit window assembly used on the PA-23-250 model. The applicable MM, part number (P/N) 753-564 has been revised, dated 31 July 2021. This latest revision provides clear, detailed instructions for the removal and installation of the emergency exit window assembly.

Transport Canada Civil Aviation (TCCA) strongly suggests owners, operators and maintainers review and adopt the latest publication of Piper Aztec MM P/N 753-564.

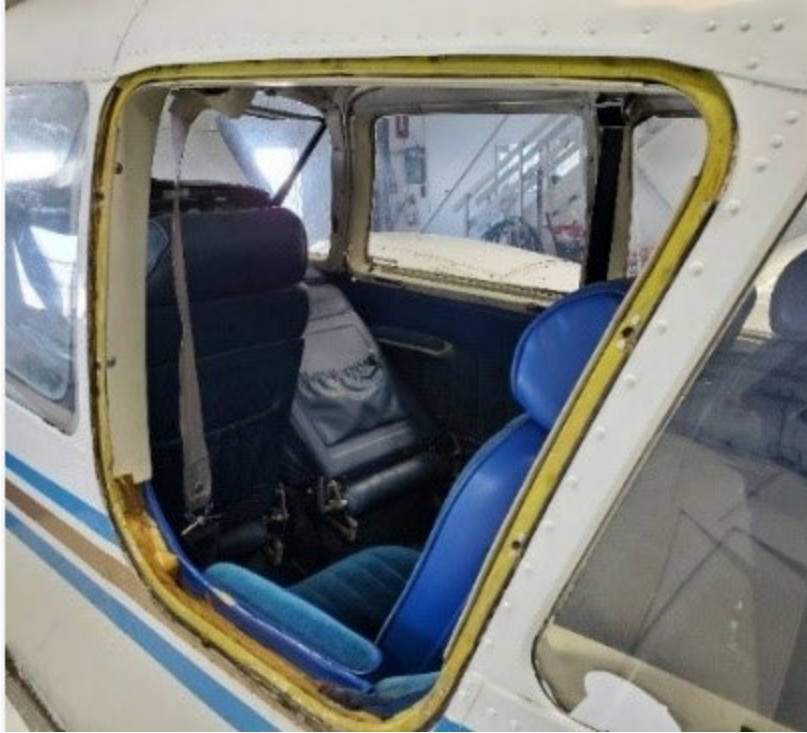
Picture 2 – Emergency exit window removed (Source: TSB A19Q0091)

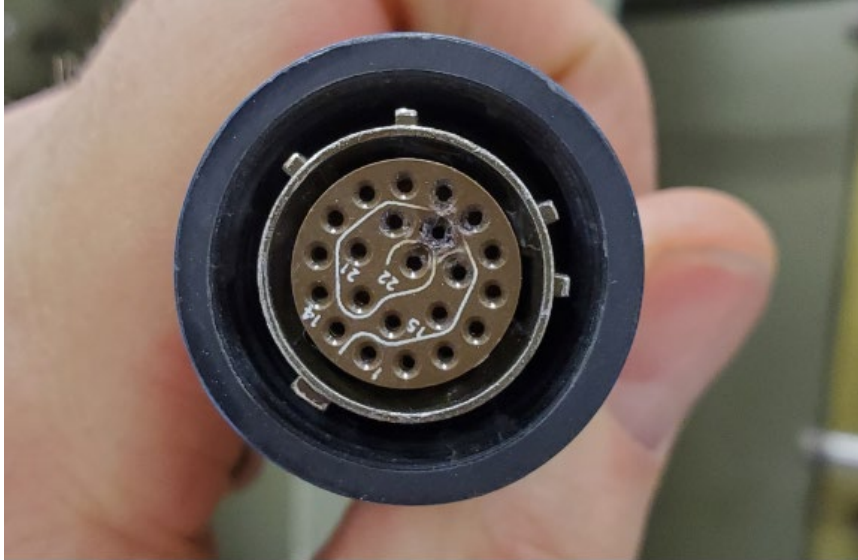
The aircraft was taxiing to depart, and during taxi, a fail message ENG T2 HTR fail came on and the aircraft returned to the hangar. The turbine temperature (TT2) sensor failed, and on inspection, the wiring harness to the probe had arcing in the connector.

In this event, the arcing of the contact in the connector may have been caused by an internal failure, or damage to the connector sealing grommets, or a foreign object shorting between contacts, or shorting by corrosion from moisture ingress, as examples. From the photos provided, it appears that the keyways are serviceable, which would rule out misalignment of the connection.

Photo 1 – Electrical connector socket with arcing damage

Commonly, the repair and maintenance of electrical connectors is carried out in accordance with either the manufacturer's principle Instructions for Continued Airworthiness (ICA) or Advisory Circular (AC) 43-13, which provide a wide range of standard practices. Transport Canada would also like to highlight that many manufacturers now publish specific electrical standard practice procedure manuals for their products. These procedures have useful information specific to connector care, as well as recommended products used to protect from moisture or other liquids when environmental protection is needed. When performing tasks on or around electrical wiring or hardware, remember to consult the manufacturer's specific connector care publications, if provided.

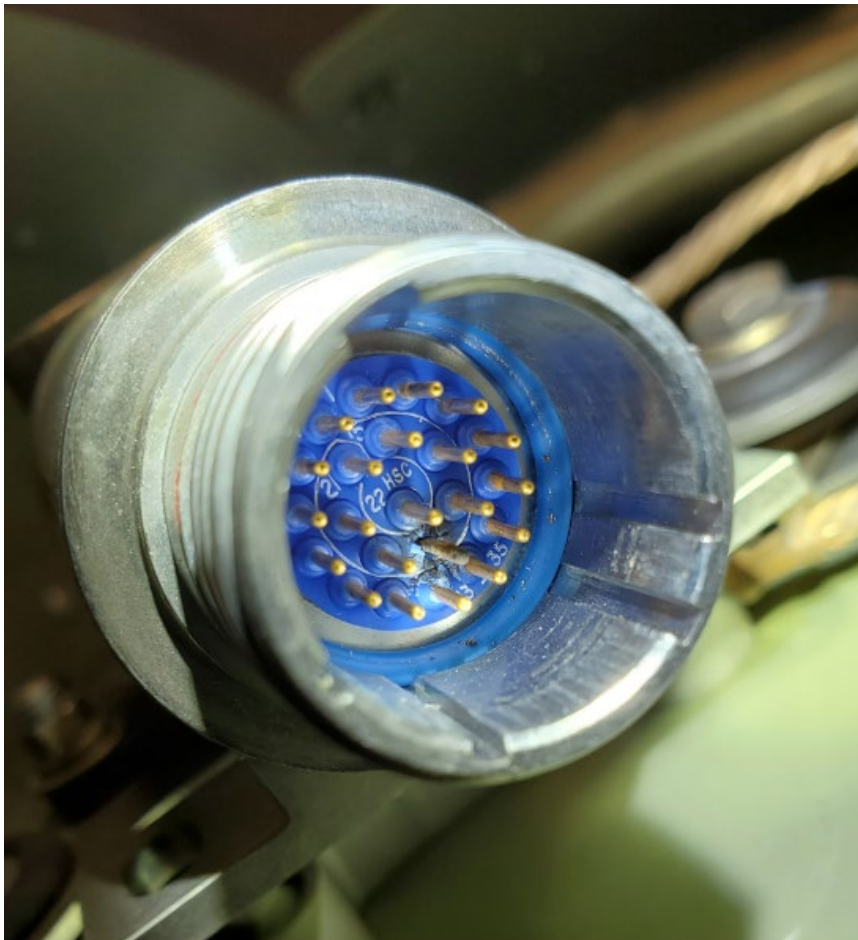
Photo 2 – Electrical connector pin with arcing damage
