SAFETY INVESTIGATION REPORT
CAA OCCURRENCE 19/4241
VAN'S AIRCRAFT INCORPORATED RV-12
ZK-LSV
CONTROLLED FLIGHT INTO TERRAIN
KAKATARAHAE HILL, COROMANDEL RANGE
14 JUNE 2019

Foreword

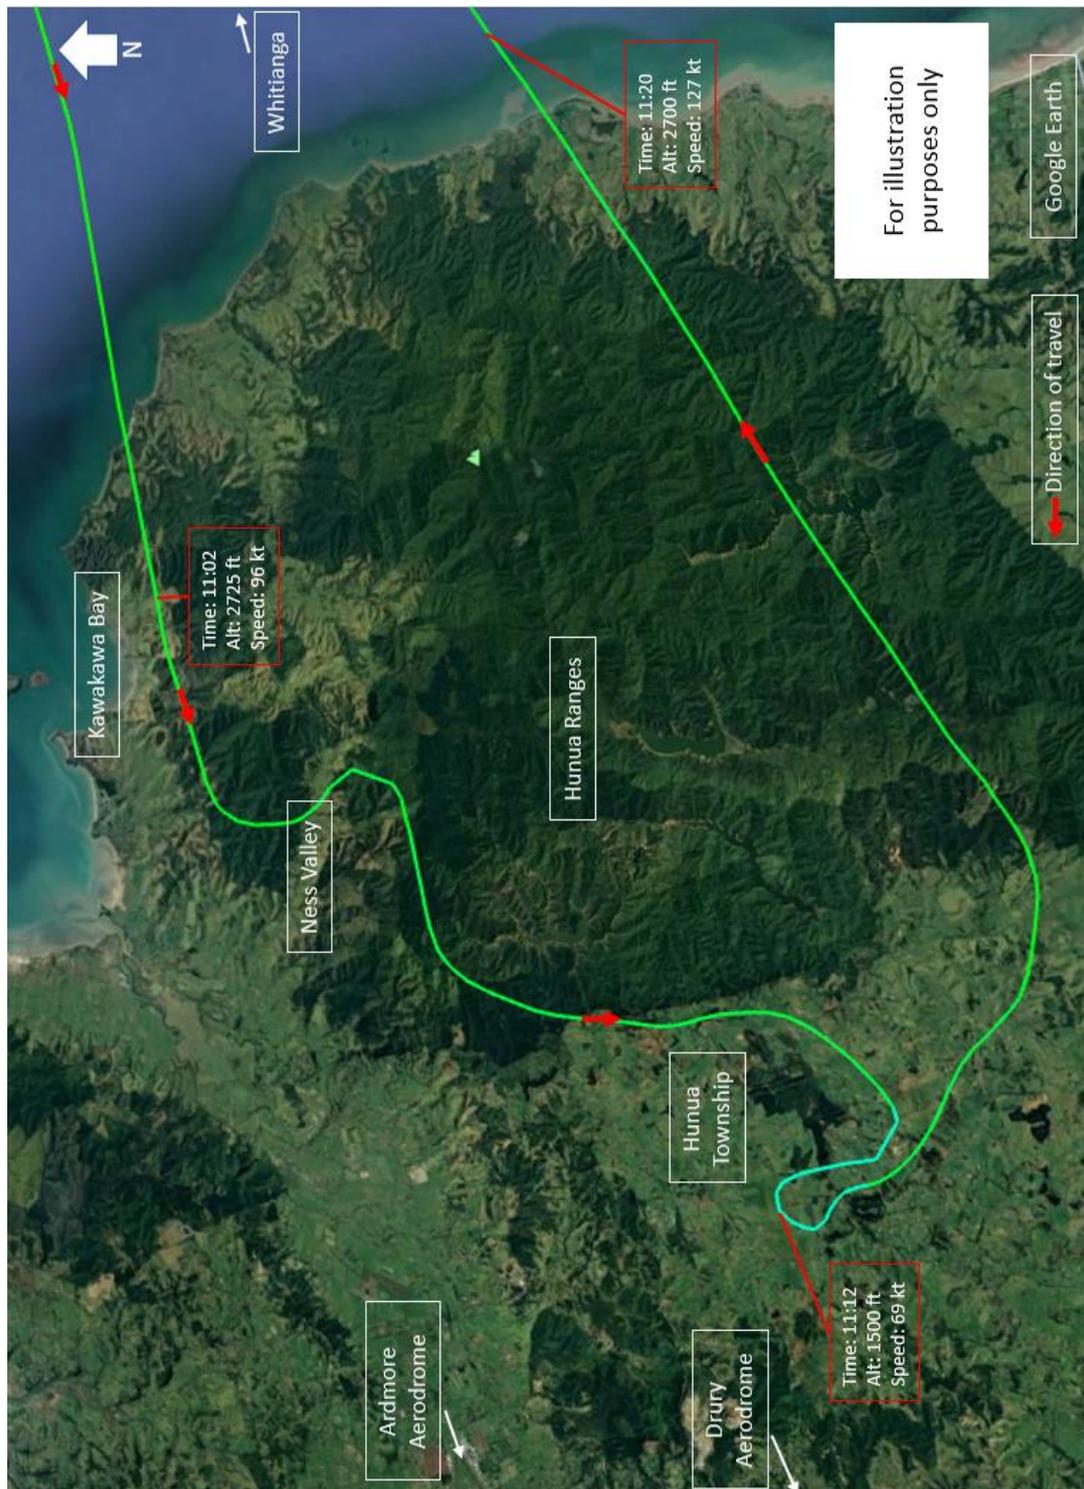
Figure 1: ZK-LSV flight track from ADS-B flight data.

- 1.1.6 Near Kawakawa Bay, at approximately 2720 ft, the aircraft turned to the south and flew down the Ness and Wairoa Valleys towards Drury. When the aircraft was in an open plateau, at approximately 1500 ft, just south-west of Hunua township the pilot commenced a reversal turn and then began an ascending turn to track north-east, in the direction of Whitianga. Refer to Figure 1.

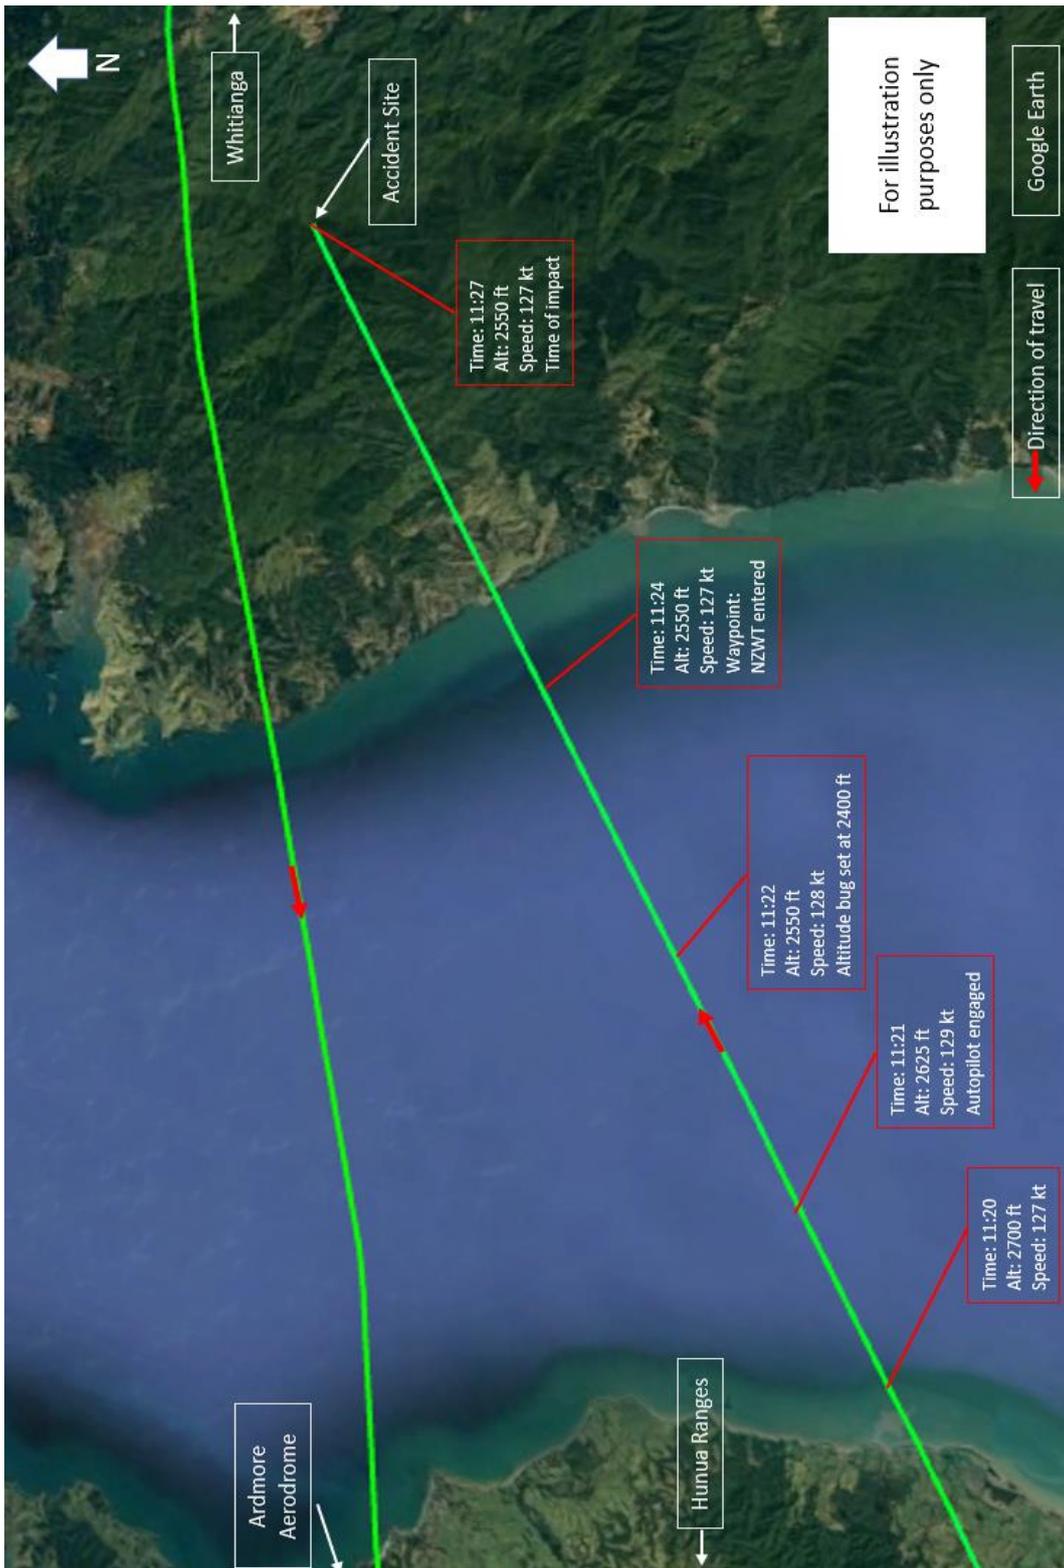
Figure 2: ZK-LSV flight track from ADS-B flight data.

- 1.1.7 The pilot initially climbed to 2700 ft. Data recovered from the electronic flight instrument system (EFIS) showed the pilot engaged the autopilot at 1121 and the altitude bug⁶ was set at an altitude of 2400 ft at 1122. The pilot also entered the waypoint for Whitianga aerodrome (NZWT) at 1124. The autopilot remained engaged and the altitude bug set at 2400 ft until the time of impact. Refer to Figure 2.

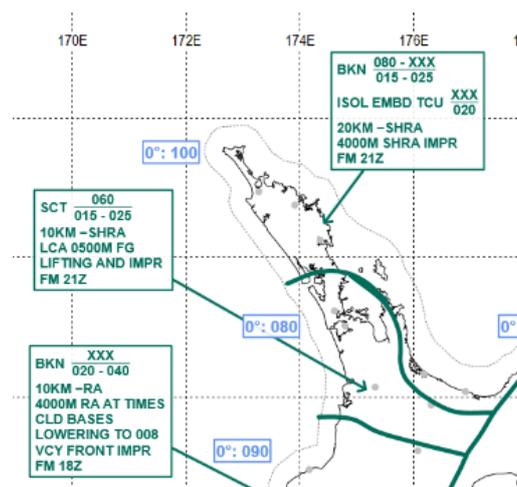
Figure 3: GRAFOR valid SFC-FL100 at 1800Z 13 June 2019.

1.7.3 Additionally, localised areas of fog were expected, reducing visibility to 500 metres. The fog was forecast to start lifting from 2100Z⁷ (0900). Refer to Figure 3.

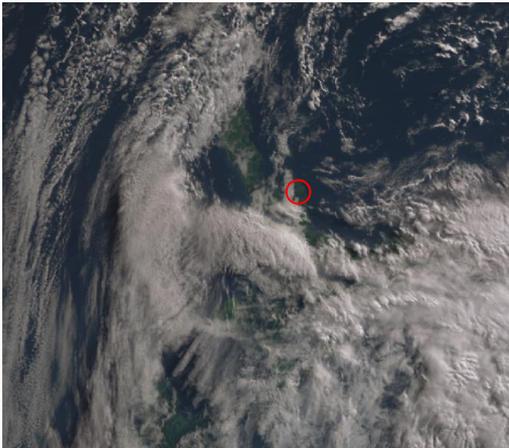
- 1.7.6 No cloud ceiling, visibility or present weather sensors are installed at the Ardmore or Whitianga aerodromes AWS.
- 1.7.7 Satellite imagery for the same day showed extensive areas of fog or low cloud in the Auckland, Western Coromandel, and Waikato regions starting to break up towards midday, with areas of cumulus cloud moving across the Coromandel. Refer to Figures 4 and 5.

Figure 4: Satellite image at 2120Z 13 June (0920 14 June NZST), red circle indicates wider Whitianga area.

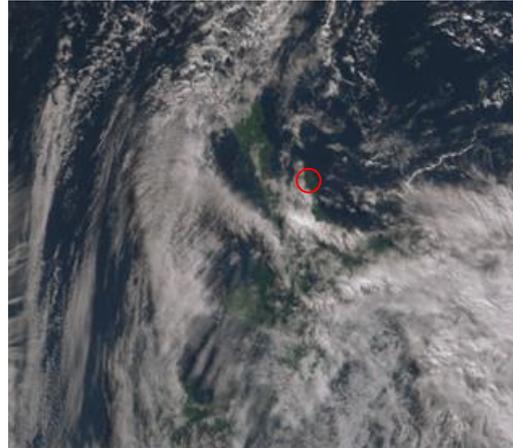
Figure 5: Satellite image at 2330Z 13 June (1130 14 June NZST), red circle indicates wider Whitianga area.

- 2.3 A pilot departing Whitianga aerodrome approximately 10 minutes prior to ZK-LSV stated that dense cloud was covering the Coromandel Range.
- 2.4 Furthermore, the same witness flying south, passing to the east of Whitianga at approximately 1050, observed little to no change in the cloud formation over the Coromandel Range. This is supported by the satellite imagery. Refer to Figure 5.

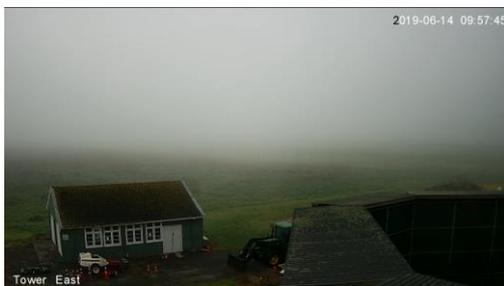
- 1.7.8 Closed-circuit television (CCTV) footage from Ardmore aerodrome between 1000 and 1130 on the day of the accident confirmed fog was present at Ardmore aerodrome, clearing from approximately 1100. CCTV footage continued to show cloud to the east of the aerodrome until approximately 1129 when the Hunua Ranges started to become visible, with some low cloud still present in the vicinity.

Figure 6: CCTV footage from Ardmore aerodrome Tower East at 0957.

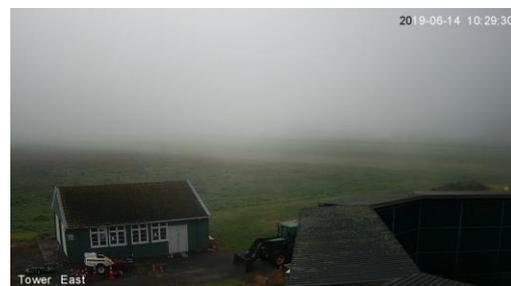
Figure 7: CCTV footage from Ardmore aerodrome Tower East at 1029.

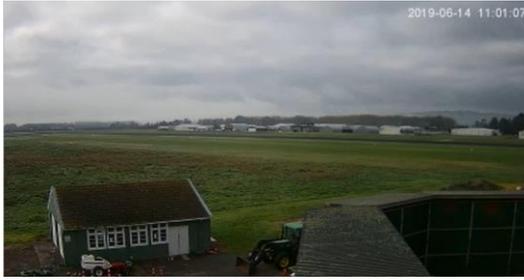
Figure 8: CCTV footage from Ardmore aerodrome Tower East at 1101.

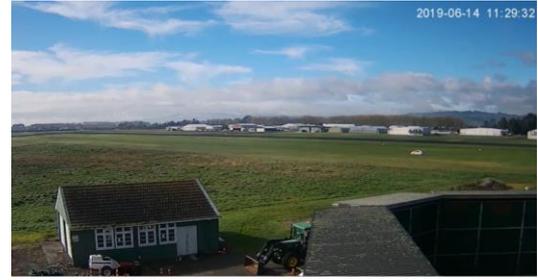
Figure 9: CCTV footage from Ardmore aerodrome Tower East at 1129.

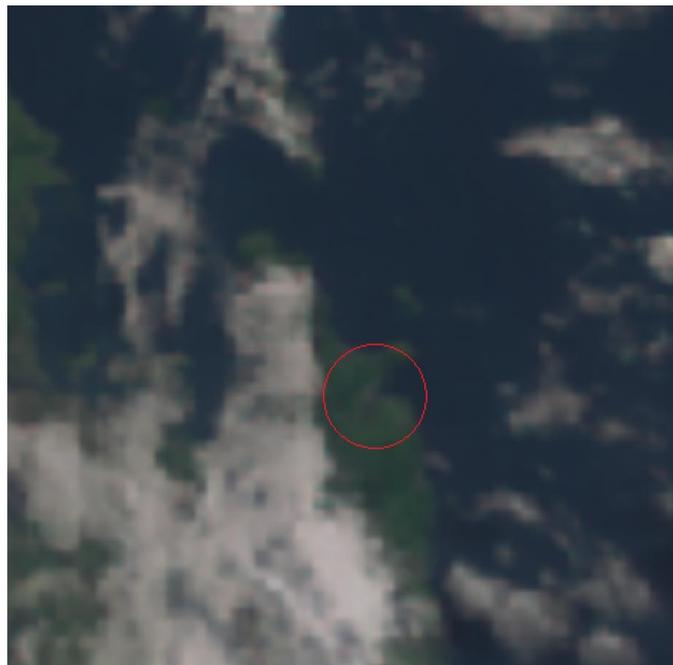
- 1.7.9 A witness statement confirmed that the weather on the day of the accident was 'beautiful and clear' in Whitianga at the time ZK-LSV departed for Ardmore, with some 'fog rolling over the hills' (Coromandel Range).
- 1.7.10 Another witness who departed Whitianga aerodrome at approximately 1035 on the day of the accident stated, 'the Coromandel Range was covered in dense clouds that touched the mountains' and the 'cloud was overcast, you couldn't go under it and you would have to go pretty high to get over it'. Refer to Figure 10.

Figure 10: Satellite image at 2230Z 13 June (1030 hours 14 June NZST), red circle indicates wider Whitianga area.

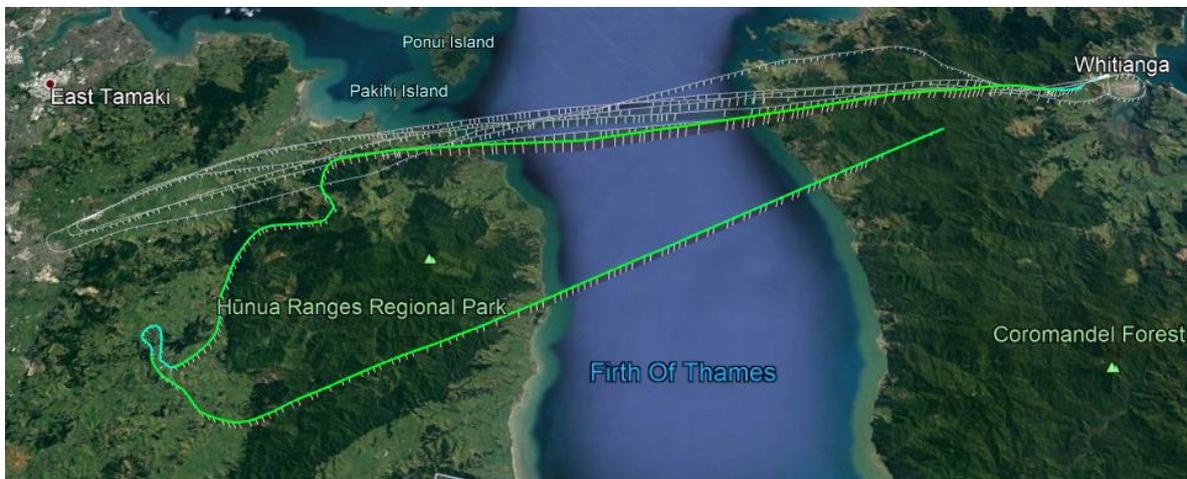
Figure 11: ZK-LSV ADS-B data of previous flights. Source: edited Google Earth™ image.

- 1.8.6 Recovered data also showed the aircraft flew a similar path on previous flights between Whitianga and Ardmore aerodromes. The accident flight initially followed the same path. However, the return portion was from further south than previous flights. Refer to Figure 11.
