**SAFETY INVESTIGATION REPORT
CAA OCCURRENCE 22/2536
PIPER PA-25-235 PAWNEE
ZK-CIG
TOW UPSET DURING GLIDER AEROTOW
FEILDING AERODROME, FEILDING
07 MAY 2022**

Aircraft type, serial number and registration:	Piper PA25-235 Pawnee, s/n 25-3012 ZK-CIG
Number and type of engines:	One, Lycoming O-540-A1A5
Year of manufacture:	1964
Date and time of accident:	07 May 2022, 1410 hours ¹ (approximately)
Location:	Feilding Aerodrome, Feilding Latitude ² : S 40° 15' 09" Longitude: E 175° 36' 01"
Type of flight:	Glider towing
Persons on board:	Crew: 1
Injuries:	Crew: 1 fatal
Nature of damage:	Aircraft destroyed
Pilot-in-command's licence	Private Pilot Licence (Aeroplane)
Pilot-in-command's age	74 years
Pilot-in-command's total flying experience:	909 hours (approximately) 416 on type (approximately) 2519 glider tows (approximately)
Investigator-in-Charge:	Mrs SJ Mandich

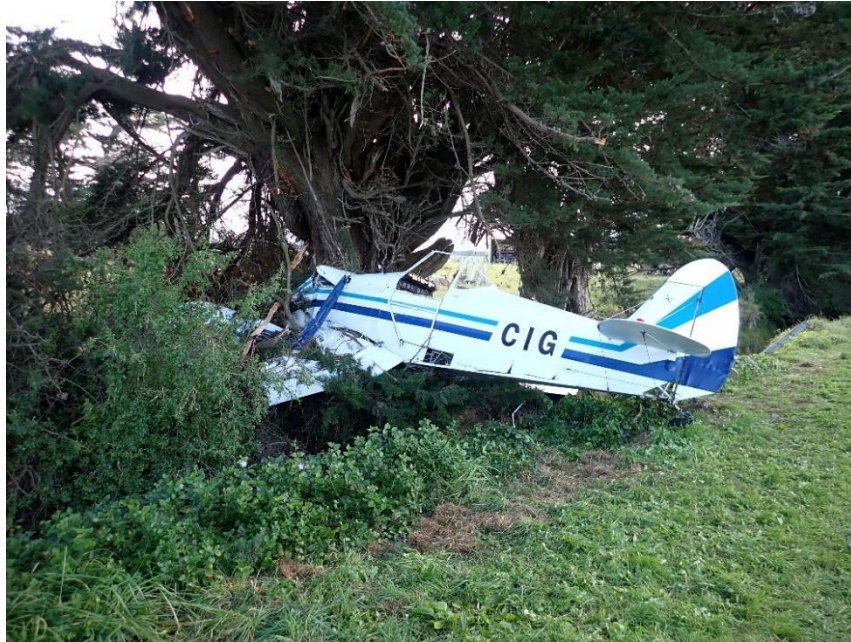
Figure 1: ZK-CIG accident site. Source CAA

- 1.12.1. The aircraft wreckage was located approximately 100 metres (m) NNE from the end of runway 28, along Taonui Road.
- 1.12.2. The site examination indicated the aircraft struck a large tree in a steep nose-down attitude and came to rest at the base of the tree, across a deep ditch.

- 1.12.3. All aircraft components were accounted for on site. There was significant damage to the front section and wings of the aircraft.
- 1.12.4. Pre-accident control integrity was established, with no issues identified. This also included the tow release mechanisms for both aircraft.
- 1.12.5. Medical and rescue staff cut the aircraft fuselage fabric and the door frame to gain access to the pilot.
- 1.12.6. Post accident, the tow rope was measured to be 42.8m, ring to ring.

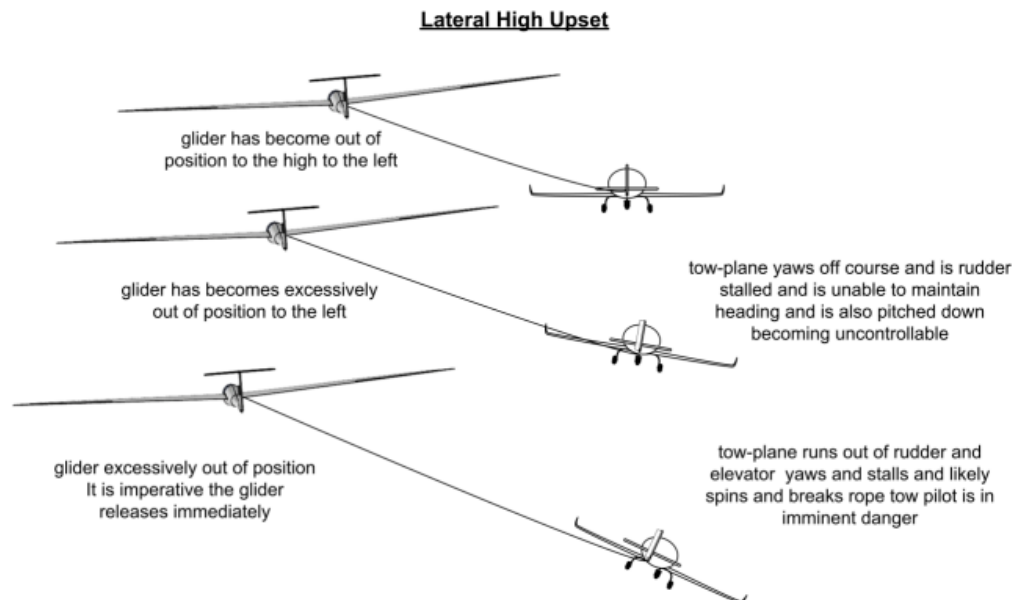
Figure 2: Lateral High Upset Diagram

2.3. As the tow rope re-tensioned, the glider appeared to kite up while still out to the left of the tow plane causing a lateral high upset of the tow plane. The result of a lateral high upset is an uncommanded yaw, roll and nose pitch down of the tow plane. This would have developed rapidly and probably startled the tow pilot.

- 2.4. The tow plane departed controlled flight and the tow pilot was unable to regain control in the height available.
- 2.5. The forces created by the increasing divergence between the glider and tow plane caused the tow rope to fail at the glider-end splice.

- 4.4. It is recommended that GNZ remind pilots of the factors that can contribute to an increased risk of an upset during an aerotow, as outlined in the GNZ Pilot Training Programme and BGA guidance for safe aerotowing.
