AIRCRAFT ACCIDENT REPORT
OCCURRENCE NUMBER 07/4533
ALEXANDER SCHLEICHER FLUGZEUGBAU ASG-29
D-2929
TURRET PEAKS, NEAR MAKARORA
21 DECEMBER 2007

AIRCRAFT ACCIDENT REPORT

OCCURRENCE No 07/4533

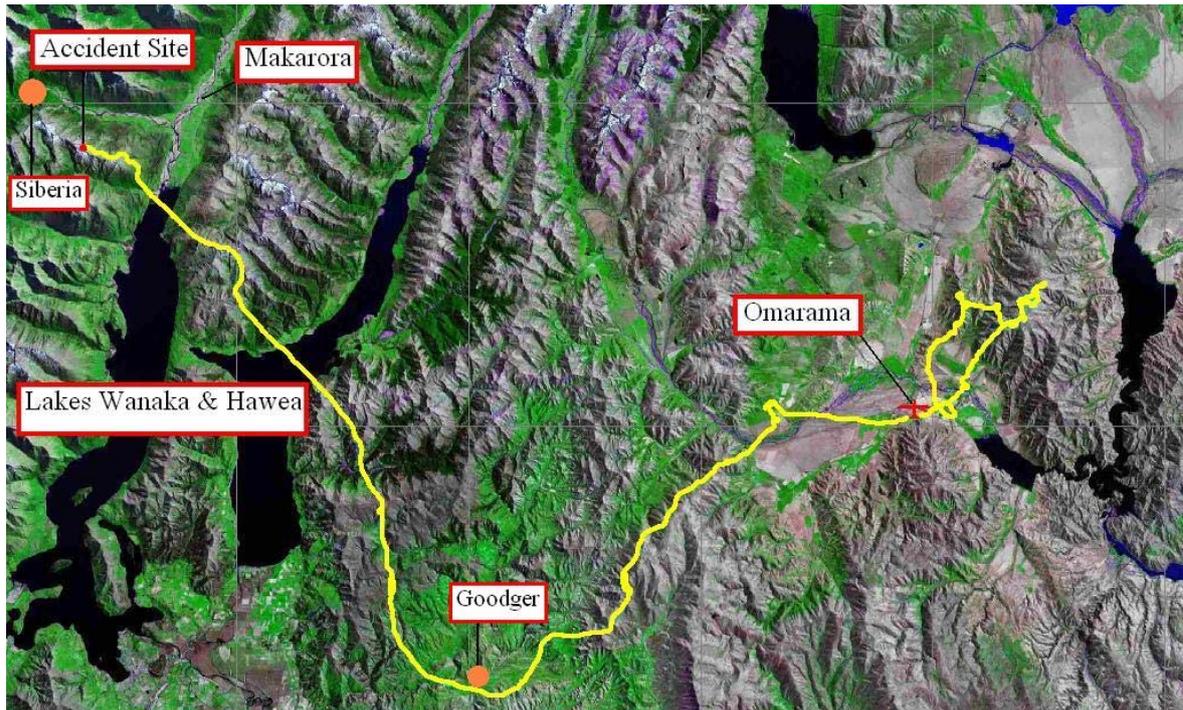
- 1.11.1 The two onboard navigation systems also recorded flight data which was downloaded at the end of each flight for validation and scoring using proprietary scoring software designed to score IGC sanctioned competitions. It was a competition requirement that all gliders carry two IGC approved recorders during race events.
- 1.11.2 Both recording devices were recovered from the glider. The “Zander” unit provided detailed information of the entire race. At the time of the accident it was recording data points every four seconds. (see Figure 1).

Figure 1. The route flown by D-2929 as recorded by the Zander data unit

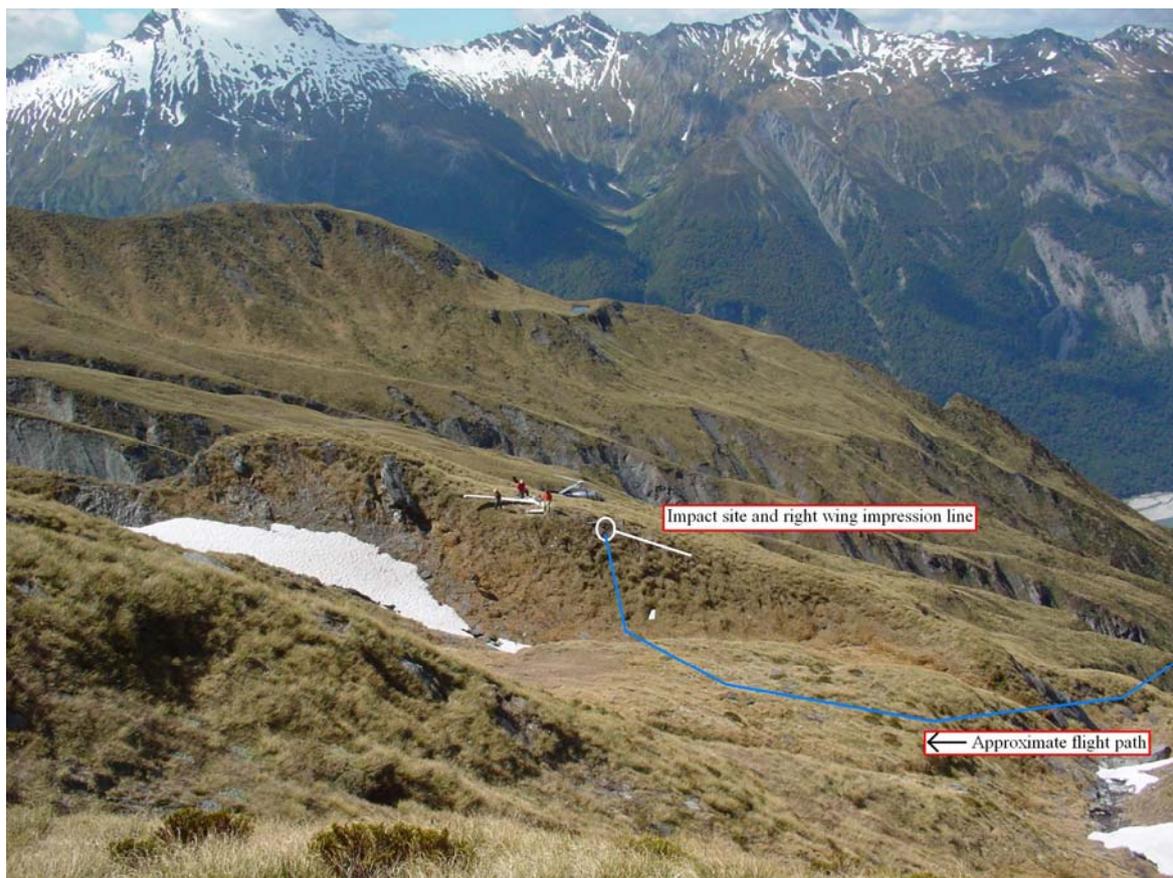
1.12.1 The glider struck a small spur that extended out from the main mountain slope and then parallel back toward the pilot's flight path. The glider struck the lower slopes of this spur about half a meter below its ridgeline line while banked over to the right approximately 30 degrees. The slope of the ridgeline at the point of impact was also approximately 30 degrees (see Figure 2).

Figure 2. Photograph showing accident site, flight path and angle of bank.

1.12.2 After striking the spur the glider bounced into the air and rotated before coming to rest inverted about four metres from the initial impact point. During the impact sequence the right wing created a very distinctive straight line impression in the moss just below the ridge line and both wings were split open along their leading edges. Both winglets had also detached and were lying nearby. The tail boom section showed signs of twisting and had broken just aft of the fuselage wing junction and at the tail fin section. The left wingtip skid pad was found pressed down into the ground on the top of the spur providing evidence that the wing had tapped the ground with a vertical component before the glider rolled over.

- 2.4 In view of the fact that the other two pilots saw the glider generally flying very close to the mountain slopes, it is possible that the pilot of D-2929 may have encountered unexpected severe local turbulence and downdrafts as he turned away from the mountain face. These conditions may have contributed to the glider being unable to clear the spur ridge line that it collided with.
