CAA OCCURRENCE 21/5661

BABY GREAT LAKES

ZK-ULM

DEPARTURE FROM CONTROLLED FLIGHT

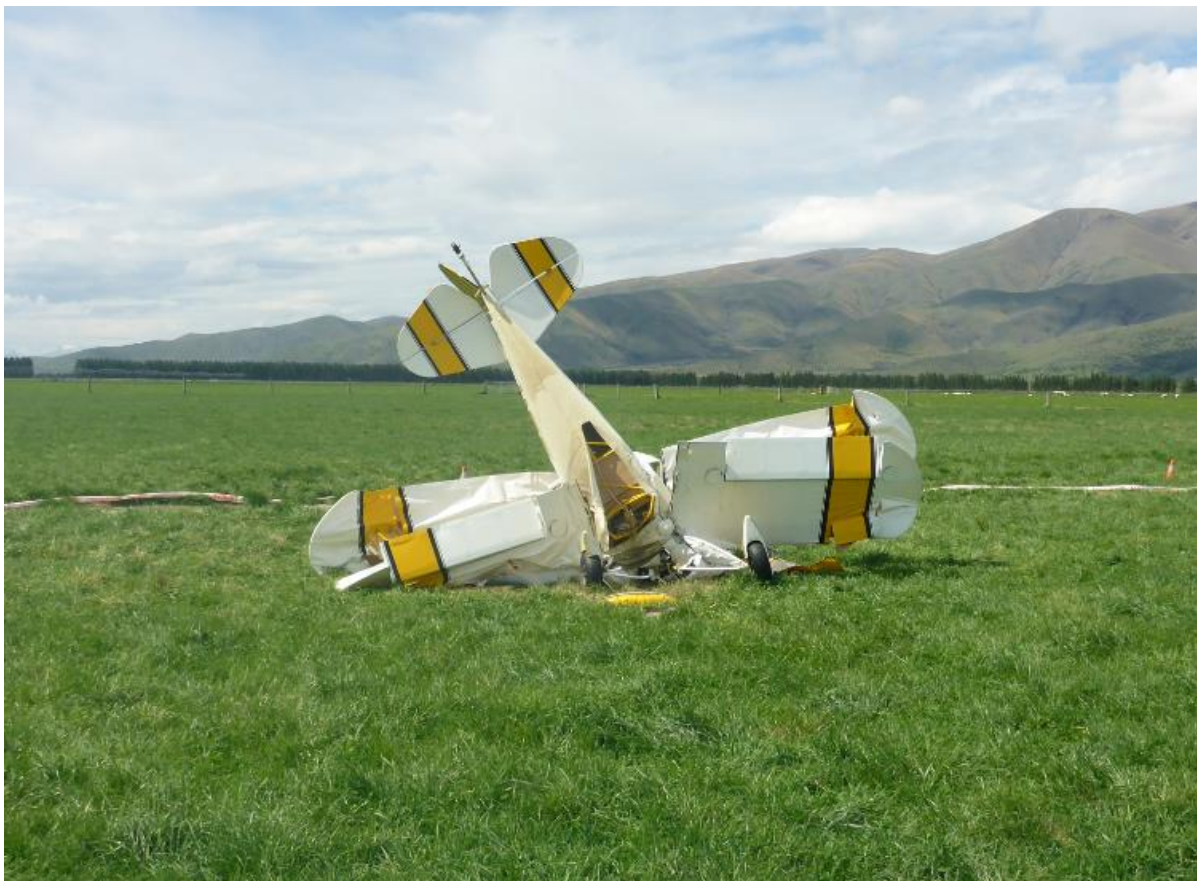
1.12.1 The aircraft impacted terrain in a steep nose-down attitude.

1.12.2 The wreckage signatures indicated high vertical forces with little forward horizontal energy.

1.12.3 Ground scars indicated that the aircraft was rotating at the time of impact.

1.12.4 The throttle was observed to be at a full-power setting. The RPM gauge needle was trapped at a reading of approximately 6500RPM.

1.12.5 The wooden propellor was substantially damaged. Some pieces of the propellor were located several metres away from the main wreckage.

Figure 3. Rear view of aircraft wreckage in-situ.

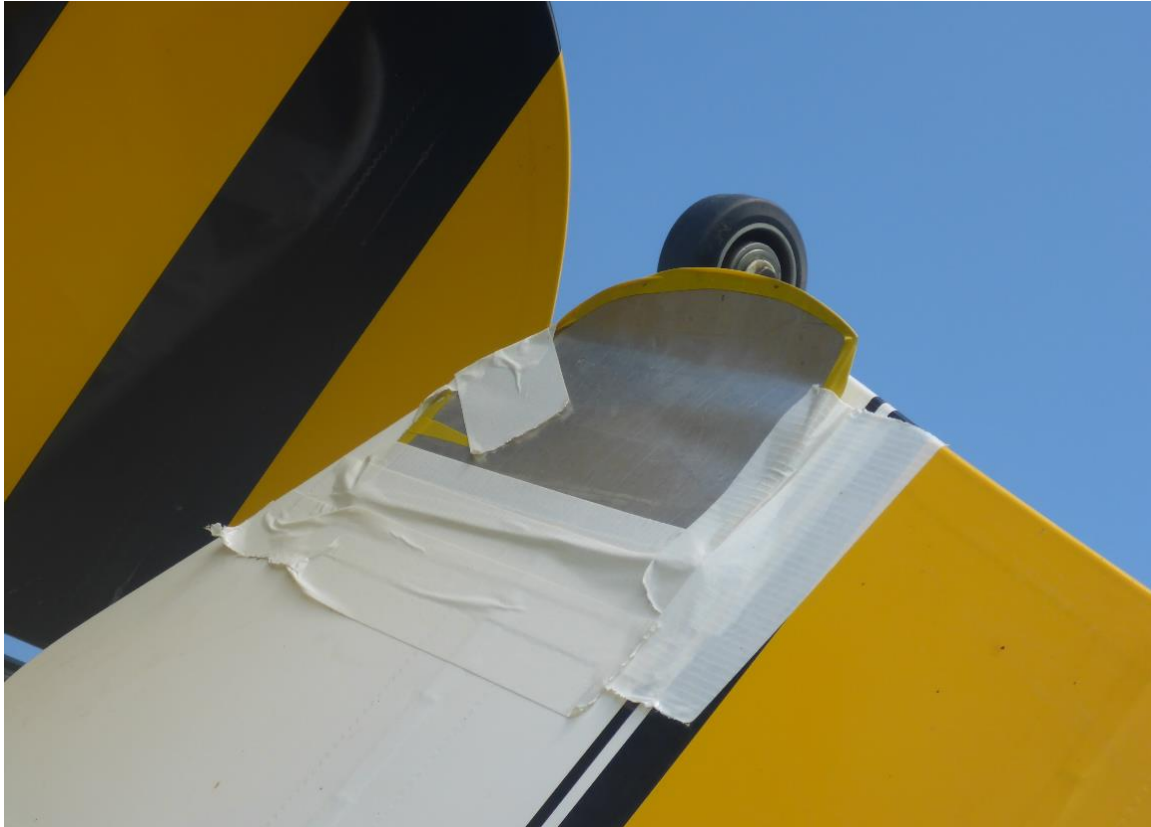
1.12.6 The trimmable horizontal stabiliser⁹ was trimmed to a full nose-down position.

1.12.7 It was noted during the field investigation that a make-shift trim tab was attached to the elevator with tape.

Figure 4. Make-shift elevator trim tab.
