**AIRCRAFT ACCIDENT REPORT**  
**CAA OCCURRENCE NUMBER 09/923**  
**NORTH WING T2 TANDEM HANG GLIDER**  
**INFLIGHT STRUCTURAL FAILURE**  
**QUEENSTOWN**  
**10 MARCH 2009**

## AIRCRAFT ACCIDENT REPORT

### CAA OCCURRENCE NUMBER 09/923

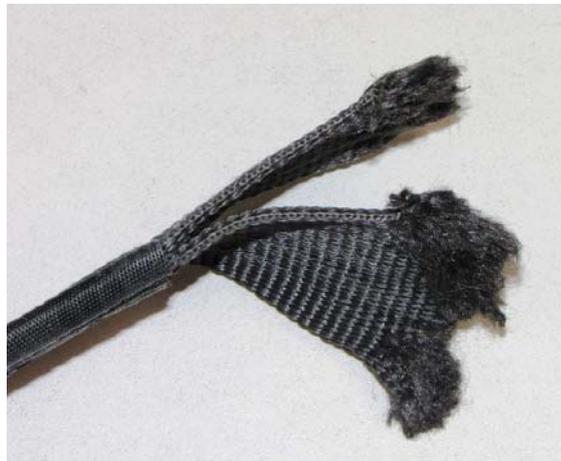
1.12.2 The reserve parachute was located 40 m away from the hang glider wreckage. It was noted on site that the parachute nylon attaching strap (Bridle) had failed at the loop where the parachute rigging lines attach. See Figure 6.

Figure 6: Failed Bridle loop

- 1.16.2 Examination of the pilot's harness, which had the reserve parachute bridle attached, showed that the bridle attachment loop where the parachute rigging lines attach was torn through at its apex. There were friction/burn marks evident on the bridle and the parachute rigging lines where the rigging lines had torn through the bridle loop. See Figure 6.

- 1.16.3 Further examination and testing of the bridle by an independent organisation experienced in nylon safety harnesses and equipment, indicates that the bridle showed signs of deterioration of the webbing due to damage and ageing. It was also noted that the design of the attachment area was poor and could be improved by the use of a connecting ring and sleeve. It was felt that the current design of the looped bridle end, could reduce the strength of the bridle by up to 30%.

- 2.9 The failure of the reserve parachute bridle was investigated further. It was determined that the following factors, or a combination thereof, most likely led to the failure:

- a. Poor physical condition of the nylon webbing,
  - b. The high airspeed at the time of reserve parachute deployment,
  - c. The maximum weight limit for the reserve parachute being exceeded, and

- d. No protection of the bridle loop in the form of a sheath or metal ring which would help to transfer the load from the parachute lines to the bridle.
