AIRCRAFT ACCIDENT REPORT
CAA OCCURRENCE NUMBER 06/4477
DH 82A (TIGER MOTH)
ZK-BAR
MITCHAM ROAD, ASHBURTON
2 DECEMBER 2006

AIRCRAFT ACCIDENT REPORT

OCCURRENCE No 06/4477

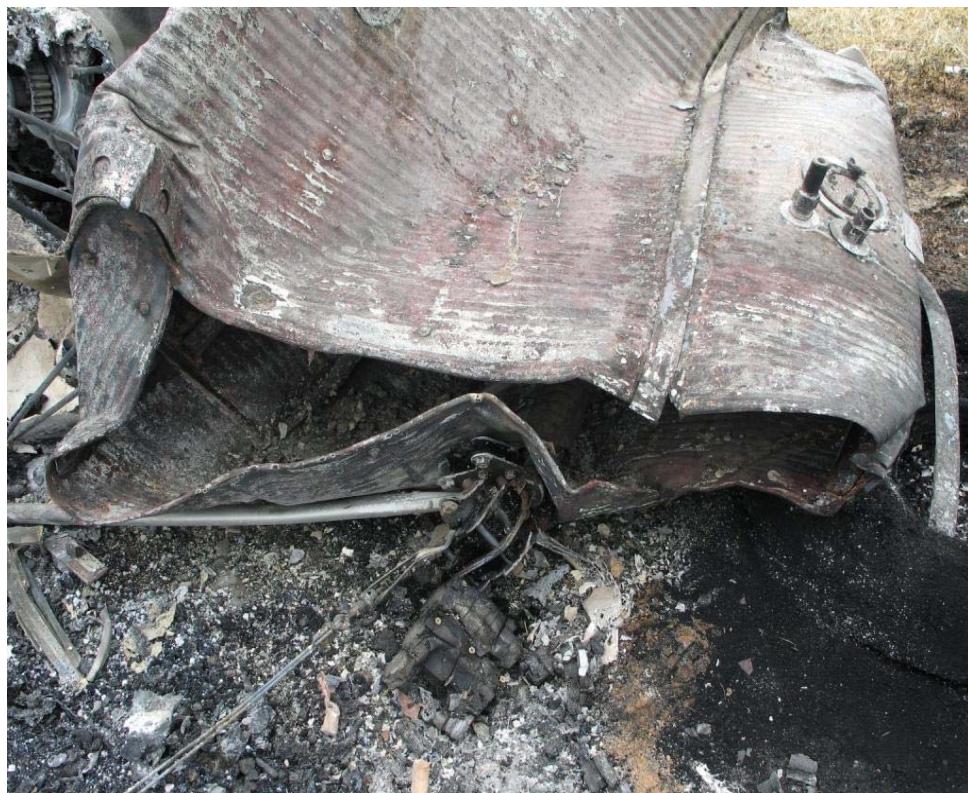
- 1.14.1 An intense fire engulfed the aircraft shortly after it had impacted the ground. The fire started as a result of the aircraft's fuel tank rupturing on impact, allowing fuel to escape rapidly and make contact with a hot section on the engine.
- 1.14.2 Inspection of the fuel tank showed a large opening on the right side seam of the tank, and a smaller opening on the left side. (see Figure 1)

Figure 1: Open side seam (right side) of fuel tank.

- 3.6 The design of the fuel tank and the positioning of the tank between the two upper main-planes makes it susceptible to twisting and tearing action during an accident. The rapid opening of the tank seam allows the fuel to then burst (either as fluid or vapour) onto a hot engine with a resulting fire. This is not an uncommon occurrence during accidents in this aircraft type.

DHSL also advise that the fuel tank is not a standard DHSL fuel tank, based on the position of a visible solder joint seam in a picture used in the CAANZ report.

- 4.5 The CAA has raised a safety action (No. 9A1812) to address the safety issue with the state of design that the fuel tank in Tiger Moth aircraft is prone to rupturing in an accident.

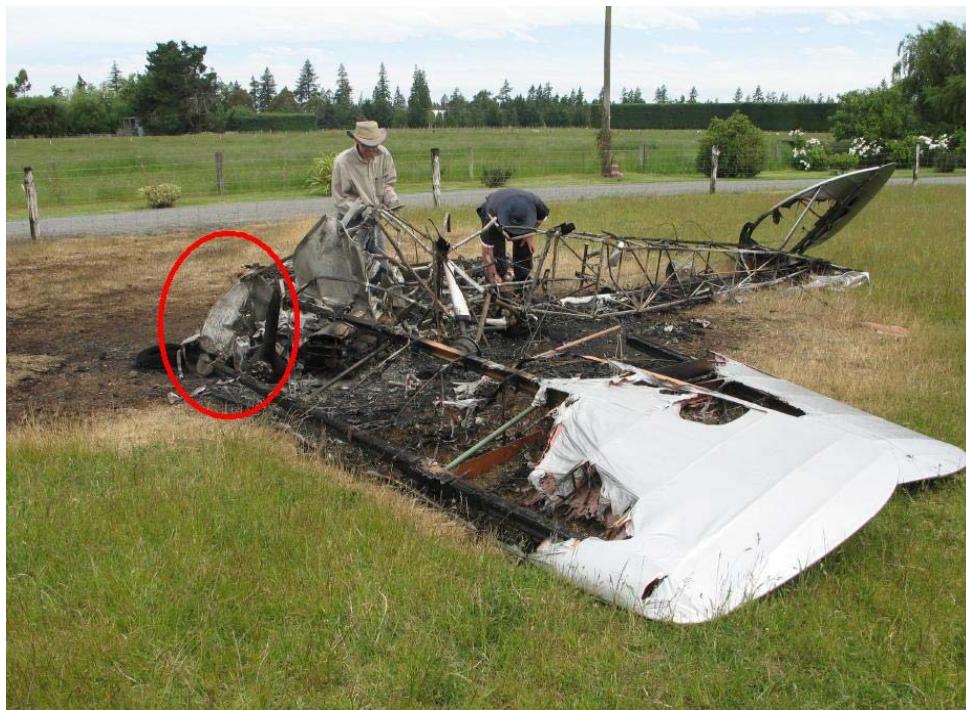
Figure 2: Position of the ruptured fuel tank.

- 2.14 Post-accident fires are also common in Tiger Moth accidents due to the susceptibility of the aircraft fuel tank to burst on impact with the ground. The fuel tank is mounted between the upper main planes where considerable twisting of the airframe is centralised.
- 2.15 The design of the tank results in a large opening in the side at impact which allows a large amount of fuel and associated fuel vapour to be released in a short timeframe, increasing the likelihood of a fire.
