AIRCRAFT ACCIDENT REPORT
OCCURRENCE NUMBER 03/2955
DE HAVILLAND DH82A
ZK-DHA
TAUMARUNUI AERODROME
18 OCTOBER 2003

AIRCRAFT ACCIDENT REPORT

OCCURRENCE No 03/2955

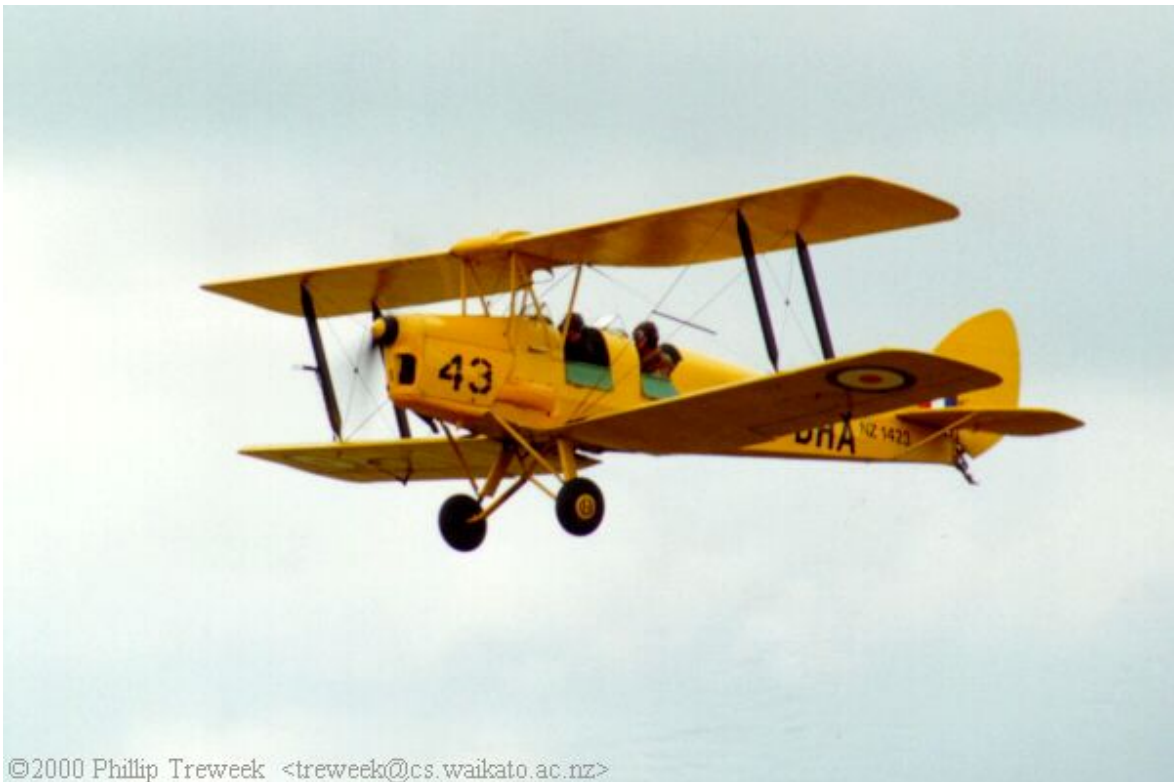
- 1.18.3 The pilot in command position of a Tiger Moth is in the rear cockpit. Forward visibility from this position is restricted in a climb by the aircraft structure and engine, as well as the front seat occupant. The aeroplane has a small access door on the left side of the cockpit and when this is opened, it allows the pilot to look along the left side of the fuselage for directional control and visual orientation. (see cover photo and the light green doors flipped down at the open position in flight)

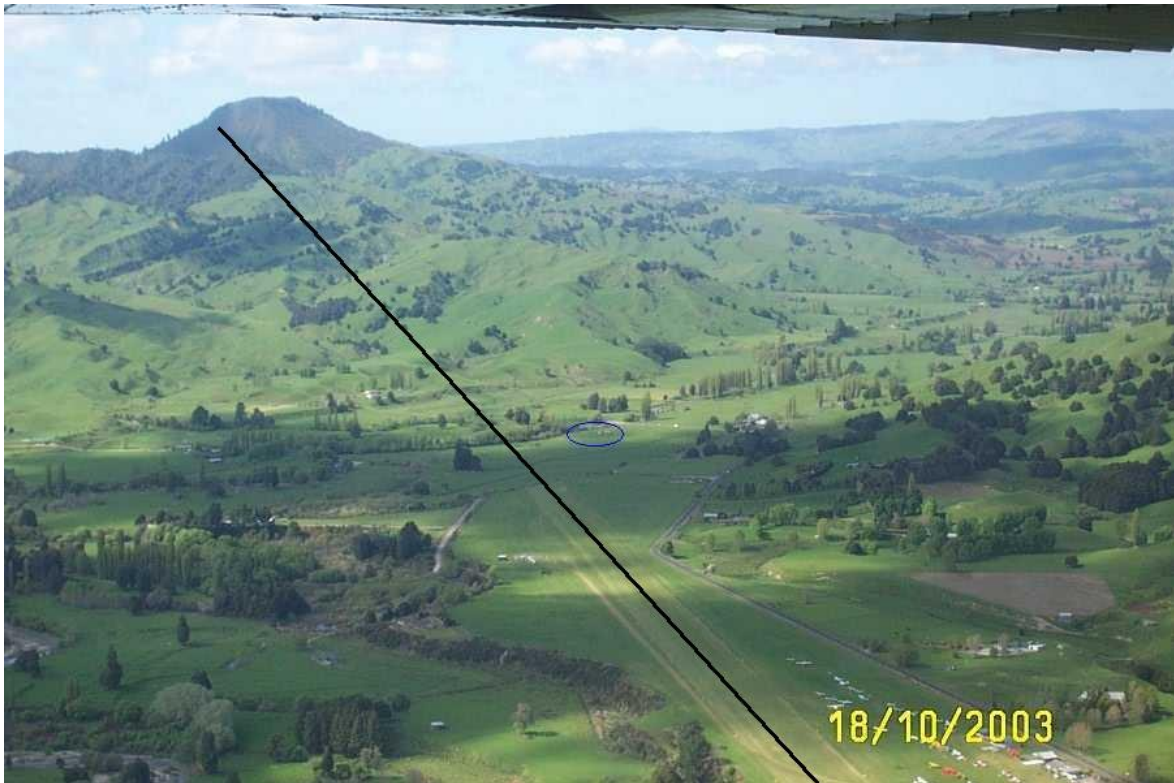
Figure 1: Taumarunui Aerodrome, looking north-east (the accident site is circled) and the black line indicates the pilot's line of sight along the left side of the aircraft.

- 2.4 The limited visual cues in this case may have played a major part, given the difficulty with forward visibility in the climb on this aircraft type, and the lack of a true horizon in the valley system. Also, commencing a right turn when visibility in a left turn would have been better, with the pilot’s view from that side of the aeroplane; and the pilot’s unfamiliarity with this aeroplane in these specific conditions may have compounded the situation. The pilot’s previous DH82A experience was at Paraparaumu and Ardmore, where lack of a horizon is not generally a problem. The pilot may have previously conducted an hour’s circuit flying at Taumarunui 12 months previously however.

- 3.6 The pilot's restricted view along the left side of the aeroplane during the right turn, which was towards rising terrain, may have contributed to the false horizon illusion.
