AIRCRAFT ACCIDENT REPORT
OCCURRENCE NUMBER 06/4354
AMATEUR-BUILT SMYTH MODEL S SIDEWINDER
ZK-DYY
MOUTH OF THE KAIPARA HARBOUR, NEAR POUTU POINT
25 NOVEMBER 2006

AIRCRAFT ACCIDENT REPORT

OCCURRENCE No 04/4354

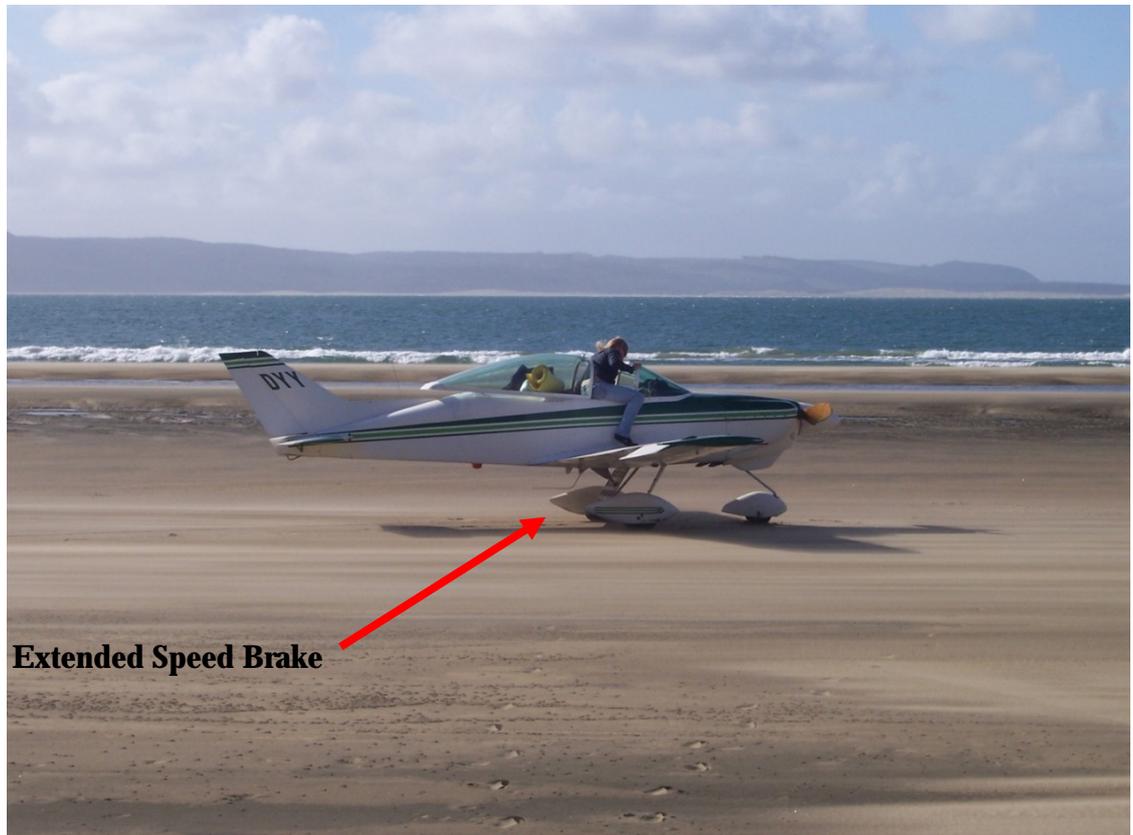
PRESTART
Figure 1

become airborne in approximately 300 metres. One of the residents took photographs (Refer Figures 1, 2, and 3). Each photograph depicts the aircraft's speed-brake, which protrudes below the fuselage, in an extended position.

- 2.3 There is the possibility that the speed brake position indicator LED light(s) were not operating because the indicator circuit integrity could not be fully established. However, there was ample opportunity for the pilot to check his aircraft prior to take-off and he should have noticed during his pre-flight checks that the speed brake was in the fully open position.

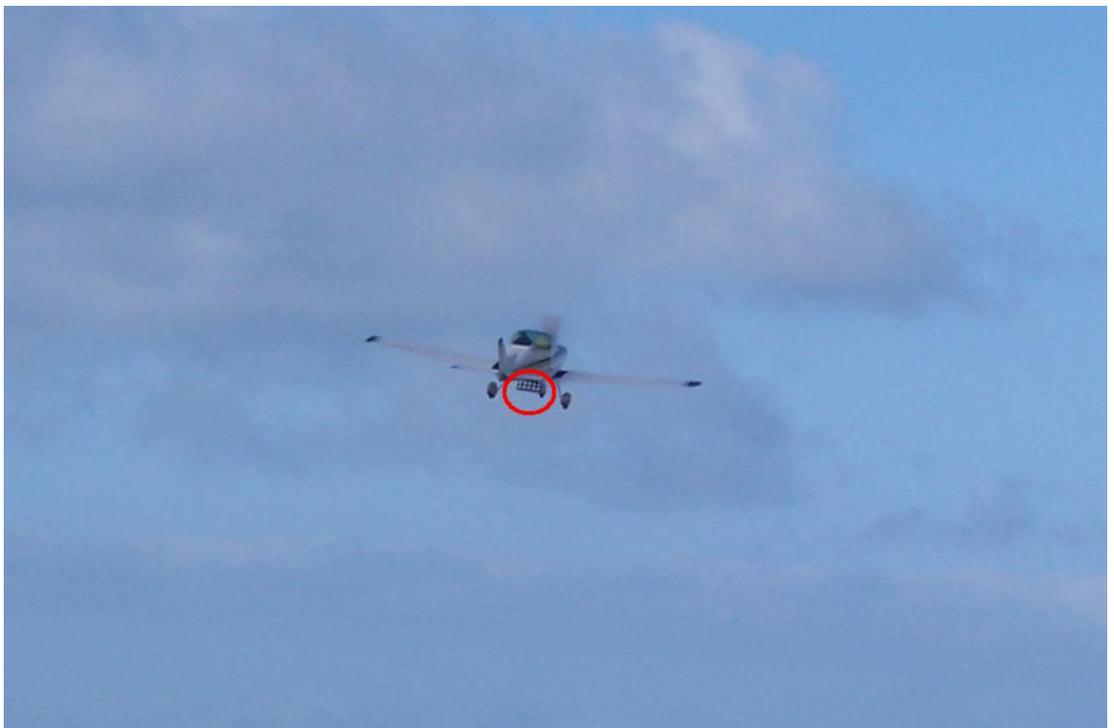
CLIMB
Figure 3

- 1.1.7 The aircraft was further observed to climb away until approximately 300 feet AGL where it was described that the aircraft's attitude appeared to steepen markedly. Shortly after, the aircraft suddenly banked to the left, and then pitched nose down. The aircraft did not recover and it dived into the sea some 100 metres off the beach with the engine, according to eye witnesses, "as still roaring". The aircraft floated upright initially but turned over and sank after about 30 minutes. Rescue services that attended the scene found both occupants had not survived the accident.
- 1.1.8 The accident occurred in daylight, at approximately 0850 hours, in the sea off the foreshore of North Head, Kaipara Harbour, latitude S 36° 23.36', longitude E 174° 08.75'.
