## **Erratum to tow upset during glider tow involving Piper PA28-236 Dakota, ZK-FMT**

CAA Safety Investigation Report  
CAA Occurrence No. 14/155  
Erratum date: 17 May 2021

**SAFETY INVESTIGATION REPORT  
CAA OCCURRENCE NUMBER 14/155**

**ZK-FMT  
PIPER PA28-236 DAKOTA  
TOW UPSET DURING GLIDER TOW**

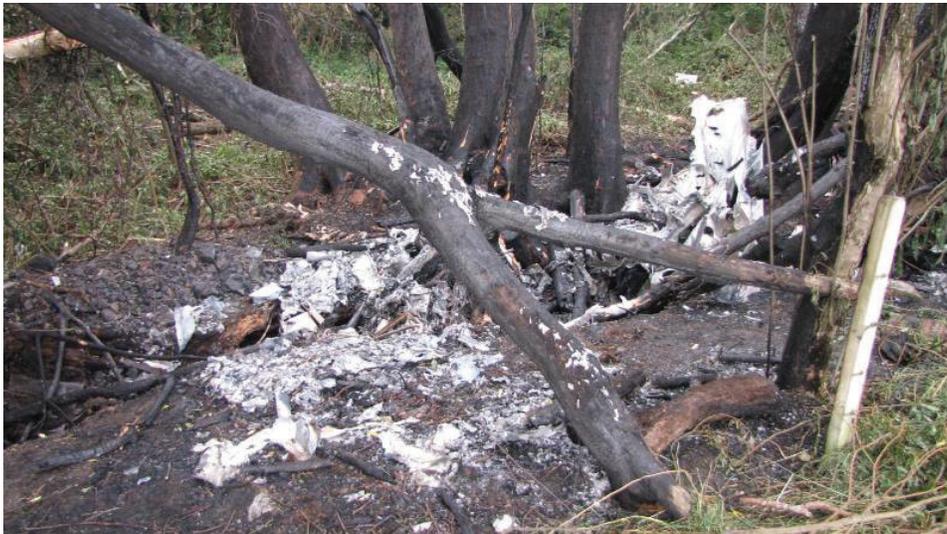
Figure 1: Accident site

- 1.11.1 The aircraft had entered a stand of willow trees at an approximate 20 degree nose down attitude and slightly right wing low. The majority of the aircraft had come to rest in a small ditch at the base of the trees. The left wing had detached and was found on the right side of the aircraft.
- 1.11.2 The continuity of all flying control system cables was established however the complete integrity of the flight control systems could not be confirmed because of fire damage. The tow hook assembly was located and it was determined by operation that the tow release mechanism was operational at the hook mechanism.

- 1.11.3 The engine and propeller had separated from the airframe on impact with the trees and came to rest approximately seven metres forward of the main wreckage. The QGP commented that when the aircraft entered the trees, branches were observed being flung into the air by the propeller. Although this observation may indicate normal operation of the engine, it was removed from the site for testing.
