AIRCRAFT ACCIDENT REPORT
CAA OCCURRENCE NUMBER 08/497
WSK "PZL-SWIDNIK" S.A. PW-5
ZK-GJO
WAHAROA
11 FEBRUARY 2008

AIRCRAFT ACCIDENT REPORT

OCCURRENCE No 08/497

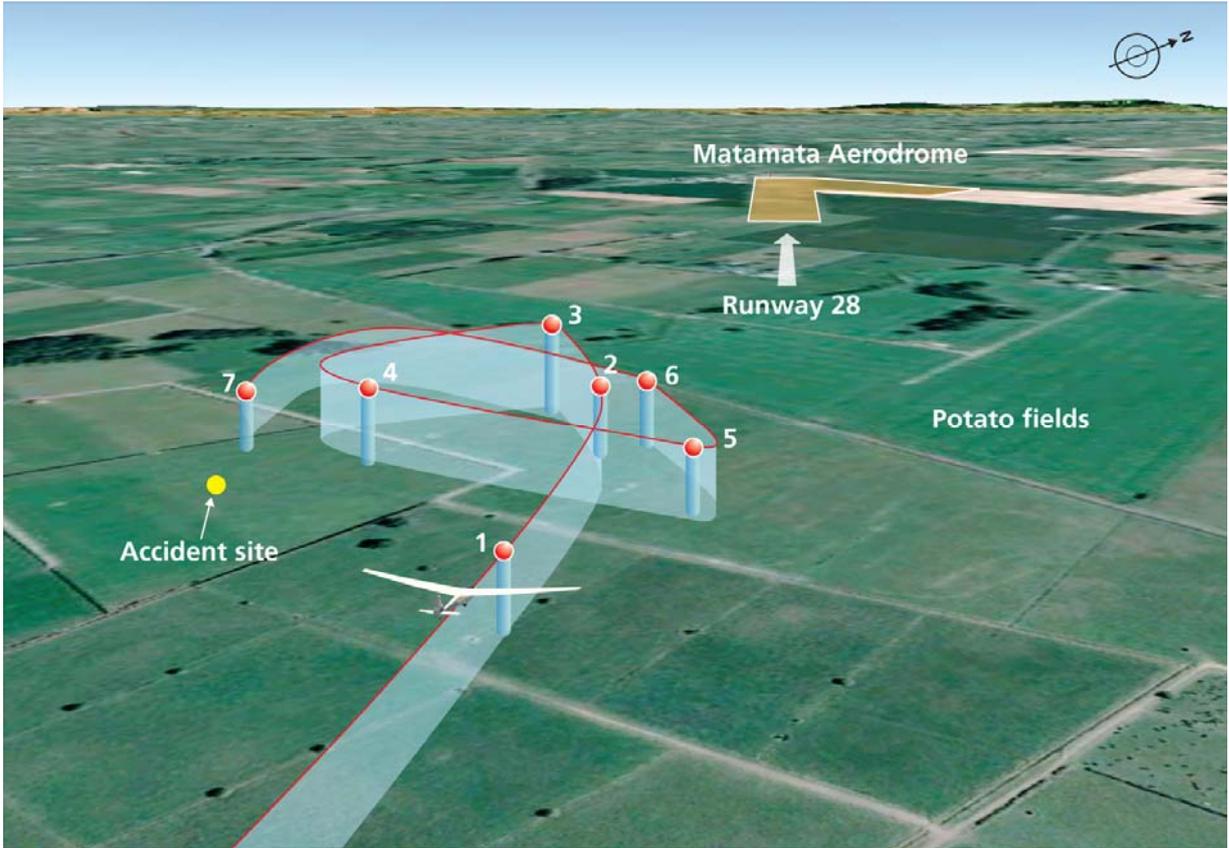
- 1.1.6 Five nautical miles from the Matamata Aerodrome the glider had descended to 1900 feet. At three nautical miles, it had further descended to 1315 feet. At 1801:18, recorded data indicated the glider was one nautical mile from Matamata Aerodrome directly in front of a large potato field. At this point the glider was manoeuvred into wind and a climb was commenced from 344 feet. Over the next ten seconds the glider gained 38 feet in height. The glider then completed a 360 degree turn to the left.

- 1.1.7 At the completion of the first orbit, the glider was at the same height and approximately the same groundspeed at the point when the pilot had first turned into wind. During the second orbit, and up until the end of data recording, the glider lost height and groundspeed.

- 1.1.8 The last data was recorded at 1802:08. No speed data was captured at that time but the glider had tracked towards the south and had descended to a height of 315 feet. GPS co-ordinates taken at the accident site indicated that prior to impact the glider had to have turned and continued horizontally a further 296 feet in a north-easterly direction. At the time of the accident it was estimated that the glider had been airborne for approximately 4 hours and 31 minutes. The last seven Volkslogger recordings are displayed in Figure 1. Expanded data in table format is provided in Table 1.

ZK-GJO Volkslogger Retrieved Data Recorded Positions

(Note – Track between points in Figure 1 is for illustrative purposes only)
