**AIRCRAFT ACCIDENT REPORT
OCCURRENCE NUMBER 04/1624**

HUGHES 269C

ZK-HDL

16 MAY 2004

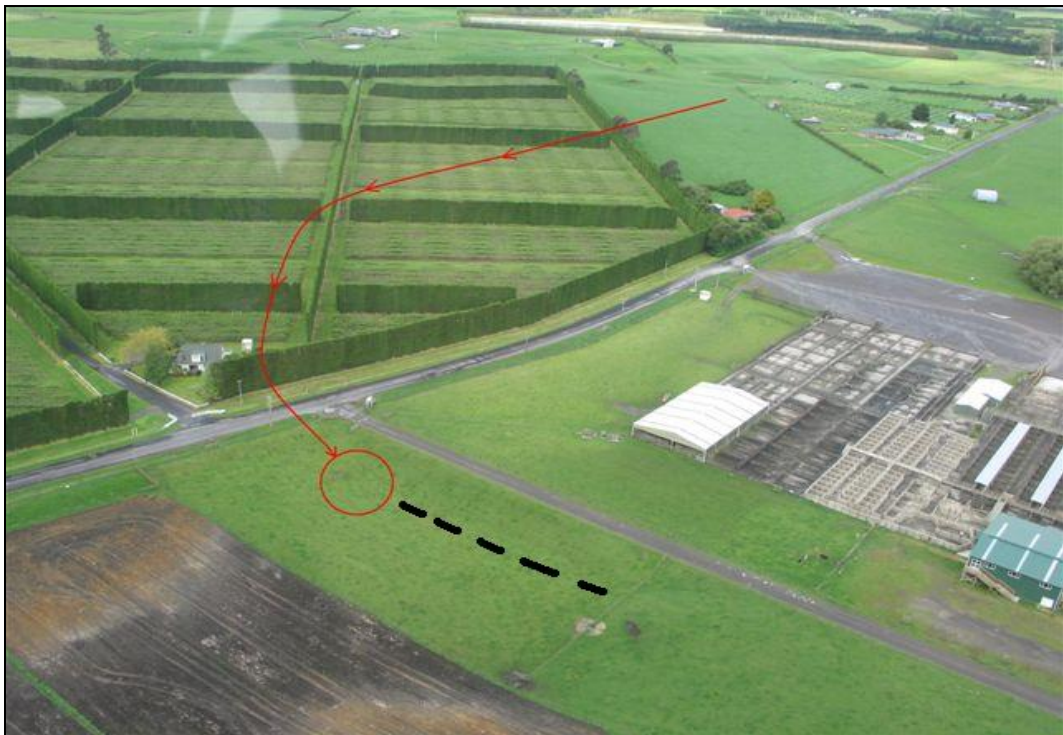
Fig 1: Red line indicates autorotation approach and impact area (circled). Dashed line is at the base of hollow depression of paddock sloping down from adjacent road. Note proximity of power lines along roadway from left to right.

- 2.4 The resulting hard landing was due to the helicopter being flared too high and subsequent loss of main rotor RPM. This was probably due to the pilot's visual references being the relatively well lit adjacent roads, trees and sale yards, but the actual landing ground surface was much lower in a hollow. With the low light conditions at the time the pilot was probably flaring into a darkened area with very limited visual cues while the surrounding countryside would have been clearly visible. The photo taken in daylight at Figure 1 shows the difficulty of detecting the depression in the selected paddock.

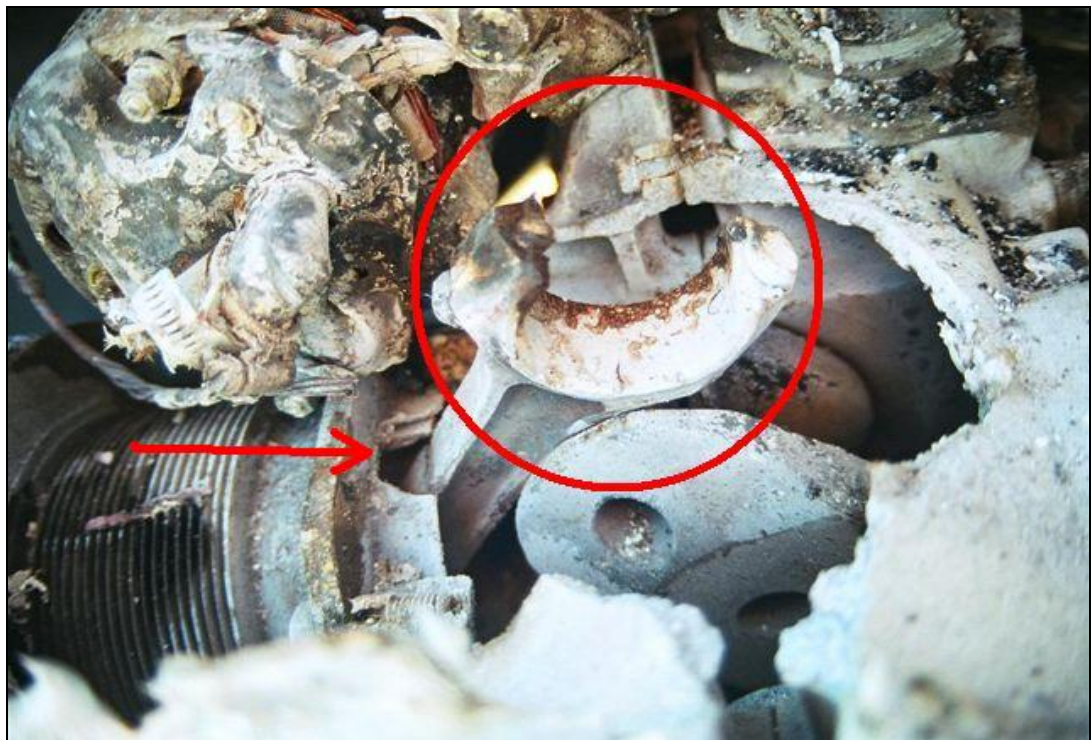
Fig 2: Failed con-rod big end bearing (circled). Arrowed area shows damage resulting from continued engine running in this failed condition.

- 2.1 The loud bang and loss of power as described by the pilot is consistent with the failure of the number 2 con-rod. The subsequent autorotation from 500 feet resulted in a very hard landing which was survivable although both occupants suffered spinal injuries common in hard landings of this type and in particular, in helicopters not fitted with energy absorption systems.

- 3.1 The pilot was appropriately licensed and rated for the private flight.
- 3.2 The helicopter had a valid airworthiness certificate and had been maintained in accordance with CAA rules.
- 3.3 The initiating accident cause was an engine failure due to a failed con-rod, possibly as a result of an unrecorded engine overspeed.

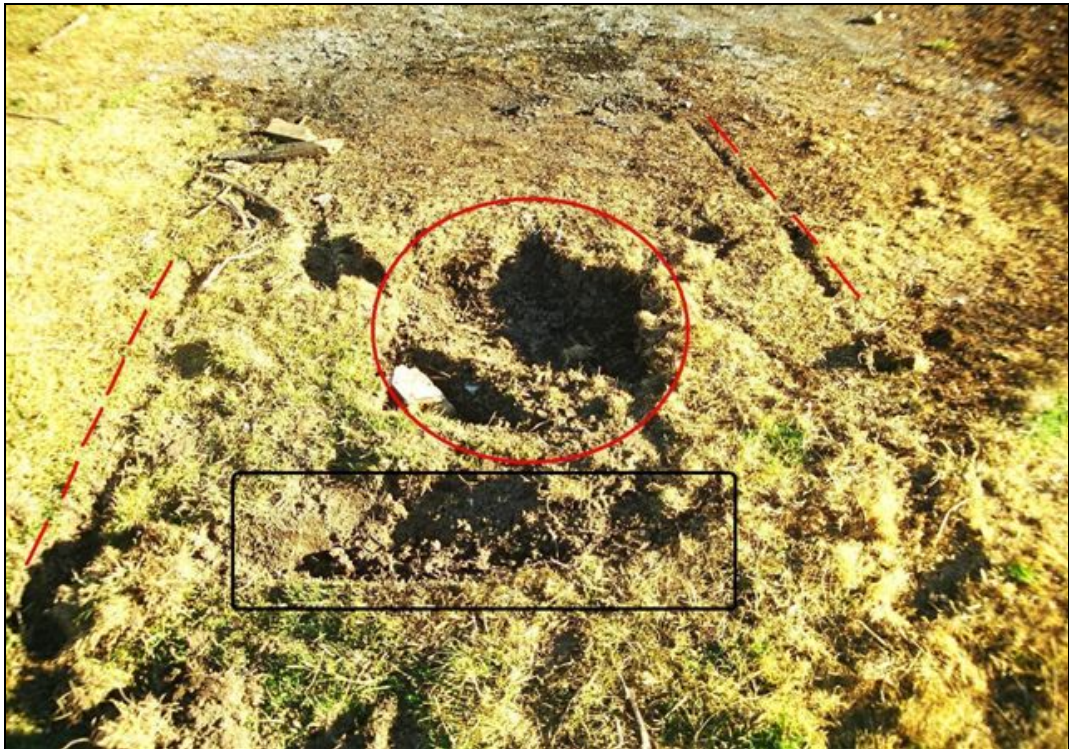
1.12.2 The contact with the ground was heavy with some forward movement. The lower vertical fin was severely crushed and ploughed a short furrow along the ground. The cross tube structure and rear cross tube flexed sufficiently on contact to dig a hole in the ground at the contact point, as did the engine. Spinal injuries to the pilot and passenger are also consistent with heavy ground contact.

Fig 3: Severity of Impact: Black rectangle outlines rear cross tube ground scar, and red circle indicates engine contact. Both landing gear skids impressions are clearly visible next to red dashed lines.

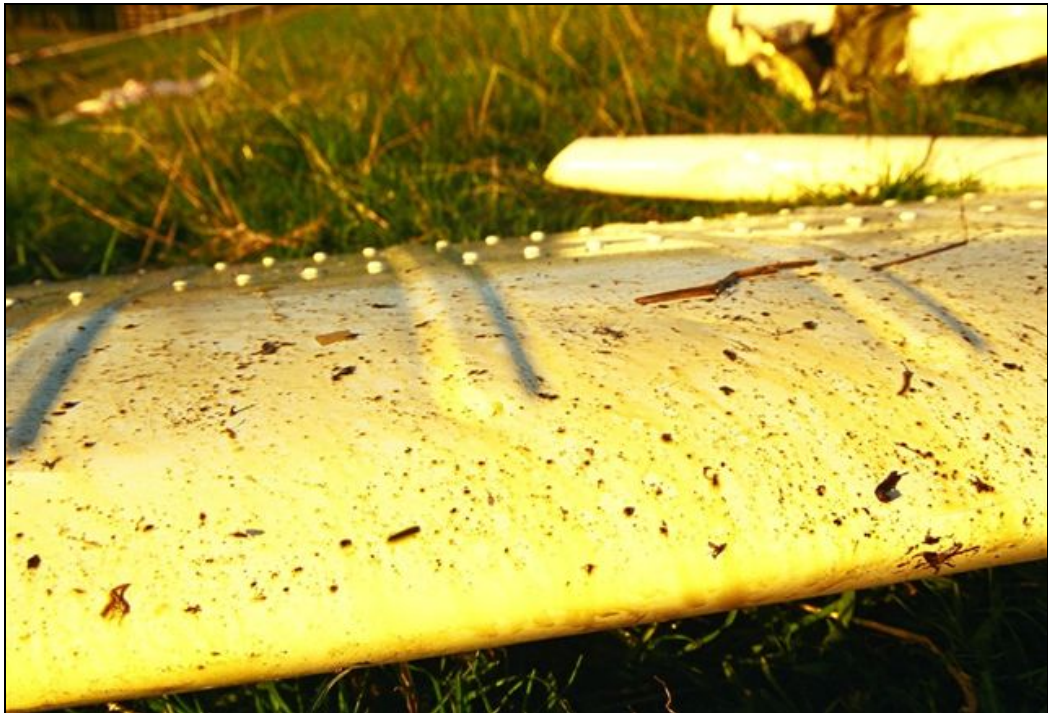
- 2.6 The tail boom and stabiliser which were separated from the helicopter during impact were examined. Considerable clean, unburnt oil was found across the surfaces indicating that the oil streamed from the damaged engine in flight during the autorotation. Comparison with a previous fixed wing accident from a failed con-rod and subsequent hole in the crankcase showed similar oil coverage over the tail plane. Refer www.caa.govt.nz ZK- FGF accident report 99/3689 paragraph 1.12.4.

Fig 4 Considerable amounts of engine oil covered the tail boom and stabilizer.
