**AIRCRAFT ACCIDENT REPORT
OCCURRENCE NUMBER 02/2468**

HUGHES 269C

ZK-HFW

16 AUGUST 2002

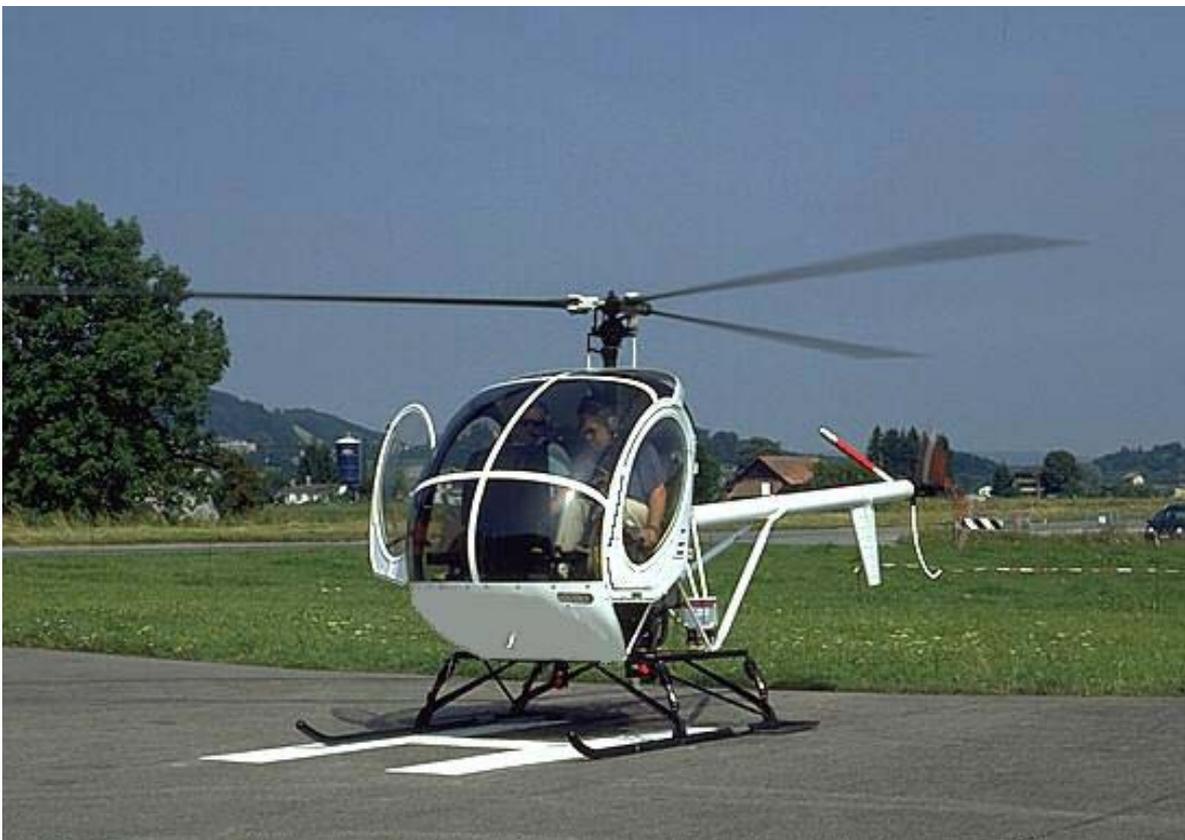
1.3.1 The helicopter was destroyed.

- 1.12.1 The helicopter struck the face of a moderately steep ridge at an elevation of approximately 590 feet on an impact heading of 227°M. The complete helicopter was accounted for at the site.
- 1.12.2 Ground scarring and debris at the initial impact point indicated that the helicopter had descended more or less vertically, at low forward airspeed, and in a straight and level attitude. Ground strike marks also showed that prior to impact, the helicopter had appeared to have turned left from the north-easterly track flown over the ridge top, through approximately 100° (a left turn was also observed by the loader driver). After the initial impact, the helicopter had bounced and rolled

- 1.12.3 Impact forces were initially absorbed by the forward left hand side of the helicopter. The left skid, left front section of canopy and support structure were all severely crushed; the left spray boom and tank had torn away from their respective attachment points. The right-hand spray boom and the spray pump motor and tank had detached during the rollover. The dump release mechanism for the spray tanks was found in the release position and the tanks were completely dry.
