**AIRCRAFT ACCIDENT REPORT
OCCURRENCE NUMBER 98/8
HUGHES 269C ZK-HHS
NGONGOTAHA
10 January 1998**

OCCURRENCE NUMBER 98/8

Aircraft Type, Serial Number and Registration:	Hughes 269C, 1230259, ZK-HHS
Number and Type of Engine:	One Lycoming HIO-360-D1A
Year of Manufacture:	1973
Date and Time:	10 January 1998 at 1925 hours*
Location:	5 km north of Ngongotaha Latitude: 38° 01.9' S Longitude: 176° 12.1'
Type of Flight:	Aerial Work
Persons on Board:	Crew: 1 Passengers: 1
Injuries:	Crew: Fatal Passenger: Minor
Nature of Damage:	Destroyed
Pilot-in Command's Licence:	Commercial (Helicopter)
Pilot in Command's Age:	30 years
Pilot in Command's Total Flying Experience:	1555 hours
Information Source:	Civil Aviation Authority field investigation
Investigator in Charge:	Mr O J Stewart

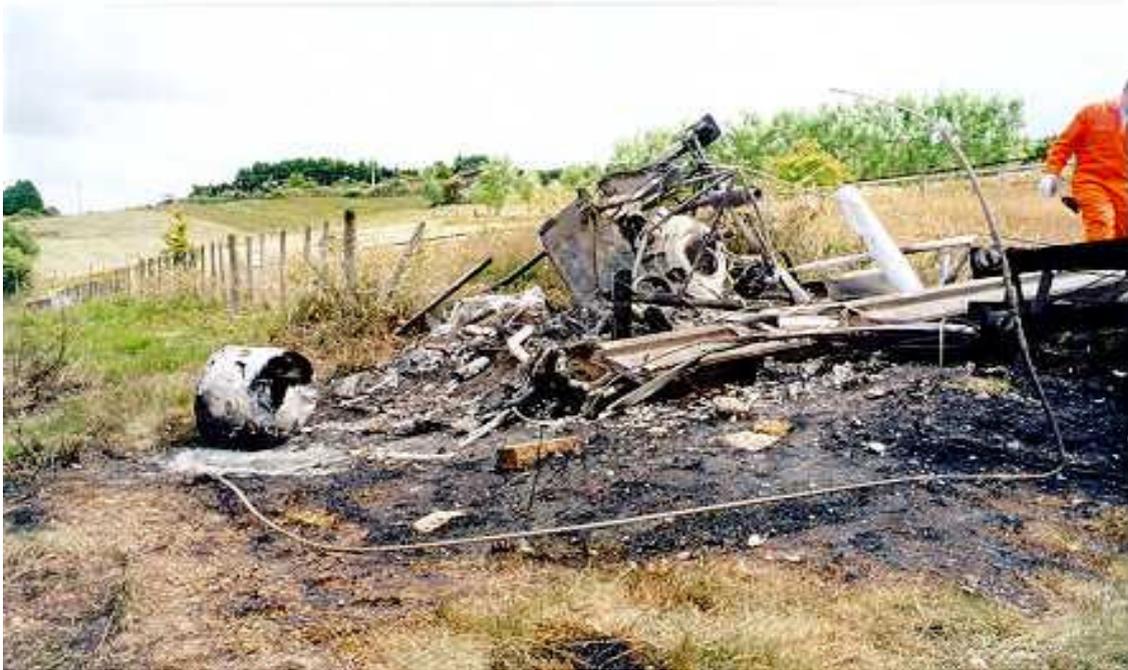
View of the accident site, approximately along the direction of flight

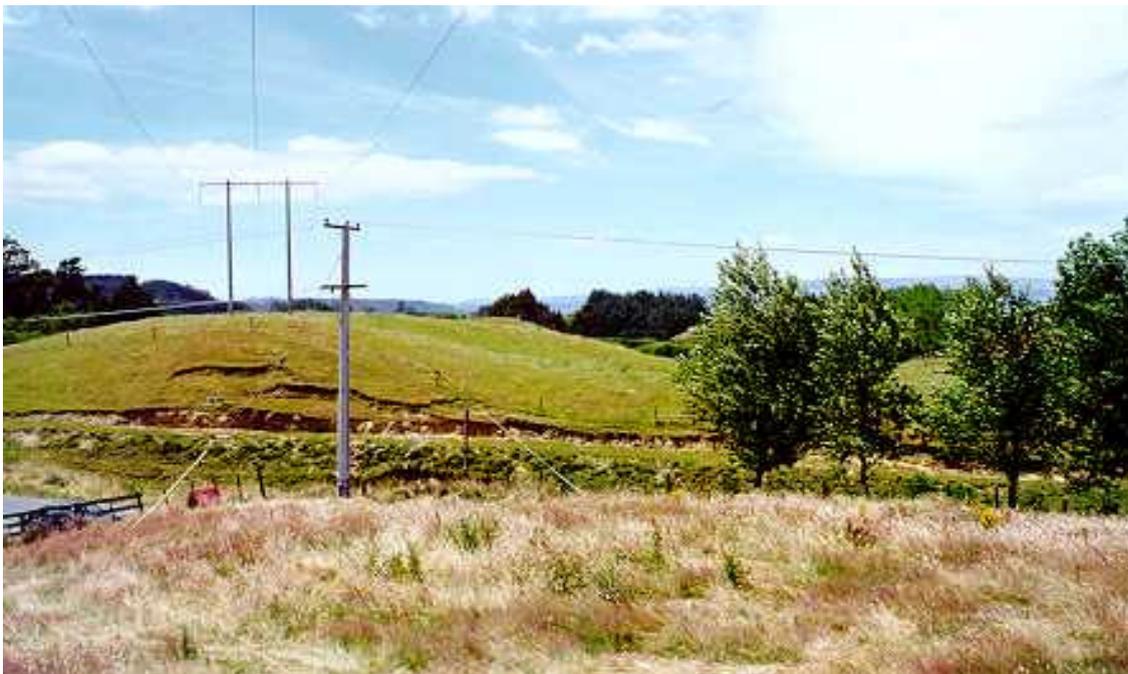
Site examination found that the helicopter main rotor blades had struck and severed one of the three conductors of the 110 kV line. This line crossed about six metres above the line being inspected. The main rotor blades and the rotor head sustained substantial damage. Pieces of rotor blade were later found up to 100 metres from the impact point.

At the time of the accident, the helicopter was flying towards a setting sun, which would have reduced the pilot's visual acuity. The 110 kV line was set against a background of scattered clouds. Trees obscured one of the timber 110 kV support towers and the other support tower was some 200 metres distant, on higher ground. These were key visual indicators for situational and environmental awareness in providing the pilot with cues to look for other power lines. Observation the next day at the same time, in similar weather conditions, indicated that the 110 kV conductors were extremely difficult to see.

View to the south-east, looking across Jackson Road, showing the relationship between the 11 kV (bottom) and 110 kV (top) lines after the 11 kV pole had been replaced. The helicopter approached left to right, striking the left-hand 110 kV conductor.

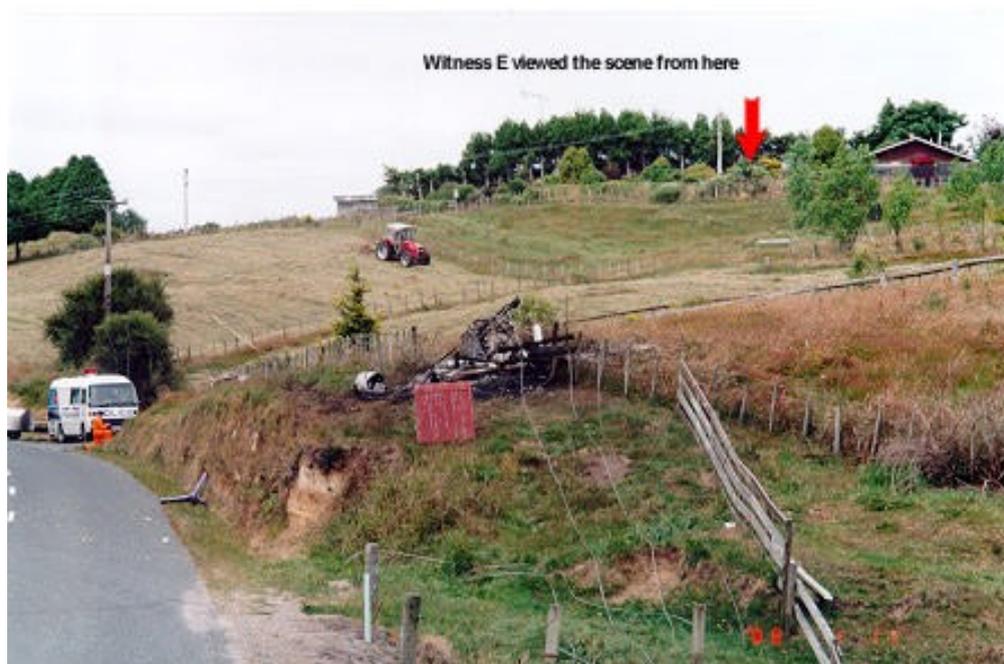
View of the scene.
