**AIRCRAFT ACCIDENT REPORT**

**OCCURRENCE NUMBER 98/2972**

**HUGHES HELICOPTERS 269C**

**MANGATOATOA HUT, UREWERA NATIONAL PARK**

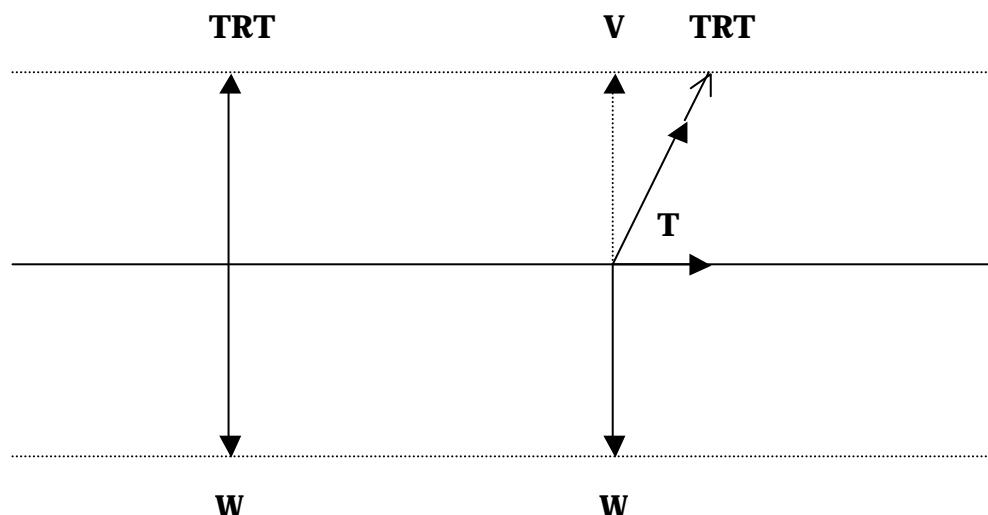
**Figure 1**

- 1.18.3 In a steady hover, total rotor thrust (TRT) is equal to weight (see Figure 1). To achieve forward flight, the TRT vector must be inclined to give a horizontal component “T” in Figure 1. For the helicopter to maintain height, the vertical component of TRT must remain at the same value as in the hover, and this will require an increase in engine power to maintain.

- 1.18.4 The left-hand element of Figure 1 represents the forces acting in a steady-state hover. The right-hand element depicts the forces acting in forward flight. For level flight, the vertical component “V” of the TRT must equal the weight. To achieve this, the TRT must be increased, by an amount depicted by the second arrow reaching to the upper index line. The length of the second arrow has been exaggerated for clarity.

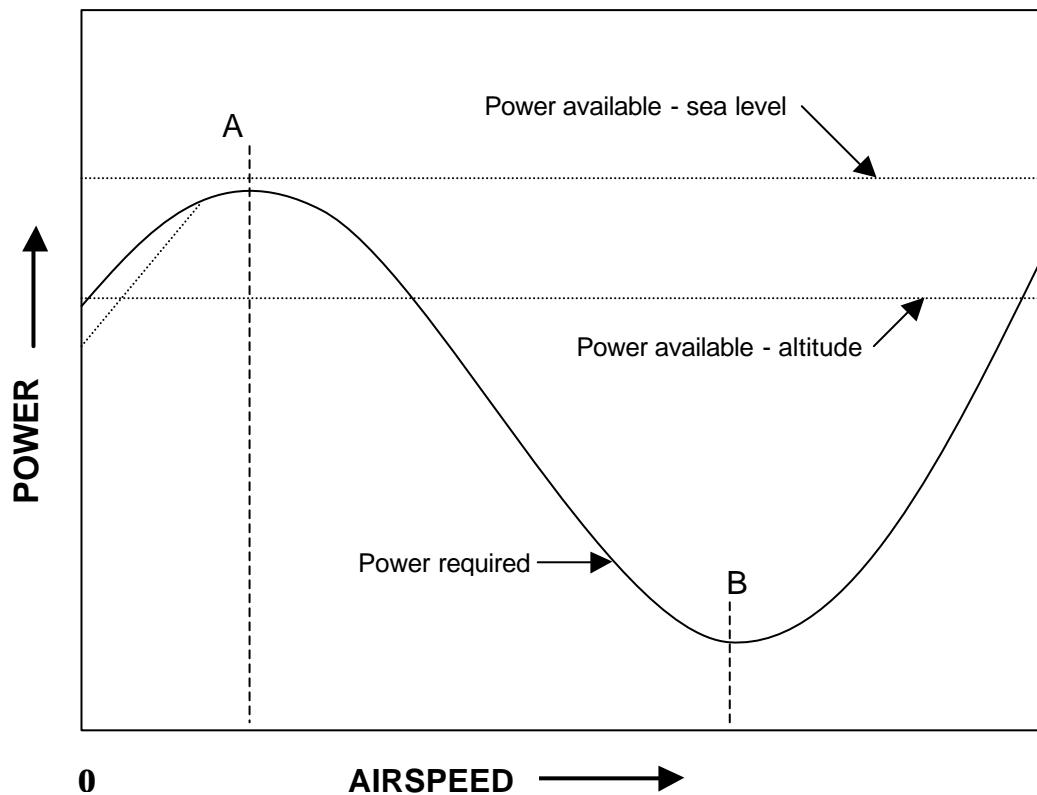
**Figure 2**

- 1.18.5 At an airspeed typically between 12 and 20 knots, the rotor develops “translational lift” as a result of the forward speed, thus requiring less engine power to produce the required TRT. The engine power required decreases with increasing airspeed (and translational lift) up to about 45 knots, above which (mainly) airframe drag will require an increase in engine power. This is depicted in Figure 2, where the zero-airspeed end of the “power required” curve represents the helicopter in a hover, A is the speed of onset of translational lift, and B is the minimum drag speed.

- 1.18.6 The effect of altitude on power available described in 1.18.1 is also depicted in Figure 2. Power available is virtually constant with changing speed, hence the straight “power available” lines. Hovering IGE requires less power than hovering OGE, and this is represented by the dotted portion of the “power required” curve. The presence of wind will provide translational lift, and if the wind is strong enough, can considerably reduce the power required to hover.

- 1.18.7 The relationship between the “power required” curve and the applicable “power available” line will determine what type of take-off technique is required. For example, if the “power required” curve is entirely below the “power available” line, there is no take-off restriction; a vertical climb may be performed if required. The other extreme is where that part of the “power required” curve at A is located above the “power available” line. In that case, only a running take-off could be performed.

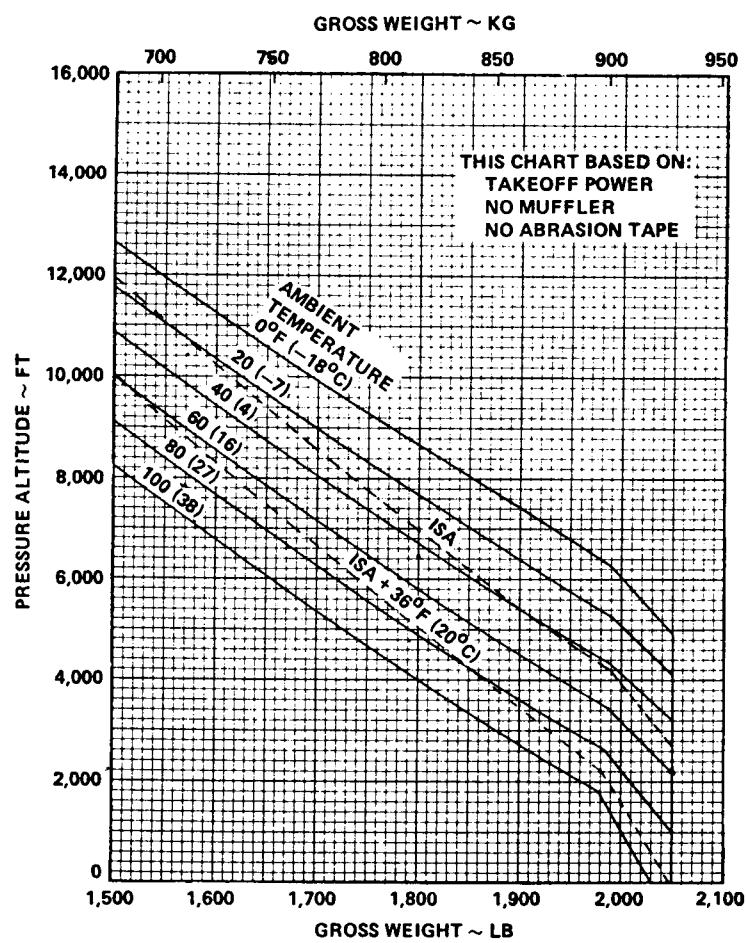
**Figure 8-1. Hover Ceiling Out of Ground Effect Versus Gross Weight  
(3200 rpm)**

- 1.18.11 Section VIII (Additional Performance and Operations Data) of the Flight Manual contains a performance graph at page 8-2: “Hover Ceiling Out of Ground Effect Versus Gross Weight”. This graph is reproduced at Appendix A, and indicates that, at a normal maximum gross weight of 2050 lb (the upper limit on this graph), the helicopter would be only just capable of an OGE hover at 2000 feet pressure altitude and an OAT of 60° F.

- 1.18.12 With reference to the graph annotations “no muffler” and “no abrasion tape”, HQZ was fitted with a muffler, which reduces the hover ceiling by about 200 feet. The rotor blades did not have abrasion tape fitted. The effects of a muffler and of abrasion tape on performance are found in Section V (Performance) of the Flight Manual.

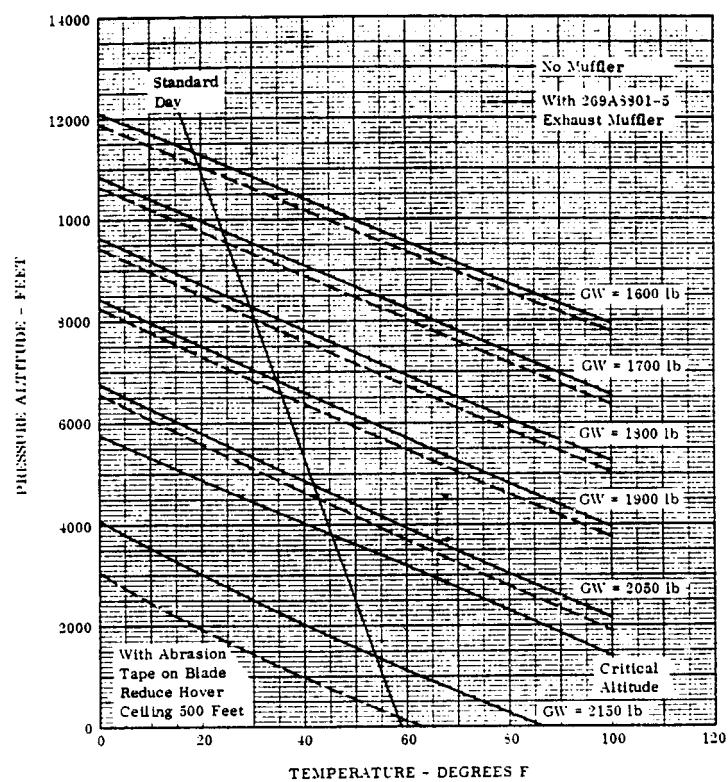
Figure 3-1. In Ground Effect Hover Ceiling Versus Temperature  
(6-foot skid height, 3200 rpm)

- 1.18.13 Flight Manual Supplement CSP-C-1G (Cargo Hook Installation Kit) contains a hover ceiling graph predicated on a six-foot hover height, which is in ground effect. Given that the majority of sling load operations are conducted out of ground effect, this graph would not have been relevant to the accident flight, even had it been included in the Flight Manual. However, reference to this graph suggests that HQZ would have been capable of maintaining a six-foot hover at a maximum weight of 2100 lb at 2000 feet and 60° F. This graph is reproduced at Appendix B.
