AIRCRAFT ACCIDENT REPORT

OCCURRENCE NUMBER 05/2733

ROBINSON R22

ZK-HVN

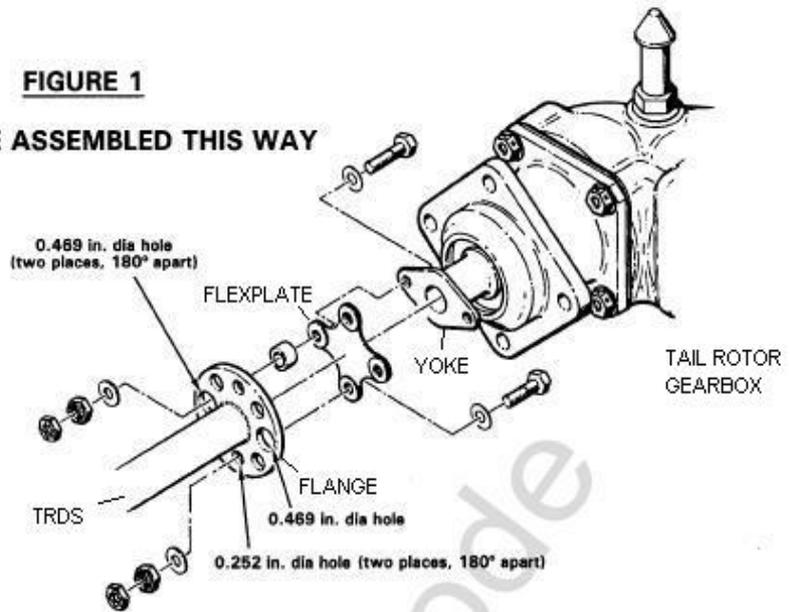
FIGURE 1
SHOULD BE ASSEMBLED THIS WAY

- 1.17.8 The tail rotor drive system is designed with ‘flexplates’ at two places along its length. The aft flexplate is installed between the aft flange of the TRDS and the tail rotor gearbox input yoke. This design allows normal shaft rotation for transmitting power to the tail rotor gearbox, while permitting misalignment between the TRDS and the tail rotor gearbox without overstressing the TRDS (shaft misalignment normally occurs in two modes; at start up and shut down because of clutch motion, and in flight as a result of tailcone deflections due to tail rotor thrust changes, air loads, and inertia loads from the stabilizers). A damper bearing is also installed one third of the way from the front of the TRDS to add support and eliminate certain harmonic vibrations during normal operation. The aft coupling has a fail safe design using two small bushes extending into clearance holes in the flange enabling continuous drive to the tail rotor gearbox in the event of the failure of the aft flexplate.

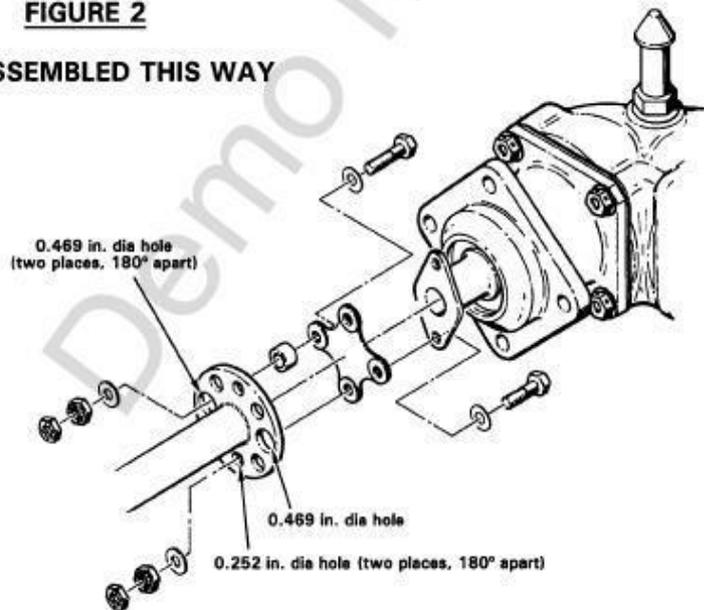
- 1.12.11 Further examination of the aft coupling revealed that it was assembled incorrectly, (refer to Figures 1 and 2, page 8).
- 1.12.12 The bolts designed to attach the flexplate to the tail rotor gearbox input yoke had been inserted through the yoke, the flexplate, and then directly into the attachment holes in the flange. Correct assembly would have the bolts inserted through the yoke, the flexplate, and then through two small bushes. The function of the bolts is to attach the flexplate to the yoke, not the yoke to the flange. Two other bolts designed to attach the flexplate to the flange had been incorrectly used to attach the two small bushes to the flexplate. This incorrect assembly had the effect of securing the TRDS directly to the yoke thus removing the ability of the flexplate to compensate for any misalignment or flexing of the TRDS.

FIGURE 2
WAS ASSEMBLED THIS WAY

- 1.17.9 During final installation of the TRDS into the helicopter the aft coupling of the tail rotor drive system was assembled incorrectly (as explained in 1.12.12). The aft flange of the TRDS was bolted directly to the input yoke of the tail rotor gearbox effectively changing the role of the flexplate from that of a flexible drive coupling component to that of a rigid spacer. This incorrect assembly resulted in the elimination of the designed flexibility of the aft coupling and the function of absorbing TRDS misalignment loads was now transferred to the next most suitable location, the root weld of the TRDS flange itself. This change caused flexing of the weld resulting in fatigue cracking that was followed soon after by

failure of the TRDS resulting in a complete loss of tail rotor drive and yaw control.

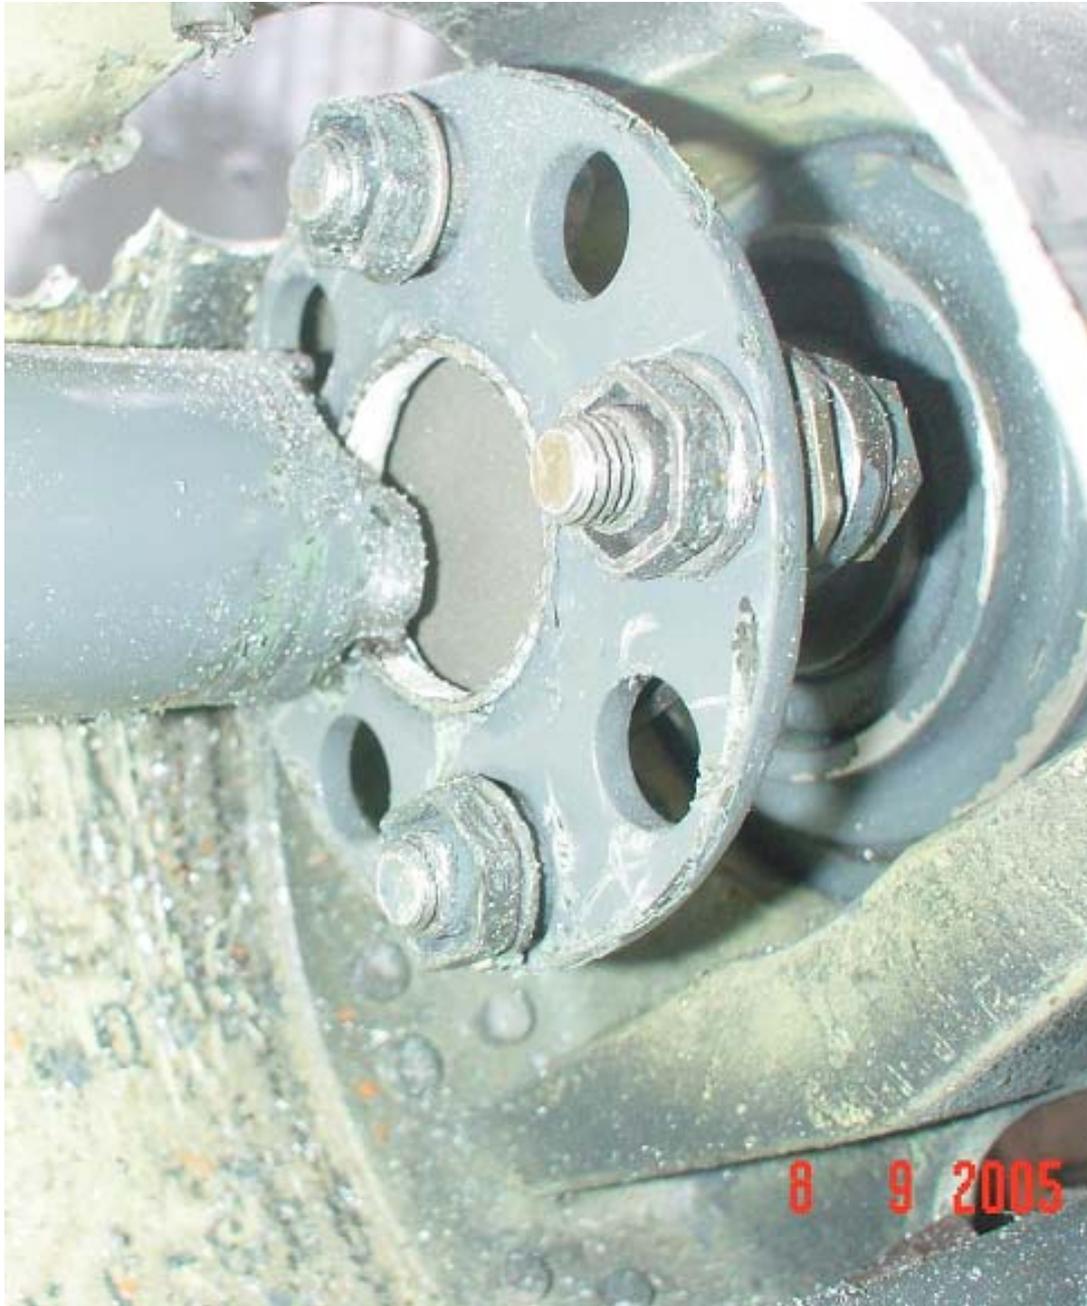
- 1.12.9 The wreckage was recovered to a maintenance facility where a detailed examination was conducted.
- 1.12.10 It was found that the tail rotor drive shaft (TRDS) flange had failed completely around the circumference of the root weld. Additionally, the TRDS was no longer supported by the damper bearing as the bearing supporting link had also failed. The TRDS was removed from the tailcone, leaving the flange (normally an integral part of the TRDS) still attached to the aft flexplate and yoke that make up the TRDS aft coupling assembly.

Failed TRDS in Situ with Incorrectly Assembled Aft Coupling

- 1.16.2 Detailed metallurgical examination of the failed TRDS flange was performed at a specialised laboratory by a qualified metallurgist. The report revealed that: *"The occurrence of fatigue cracking around several parts of the circumference of the shaft indicates that the shaft failed due to rotational bending fatigue. The fatigue initiated in the toe of the fillet weld on the shaft side of the weld"*.

The report concluded: *"The cause of the fatigue was probably the reported incorrect assembly between the drive shaft and the gearbox, introducing bending and probably vibration stresses brought about by the inability of the shaft to absorb small differential movements during rotation"*.
